Sunset Property Inspection

Confidential - Property Inspection Report - Confidential

2159 Flying Hills Ln
Inspection Prepared For: Christian Castner
Agent: -

Date of Inspection: 5/27/2021
Year Built: 1979 Size: 3209

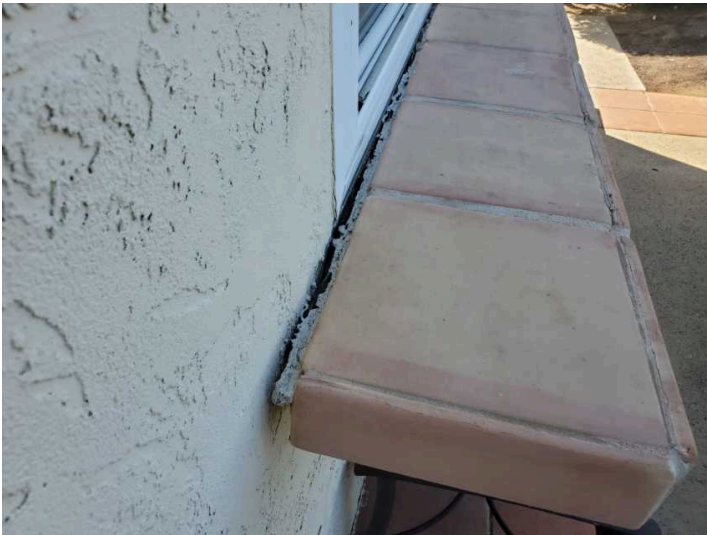
Materials:
 • **Stucco -- Portland cement exterior plaster**
 Observations:
 • The shelf mounted outside the kitchen window is failing. The shelf brackets have become loose and have created openings in the stucco. Potential for moisture intrusion exists. Recommend repairs by a qualified contractor.
 • We recommend sealing holes & gaps in the stucco to keep water infiltration from causing further damage.

Shelf pulling away from stucco

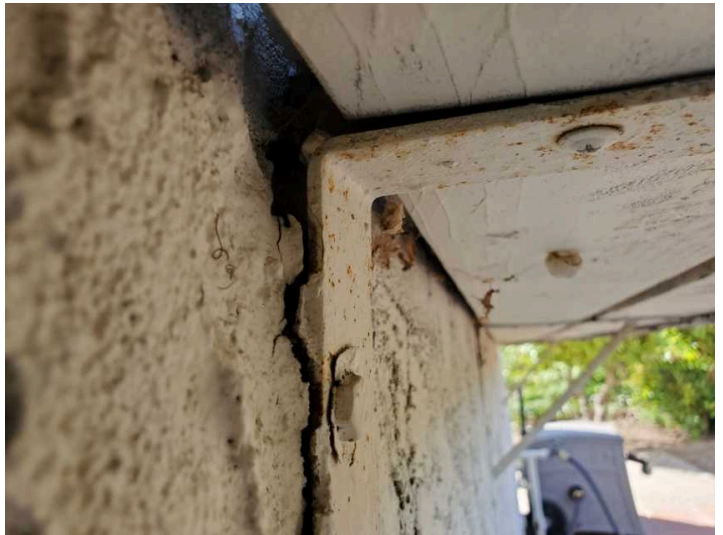
Gap at stucco and shelf brace

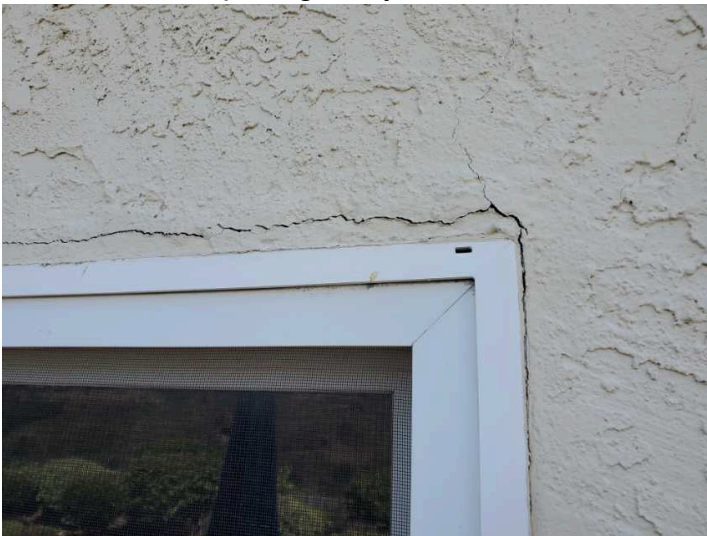
Crack

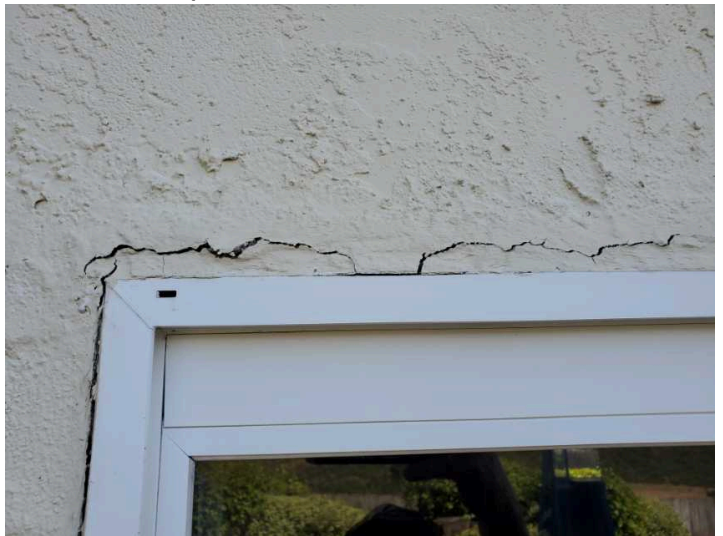
Crack

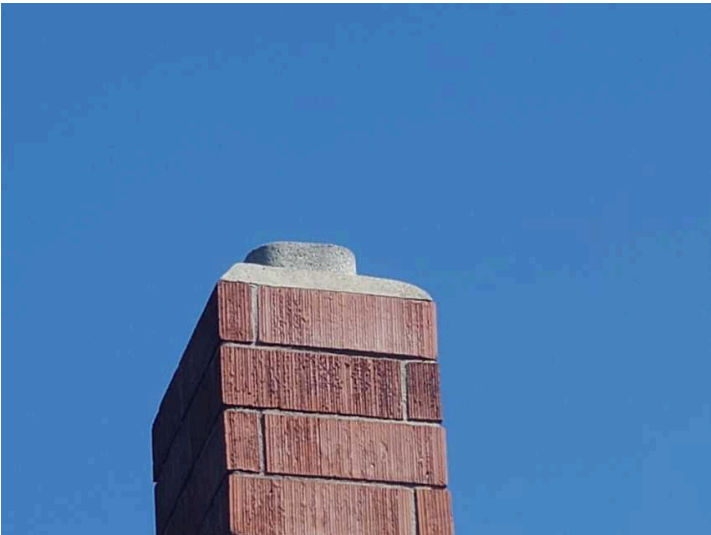
- IMPROVE: Chimney rain cap not present on chimney. Caps will help prevent moisture intrusion into the chimney flue and possibly the structure interior by unwanted wildlife. Recommend having a chimney cap installed.

No rain cap/spark arrestor

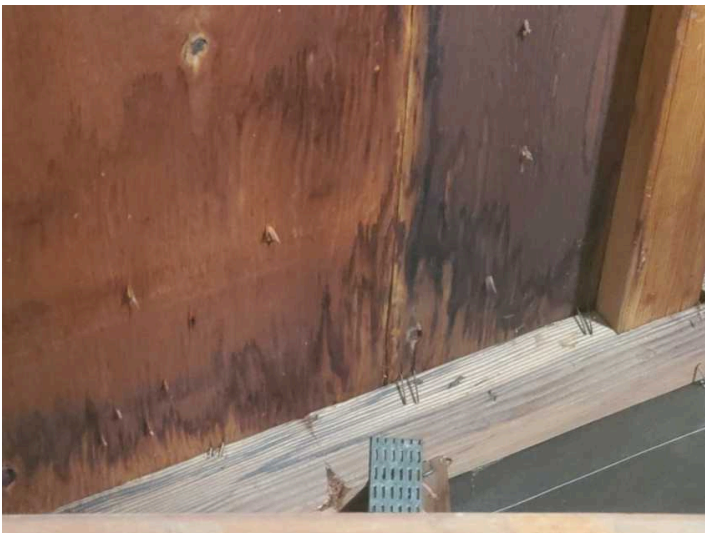
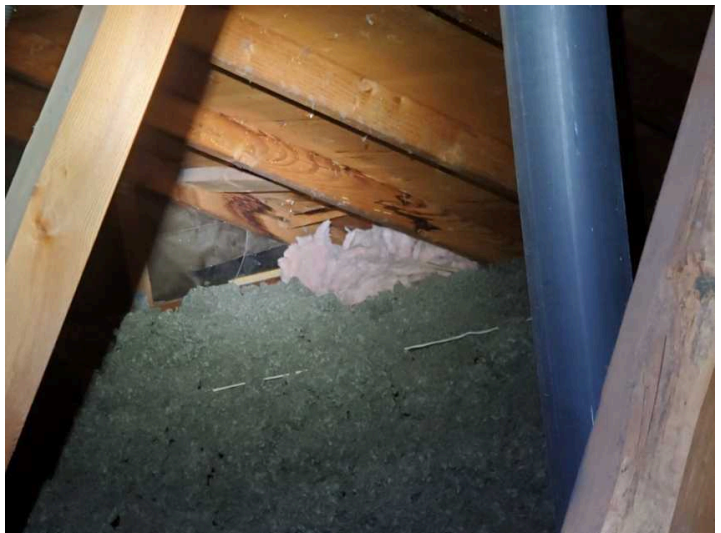
- Stain(s) observed in the roof sheathing and/or framing at various areas in the garage. Water stains on the ceilings, or on the framing within attics will not necessarily confirm an active leak. This roof may have had past repairs preformed since the roof covering was installed. The staining found in the garage may have resulted from previous roof leaks which may have been repaired. Staining in the garage was dry at the time of the inspection. We recommend asking the seller if repairs were performed by a qualified licensed roof contractor or seek further evaluation.
- Stains, possible organic growths noted at sections of the roof framing in areas of the attic space. Unable to determine the exact cause. You should consider having this further explored by a licensed environmental hygienist to determine if repairs are needed at this time.

Moisture stains

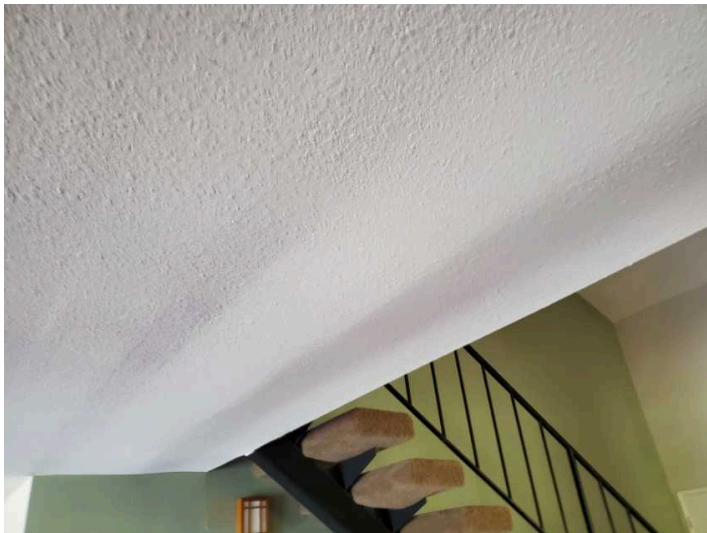
- Some cosmetic, poor workmanship/poor repairs noted at various areas of drywall in the home. Proper repairs by a qualified interior finish contractor is recommended.

Ceiling drywall

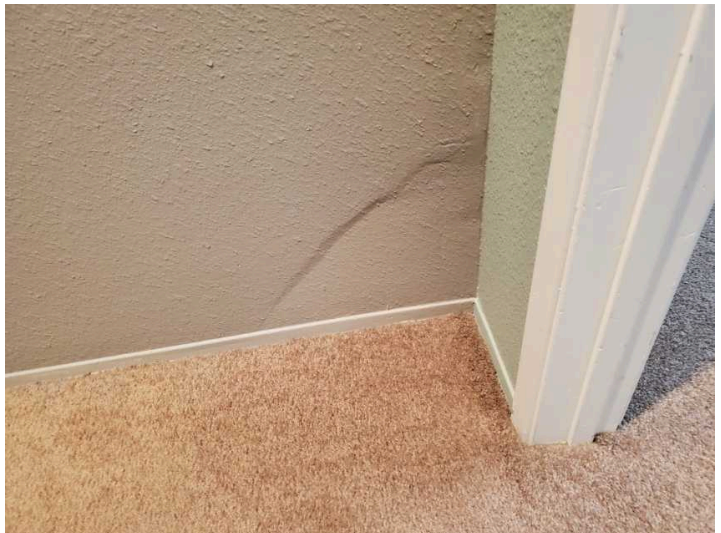
Hallway drywall

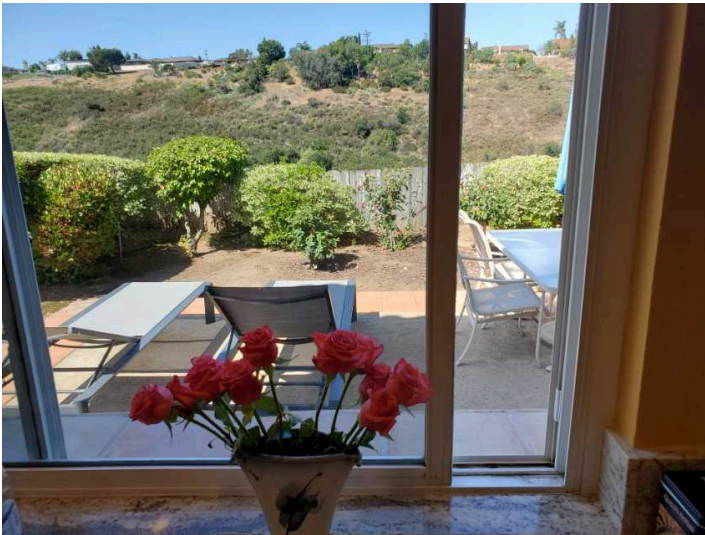
Missing screen

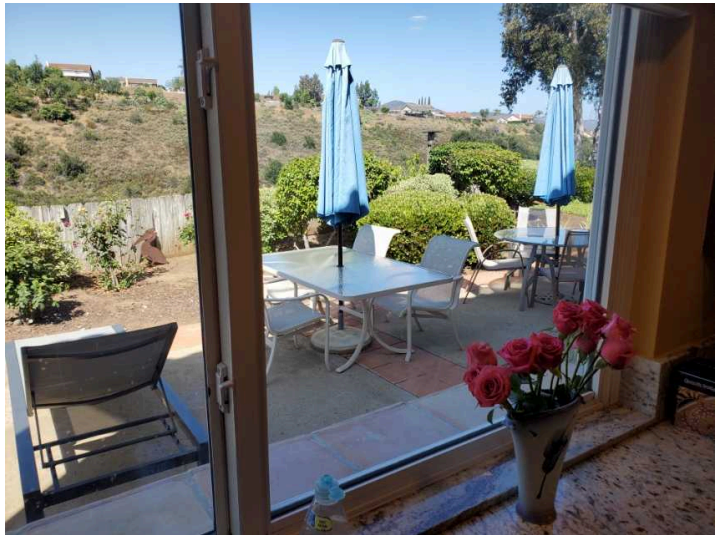
Difficult to slide

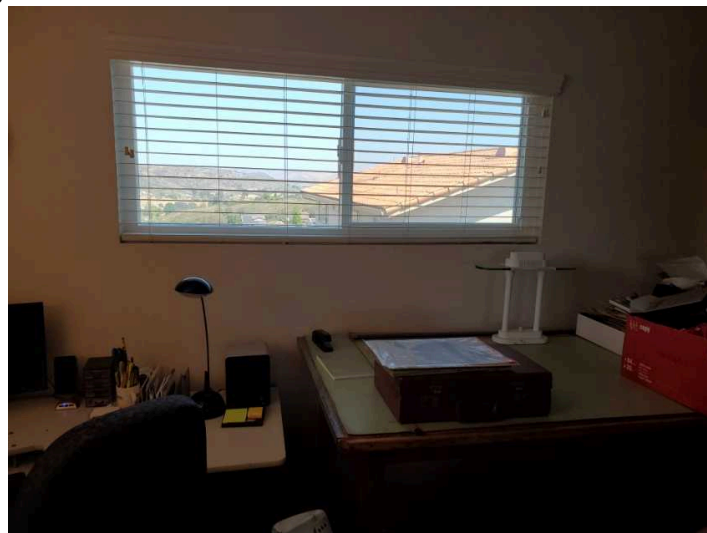
Not accessible

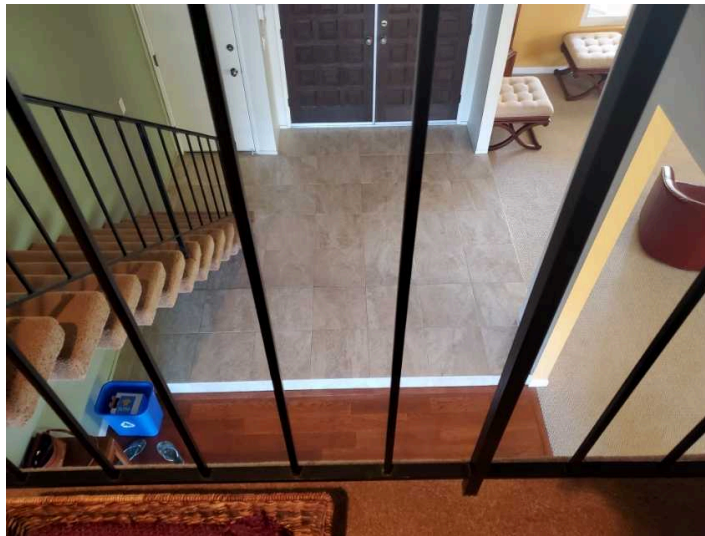
- SAFETY CONCERN: The opening between Balusters (vertical posts comprising barrier in railings) is too wide. A toddler can very easily fall through this spacing from the landing to floor below. Although this spacing was adequate when home was built -- modern building safety standards is now a maximum of 4" between balusters. Consider installing appropriate safety guard as determined.

Fall hazard

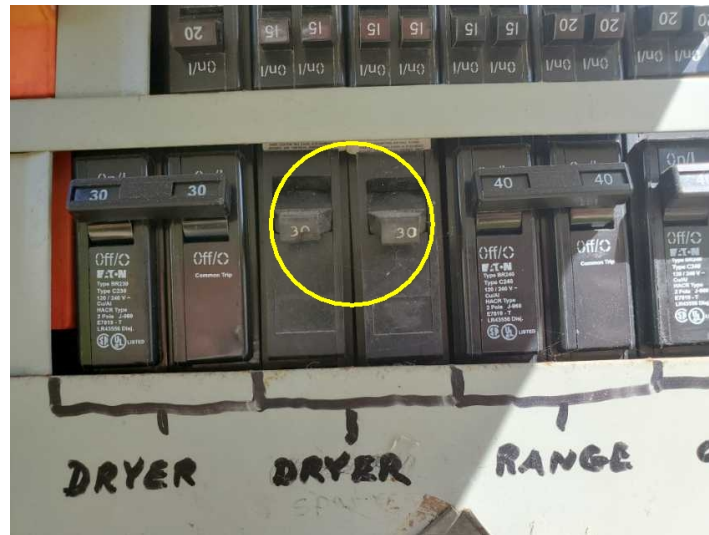
- No deficiencies noted
- Unused 30 amp breakers observed in the panel.

Unused breakers

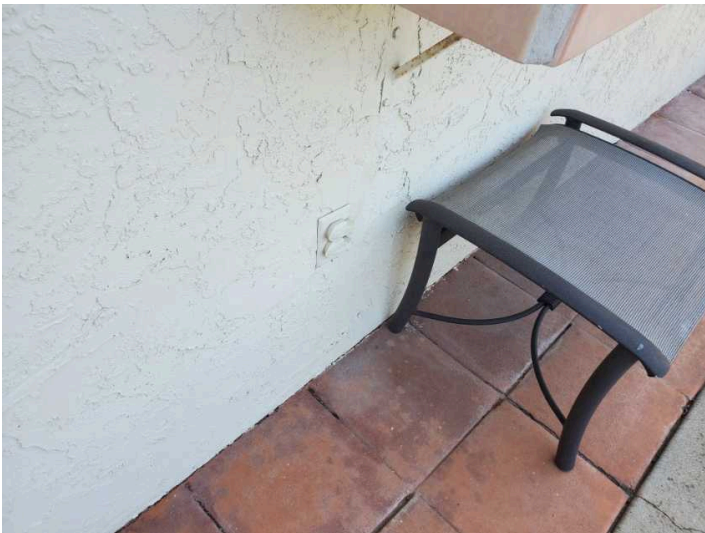
- Receptacles located at the exterior of the home are without the benefit of In-use covers. In-use covers help protect the outlets from moisture while a plug or cord is in use. Installation of proper In-use covers are recommended to be installed at all exterior receptacles by a qualified electrician.
- Switched receptacles are prohibited from being served by dimmers. This is an electrical hazard. Recommend replacing the dimmer switch with a standard toggle switch.
- Missing globe. Location: Side patio. Replacement is recommended.

In-use cover not installed

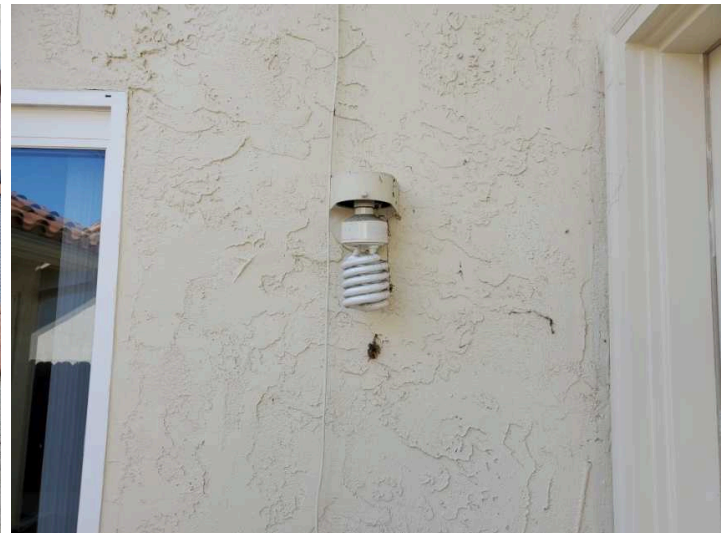
Missing globe

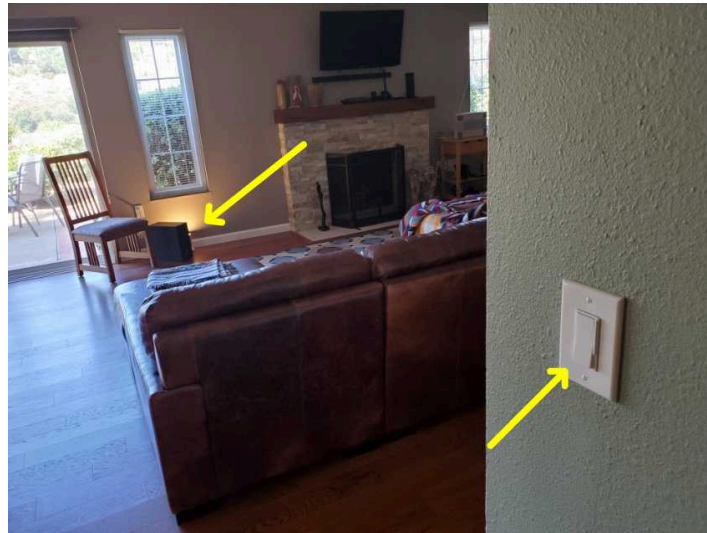
Dimmer switch and associated receptacle

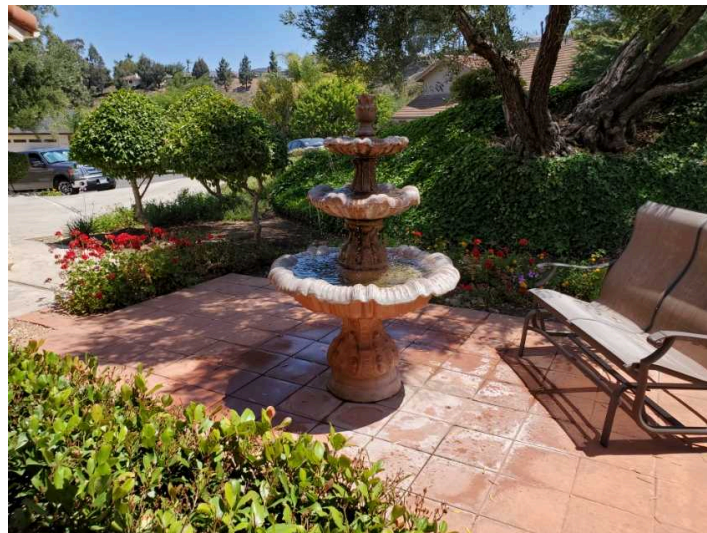
- Unable to determine if water fountain has GFCI protection. Power source could not be identified. Recommend further review by a qualified electrician.
- This house was built prior to the requirement for the installation of GFCI receptacles in certain locations in the house. The locations where GFCI receptacles are required has increased, but it is not required to retrofit older homes unless a remodel takes place. For safety, it is advisable to upgrade all receptacles within 6 feet of a plumbing fixture, in garage, all kitchen counter top outlets, and at exterior, to GFCI protected outlets. A qualified electrician is recommended.

No GFCI located

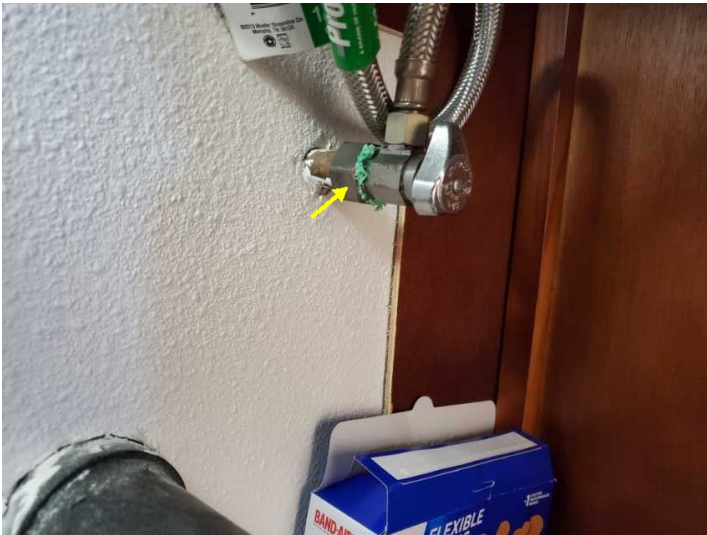
- Corrosion was found at both the water supply shut-off line under the master bathroom sink. Left uncorrected, the valves and/or lines may eventually leak and lead to moisture intrusion problems (e.g., wood damage, mold). Recommend further review for repairs by a qualified plumber.
- Copper pipes, Limited areas visible. Water flow was checked from all accessible plumbing fixtures. The life expectancy of copper plumbing is 60-90 years, though intermediate repairs may be necessary much sooner.
- Damaged supports to pipes located in the attic. The copper supply piping not being properly supported and is lying on top of ductwork and framing. Recommend repairs be performed to prevent potential damage.

Corrosion

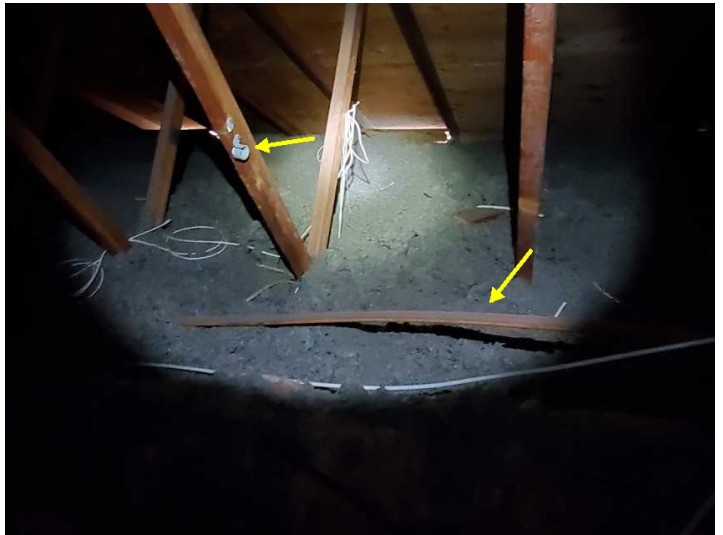
Broken support and unsecured piping

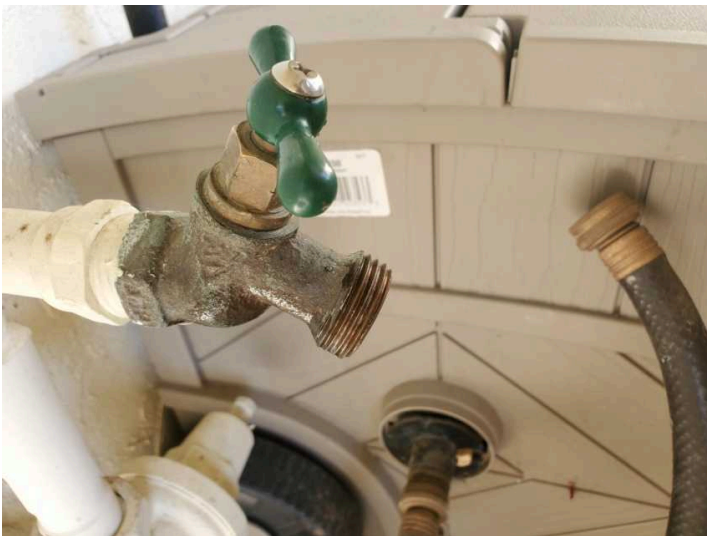
- IMPROVE: There are no anti siphon devices at some exterior faucets. Although this was not a requirement for when this house was constructed, it is recommended that these devices be installed at all exterior hose bibs. These are designed to prevent contamination should there be a pressure drop in the cities system. Anti-siphon devices will prevent water from being siphoned backwards potentially contaminating the public drinking water. Recommend installation of these devices.

Missing anti-siphon valve

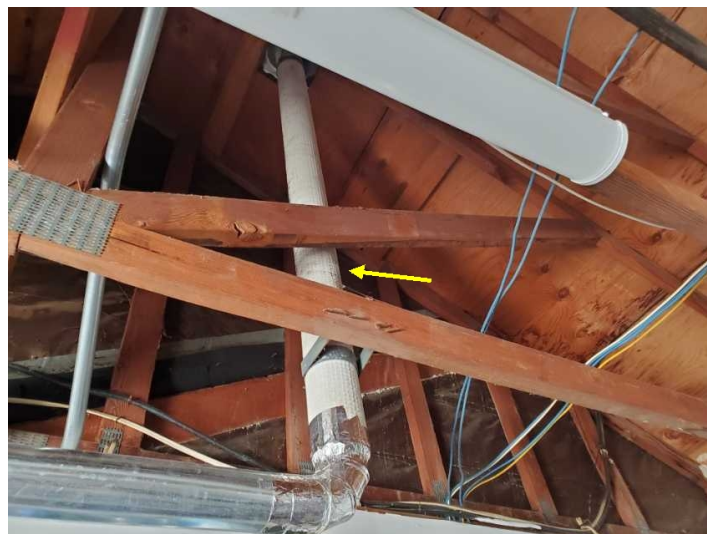
In summary, if it has become soft and friable, or if transite pipe is damaged or is cut mechanically (such as by using power equipment), friable, airborne asbestos fibers may be generated - a health and potentially a costly cleanup concern.

Transite

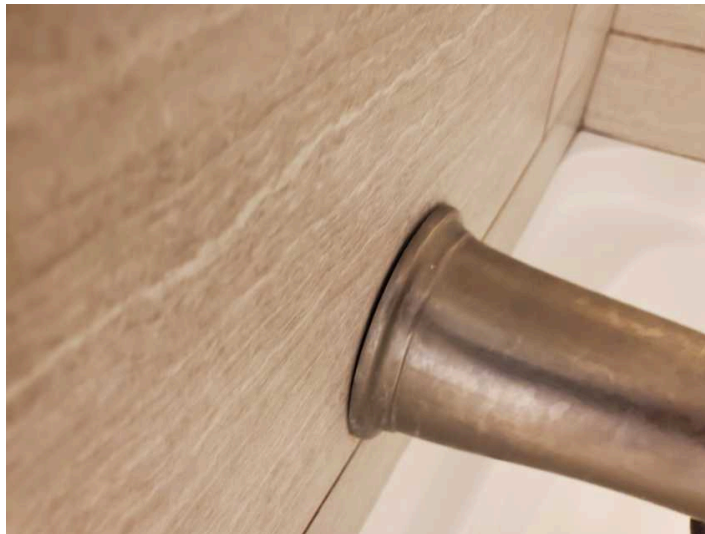
- There is a gap between the shower wall and the base of the tub spout. Water can enter the wall cavity and cause hidden damage. This area should be caulked as needed and maintained regularly.

Caulking needed
