Inspection Report
1745 South Harvard Boulevard, Los Angeles 90006

Report ID
NXT-229-001696

Inspection Date
June 17, 2021 at 10:00 AM

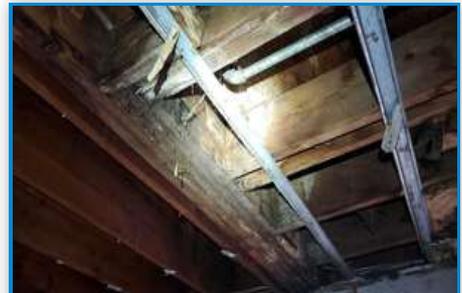
Location: GARAGES

1.5 Microbial growth

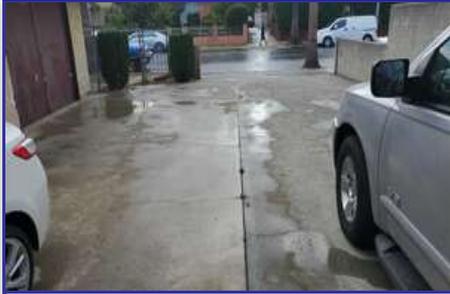
Location: EXT GROUNDS

Minor cracks were noted in the sidewalk/driveway at the time of the inspection. These cracks were less than 1/4 inch. The inspector recommends that a professional contractor seal the cracks with concrete grade sealant periodically to keep moisture from collecting under the slab and cause further damage. If you are considering doing the repair yourself, see the DIY linked video, to assist you in your decision.

2.1 Typical concrete cracks

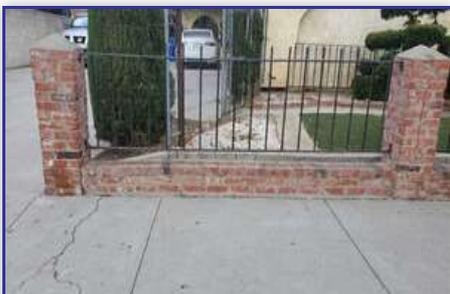
Location: FRONT FENCE

Areas of the fencing are deteriorated and damaged. Fencing should be repaired as needed.

1.1 Damaged

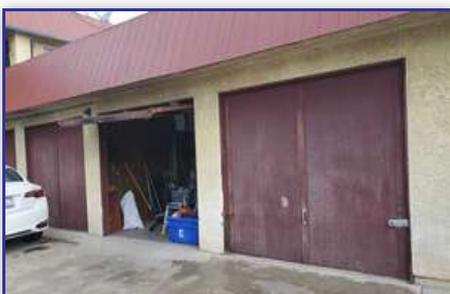
Location: EXT BUILDING

At the time of the inspection, exterior door was weathered or damaged. Weathering includes fading of paint and deterioration of the threshold, jamb and trim. The Inspector recommends that the affected area(s) be evaluated, replaced or repaired, as needed, by a professional contractor.

1.1 Damaged door frames

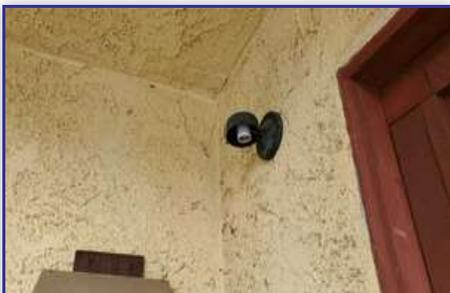
Location: EXT BUILDING

At the time of inspection, the glass which surrounds the exterior light fixture, was missing. The Inspector recommends that this be evaluated and repaired or replaced by a professional contractor.

1.1 Missing light bulb and cover

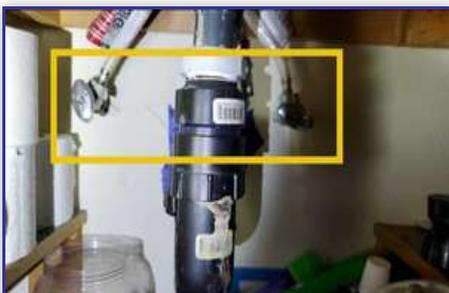
Location: 1745/ BEDROOM 1/BATHROOM

Water shut-off valves under the sink were inoperative/rust/leaking/broken which makes plumbing repairs for the sink difficult to work on. Recommend that water shut-off valves replaced for both cold and hot water lines by a professional plumbing contractor.

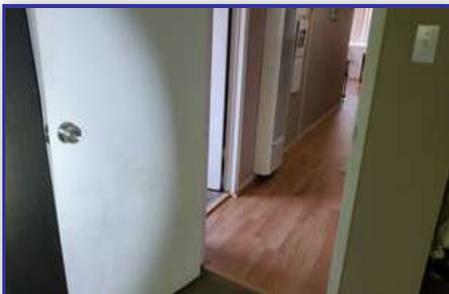
Location: 2ND FLOOR UNIT 1749 /BEDROOM 1

One or more doors wouldn't latch or were difficult to latch. Currently the door handle does not need to be turned for the door to be opened. Recommend that a qualified person repair as necessary. For example, by adjusting latch plates or locksets.

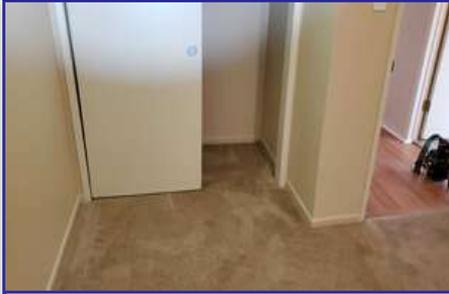
Location: 2ND FLOOR UNIT 1747 /BEDROOMS

The door guides servicing the closet in one or more rooms were damaged, missing, or installed incorrectly at the time of the inspection. This leaves the doors where they swing in and out and can fall off of the track. The inspector recommends that they are repaired or replaced as needed.

3.1 Missing lower guides

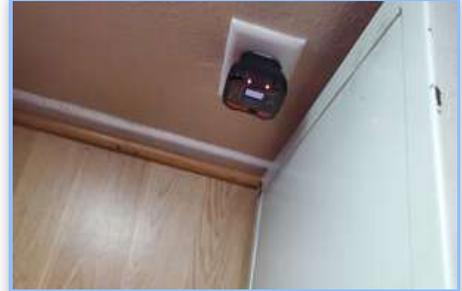
Location: UNIT 1745/LIVINGROOM

1.2 Improper wire connection

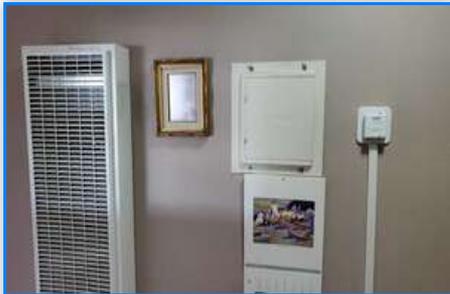
Location: 2ND FLOOR UNIT 1749 /FURNACE

At the time of inspection, the furnace was not responding to the thermostat. The Inspector recommends that the furnace and thermostat be evaluated and repaired as needed by a HVAC contractor.

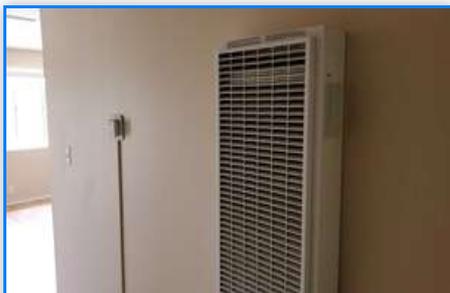
Location: 2ND FLOOR UNIT 1747 /FURNACE

At the time of inspection, the Inspector recommends the furnace be serviced by a professional HVAC contractor, based on its condition. Annual servicing is necessary for systems fueled by gas or oil and for safety reasons, as a professional HVAC contractor will inspect, clean, and make any necessary repairs. A certification should be given to the homeowner after service and repairs are performed.

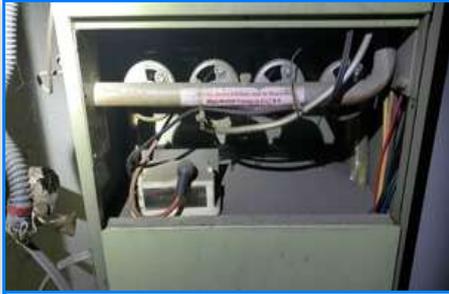
Location: 1745/ FURNACE

The furnace was at or past its recommended lifespan. It was visibly old and dirty and should be serviced at the least. The Inspector recommends that the furnace is evaluated, serviced or replaced, as needed, by a professional HVAC contractor, to ensure the best possible working condition.

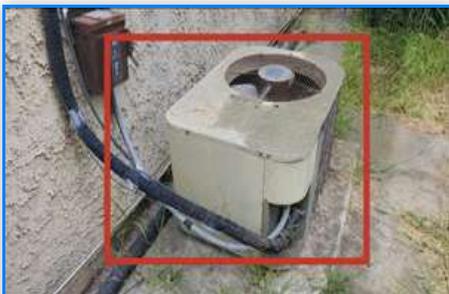
Location: EXT BUILDING/ AC

At the time of inspection, the air-conditioning system was old and inoperable. The Inspector recommends that the affected area(s) be evaluated, replaced or repaired, as needed, by a professional contractor.

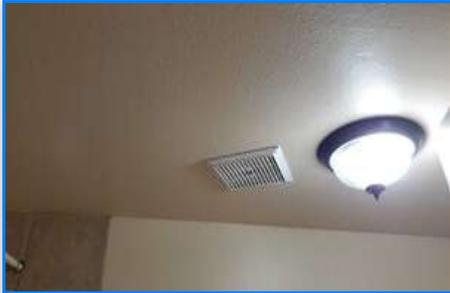
Location: 2ND FLOOR UNIT 1747 /HALLWAY

At the time of the inspection, the bathroom exhaust vent fan made unusual noises when turned on. The Inspector recommends that the bathroom exhaust vent fan is evaluated, replaced or repaired, as needed, by a professional contractor.

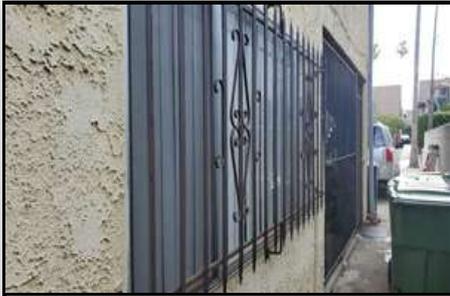
Location: EXT BUILDING

Fixed security bars around windows, does not allow security bars to open. This poses a fire safety concern as it prevents exit from the home in case of fire. The Inspector recommends that the security bars be evaluated, replaced or repaired, as needed, by a professional contractor, to allow opening bars without special tools or keys.

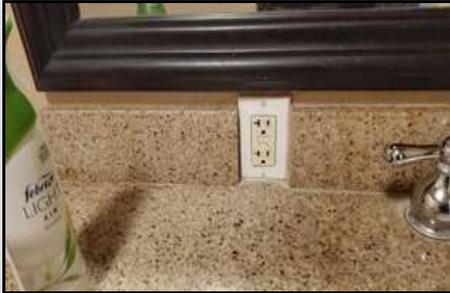
Location: 1745/ HALLWAY BATHROOM

At the time of inspection, one or more bathroom GFCI electrical outlet made a buzzing sound when the reset button was tested. Recommended these GFCI receptacles are evaluated, repaired or replaced by a professional electrical contractor.

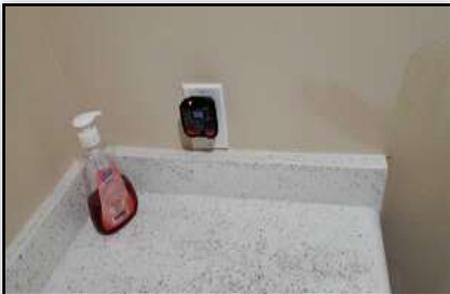
Location: 2ND FLOOR UNIT 1747 /HALLWAY BATHROOM

One or more electrical outlets were broken or damaged in the bathroom. Recommend that a professional electrician evaluate, repair or replace these electrical outlets as necessary. If replacing, consider installing GFCI outlets for safety reasons.

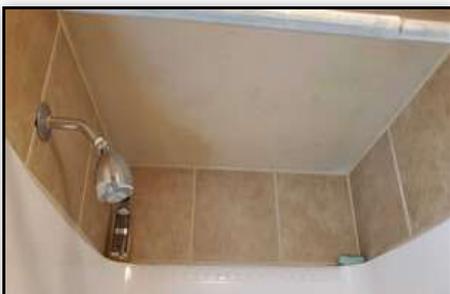
Location: 1745/ BEDROOM 1/BATHROOM

Microbial like growth or a musty odor was found at one or more locations. We did not test the substance through a lab so proper verification was not made. Growth is normally caused by moist conditions, plumbing or roof/exterior moisture issues, and issues with improper ventilation. We recommend that after the areas are verified as mould, mitigation, for mold/moisture should be done by a professional contractor.

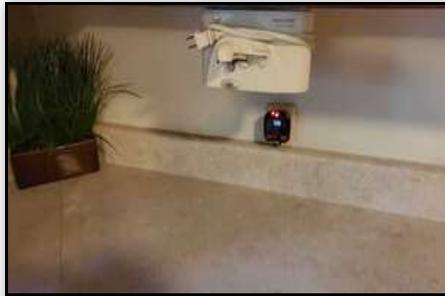
Location: KITCHEN

Kitchen electrical outlets were operable at the time of the inspection but no Ground Fault Circuit Interrupter (GFCI) protection were installed. GFCI protection should be installed for outlets within 6 feet of plumbing fixtures or on kitchen counters, as they were required in kitchens starting in 1987 by the NEC. Recommended this be done by a professional electrical contractor.

1.2 Missing gfci (update)

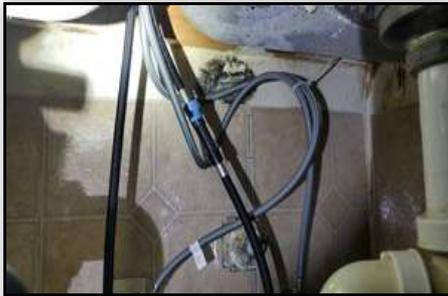
Location: KITCHEN 1745

Microbial Growth Matter is a type of fungus that consists of small organisms found almost everywhere. ... In small amounts, mold spores are usually harmless, but when they land on a damp spot in your home, they can start to grow. When mold is growing on a surface, spores can be released into the air where they can be easily inhaled. We recommend samples taken for any type of active contamination.

1.1 Microbial growth

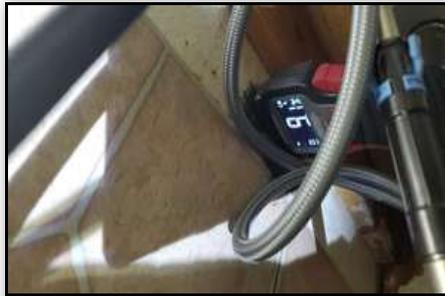
Location: KITCHEN 1745

1.2 Moisture present

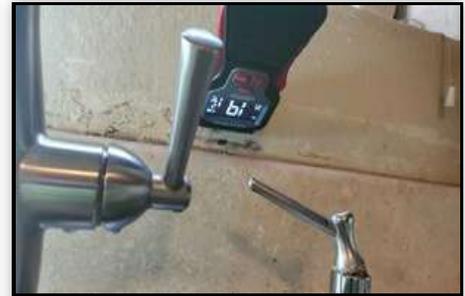
Location: KITCHEN 1745

1.3 Moisture present

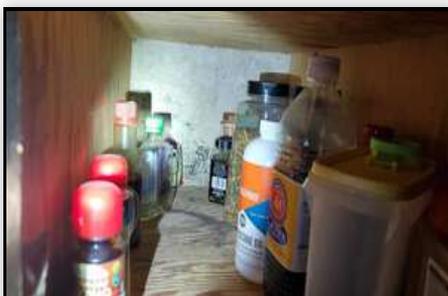
Location: 2ND FLOOR UNIT 1749 KITCHEN

1.4 Microbial growth

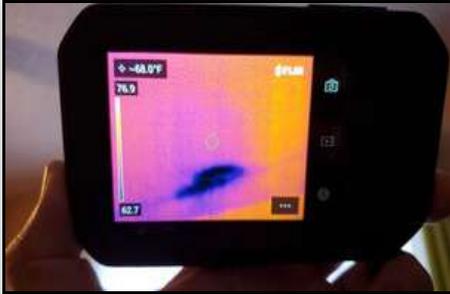
Location: 1745/ BEDROOM 2

We found one or more areas with thermal signatures that appear to moisture related issues. Verification of moisture should always be followed up with further testing with a moisture meter. All affected leaks should be found and repaired as well as any other areas that were damaged from this occurrence. All work should be performed by a professional contractor.

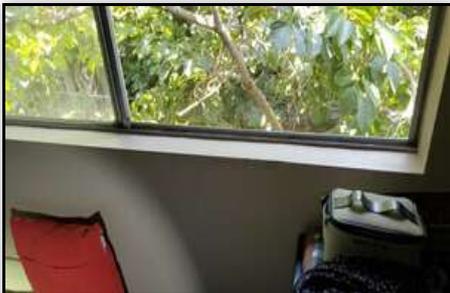
Location: 2ND FLOOR UNIT 1749 /BEDROOM 1

Microbial like growth or a musty odor was found at one or more locations. We did not test the substance through a lab so proper verification was not made. Growth is normally caused by moist conditions, plumbing or roof/exterior moisture issues, and issues with improper ventilation. We recommend that after the areas are verified as mould, mitigation, for mold/moisture should be done by a professional contractor.

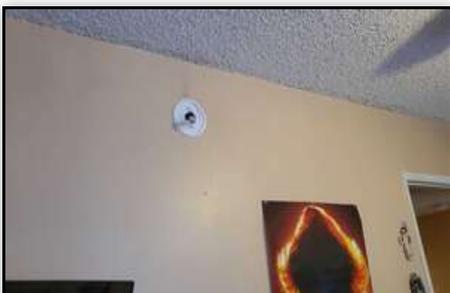
Location: 1745/ BEDROOM 2

One or more smoke detectors have been disconnected from the system. There may be issues with the system and with out a smoke detector you will not be alerted when there is a fire. The missing detectors will need to be installed and tested for proper operation.

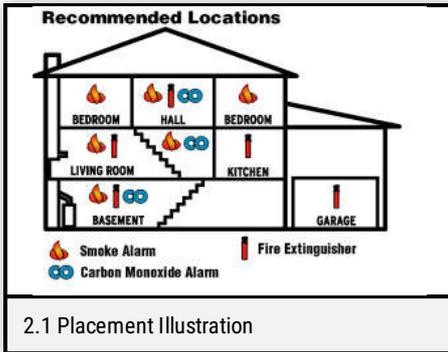
Location: 2ND FLOOR UNIT 1749 /BEDROOM 2

No smoke detectors were present in the structure. Smoke detectors should be installed in bedrooms, hallways leading to sleeping areas and on each floor. Client should add additional smoke detectors as needed. We recommend installing photoelectric type smoke detectors / alarms. Note: Homes built prior to 1992 were not required to have smoke detectors installed in each bedroom, only hallways. Regardless, calfire.ca.gov recommends installing smoke detectors in each bedroom for increased safety. Click here for more information.

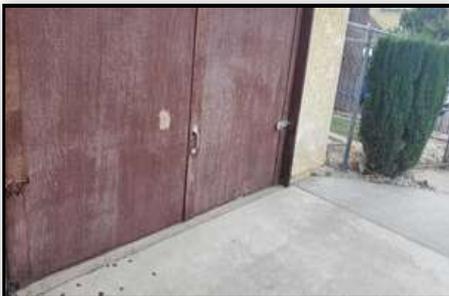
Location: GARAGES

No photo sensors were installed servicing the garage door. We recommend that they be installed.

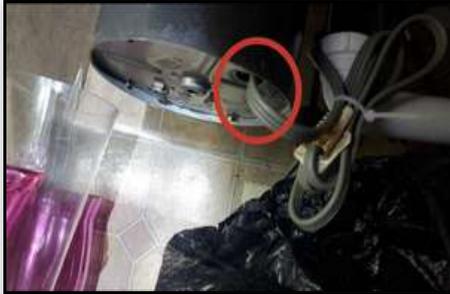
Location: KITCHEN 1745

The opening for the electric power cord to exit the bottom or side of a garbage disposal housing has sharp edges. The concern is that these sharp edges, due to use, vibration, reaching for items under the sink, or over time, may cut into the electric cord and cause a short or spark.

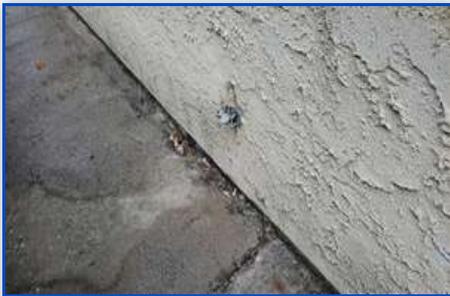
Location: EXT BUILDING

At the time of inspection, the hose bib handles are broken and/or missing. The Inspector recommends that the affected area(s) be evaluated, replaced or repaired, as needed, by a professional contractor.

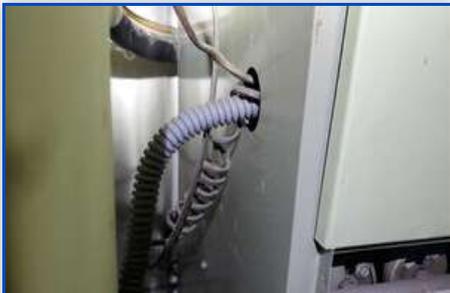
Location: 1745/ FURNACE

The gas-fired furnace flex connector was installed through the cabinet. This should be replaced with an approved hard pipe connection extended outside of the furnace cabinet that the flex connector connects to, and cannot be damaged sharp edges of the unit. All work should be performed by a professional plumbing contractor.

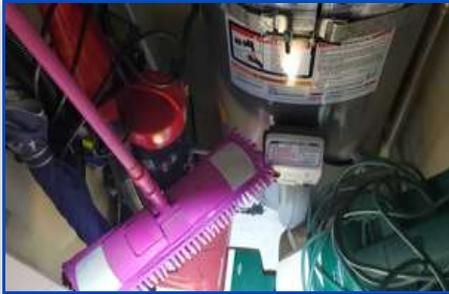
Location: 2ND FLOOR UNIT 1749/WATER HEATER

No drip leg is installed on the water heater gas supply line. Drip legs are intended to trap oil, scale, water condensation and/or debris from the gas supply lines before they reach and damage the water heater components. A qualified contractor should install a drip leg as per standard building practices.

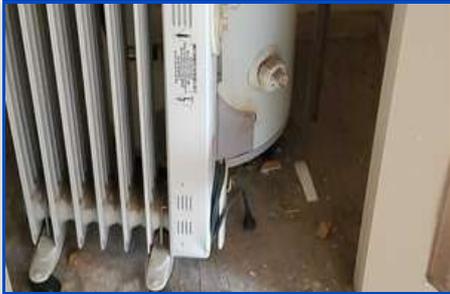
Location: 2ND FLOOR UNIT 1747 /WATER HEATER

There were scorch marks above the burner chamber indicating flame roll out. This unit needs to be serviced as soon as possible.

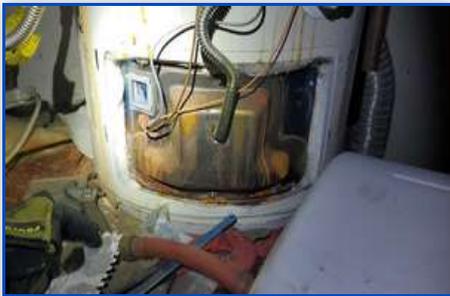
Location: 1745 WATER HEATER/GARAGE

Corrosion was found in one or more areas on the water heater. The water heater may be failing. A qualified plumbing contractor should evaluate and replace or repair water heater if necessary.

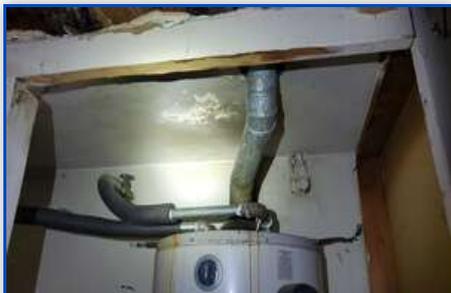
Location: 1745 WATER HEATER/GARAGE

Some or all of the water supply pipes were made of galvanized steel. Based on the age of this structure and the 40-60 year useful life of this piping, it will likely need replacing in the future. Leaks can develop, flow can be restricted due to scale accumulating inside the piping, and water may be rusty. Note that it is beyond the scope of this inspection to determine what percentage of the piping is older, galvanized steel, as much of it is concealed in wall, floor and/or ceiling cavities. Some insurance companies in the state do not insure galvanized plumbing. Recommend the following: ~ Budget for replacement in the future ~ Monitor these pipes for leaks and decreased flow in the future ~ Consider replacing old, galvanized steel piping proactively as client sees fit
