Property Inspection Report

, 1333 E J Street, Chula Vista, CA 91910
Inspection prepared for: & Joy & Rob Auman
Date of Inspection: 9/28/2021 Time: 5:30 pm
Age of Home: 1999 Size: 2314 sq ft (redfin)
Weather: Clear

Inspector: Eric Martinez
NACHI12100924
2122 W Mission Rd, Escondido, CA 92029
Phone: 619-501-8282
Email: emartinez@theinspectorscompany.com

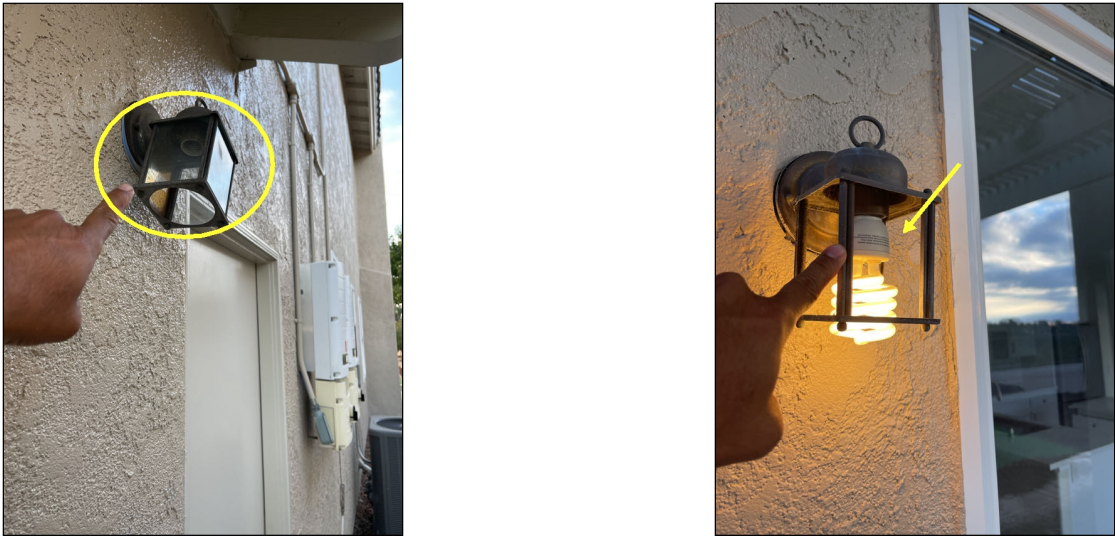
| Grounds | | |
|--|---|--|
| Page 9 Item: 9 | Lighting Condition | 9.1. Exterior light covers damaged/missing bulbs/non functional in various areas. |

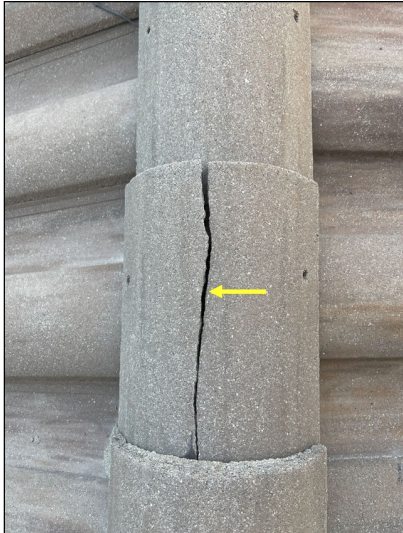
| Grounds | | |
|--|---|--|
| Page 13 Item: 1 | Roof Condition | 1.2. The tile roof was observed with cracked/chipped tiles in various locations. Seek a licensed roofing contractor for further evaluations, inspection and repairs. |

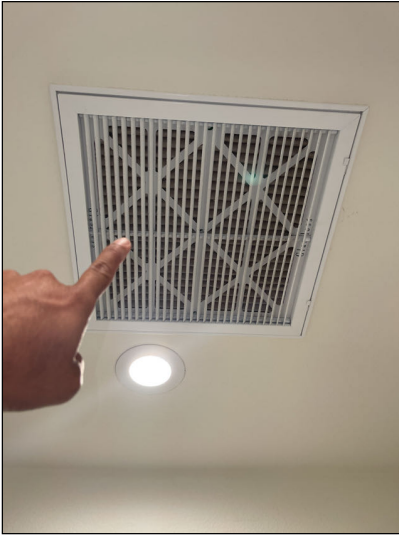
| Page 26 Item: 7 | Filters | 7.1. The HVAC filters are dirty. Needs replacement. Advise correcting by a qualified professional. |

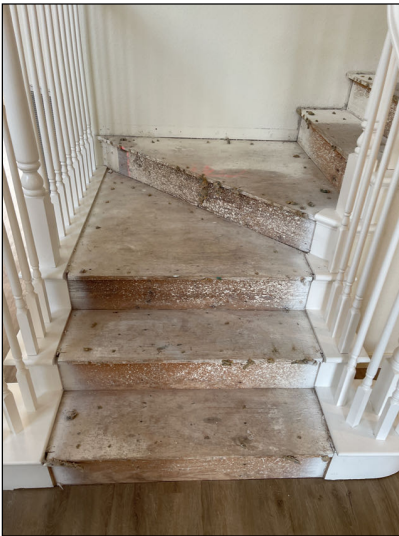
| Page 34 Item: 2 | Floors Condition | 2.1. Flooring/carpet not installed in some areas. |

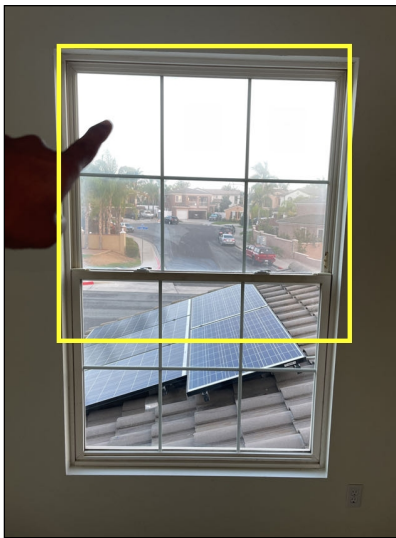
| Page 37 Item: 2 | Window Condition | 2.1. Bedroom windows show signs of loss of seal/condensation. |

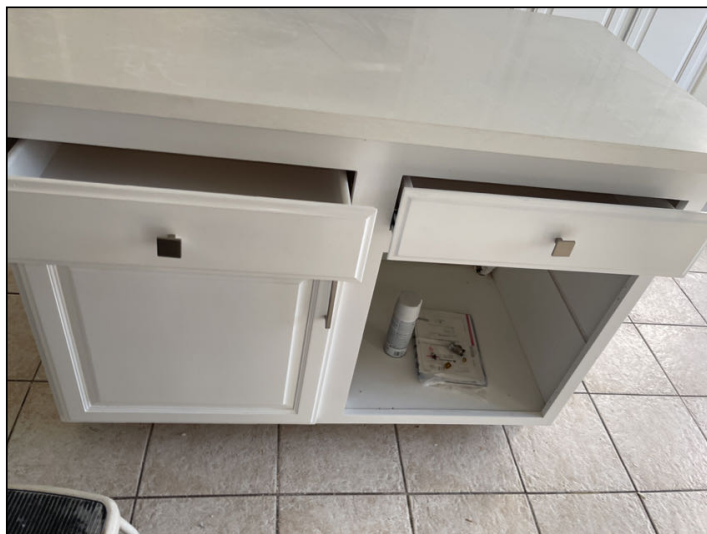
[6.1. Cabinets/shelving are missing/incomplete.](#)

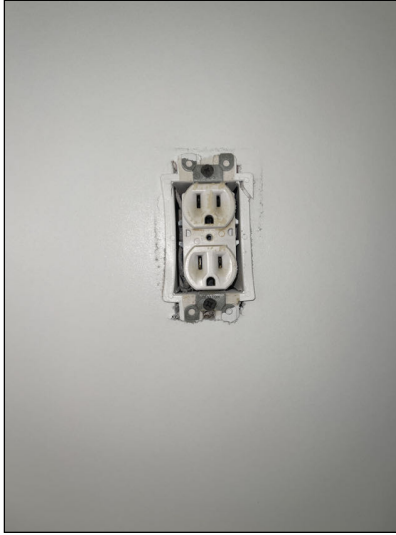
| Page 49 Item: 8 | Electrical | 8.1. Outlet covers missing inside the vent cabinet. |

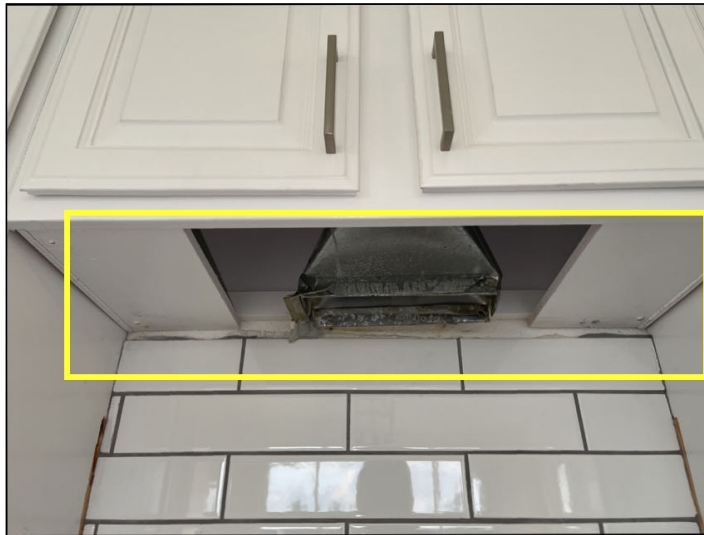
| Page 52 Item: 15 | Vent Condition | 15.1. Fan hood not installed |

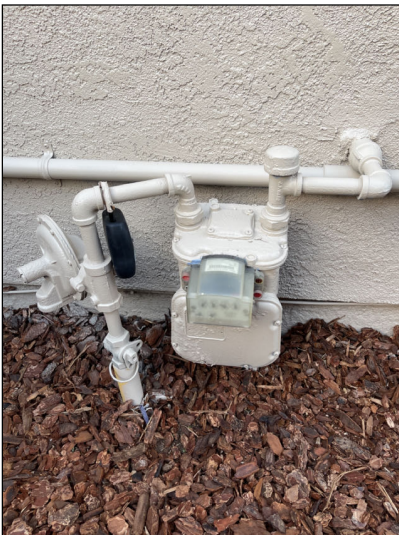
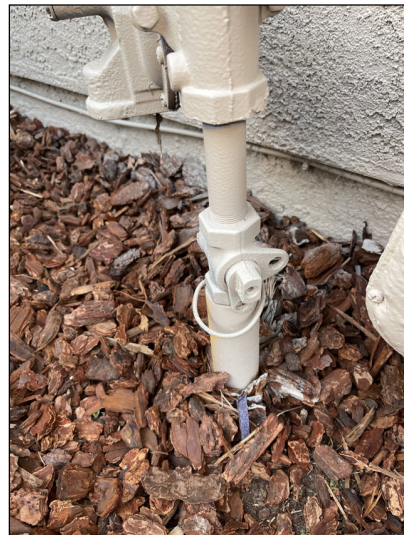
4.2. There is no wrench at the gas shut-off valve to facilitate an emergency shut-off, and inasmuch as such tools are relatively inexpensive we recommend that you buy one and leave it in-place on the valve.

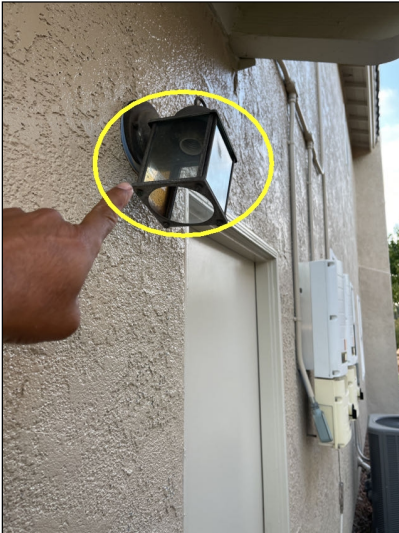
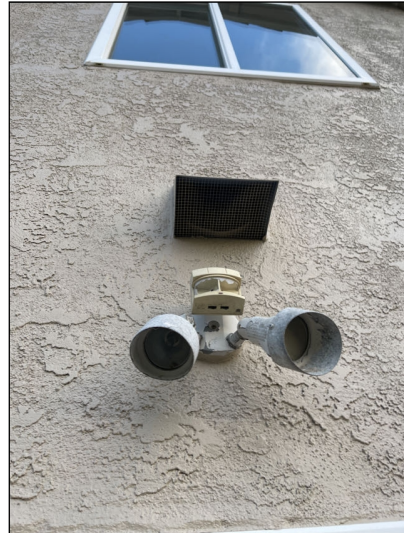
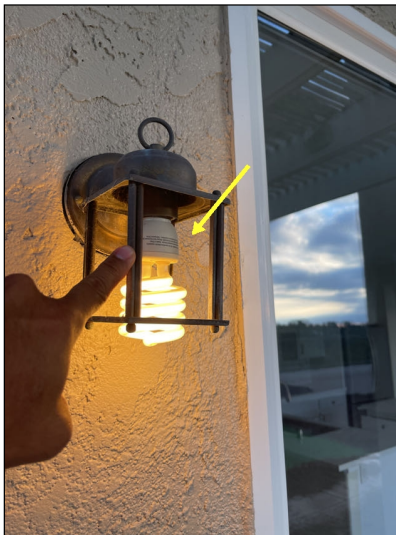
9.1. Exterior light covers damaged/missing bulbs/non functional in various areas.

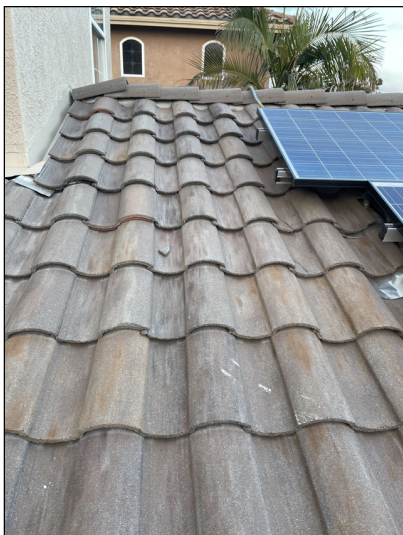
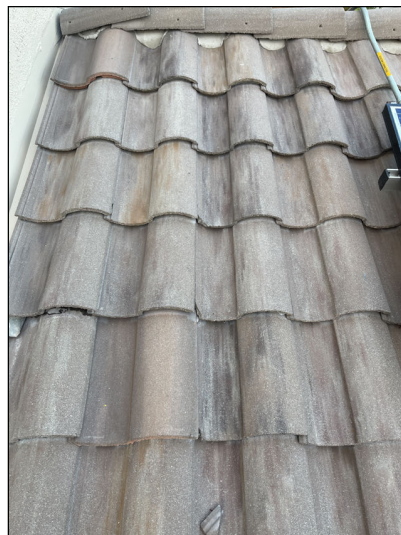
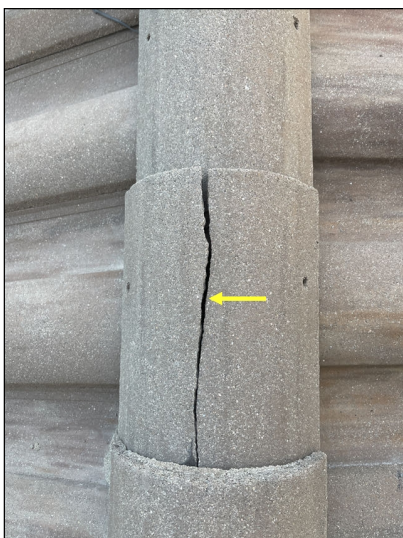
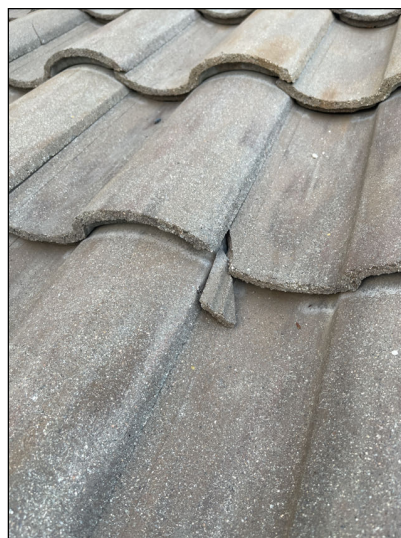
1.2. The tile roof was observed with cracked/chipped tiles in various locations. Seek a licensed roofing contractor for further evaluations, inspection and repairs.

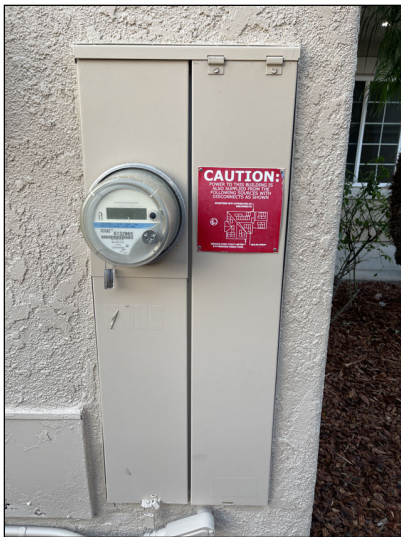
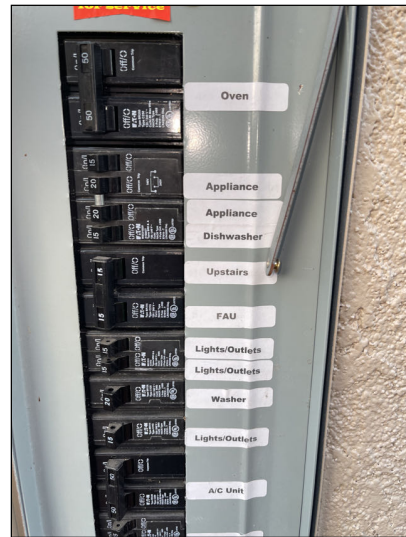
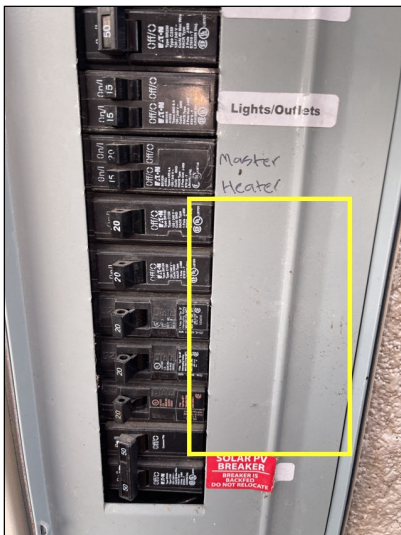
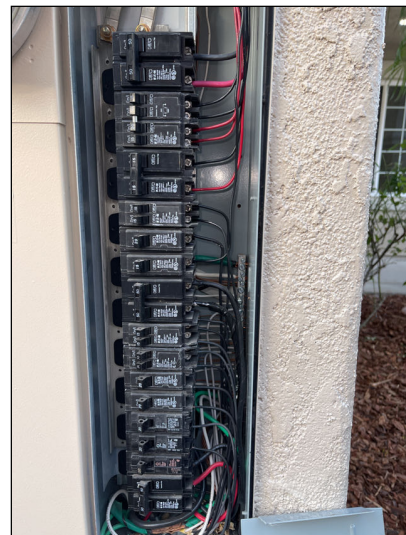
2.2. Knockouts need snap-in caps inside panel box & should be installed to keep mice out of panel box and to avoid potential electrocution hazard.

2.3. The main electrical panels dead front cover is not fully labeled. Seek a licensed electrical contractor for further evaluations and repairs.

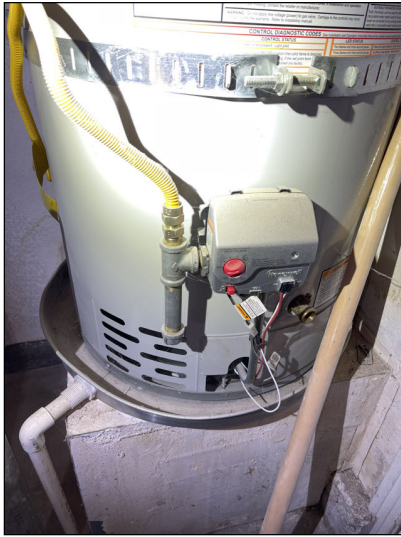
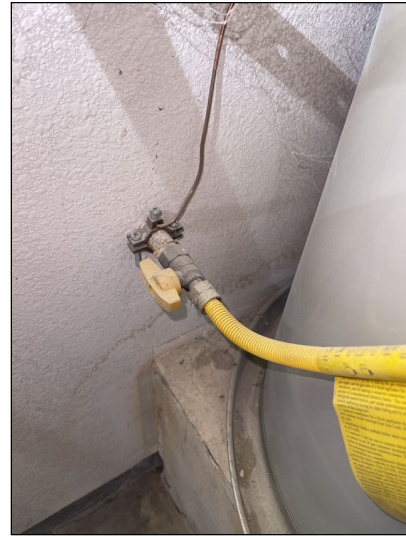
8.2. Gas water heater is not equipped with a sediment trap drip leg. Current standards require a drip leg at the gas connection. Seek licensed plumbing contractor for repairs.

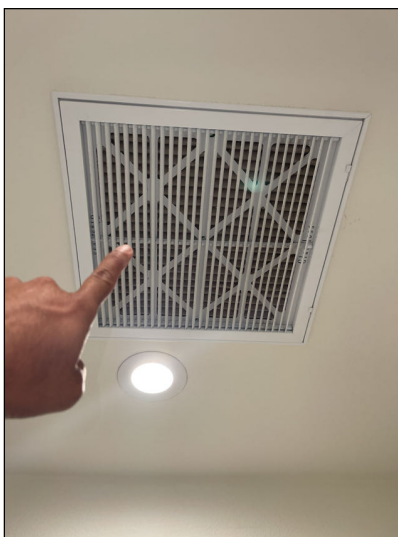
7.1. The HVAC filters are dirty. Needs replacement. Advise correcting by a qualified professional.

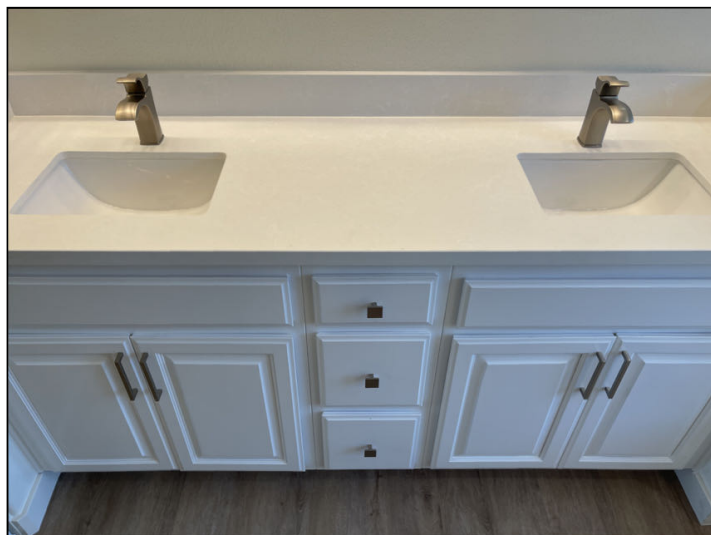
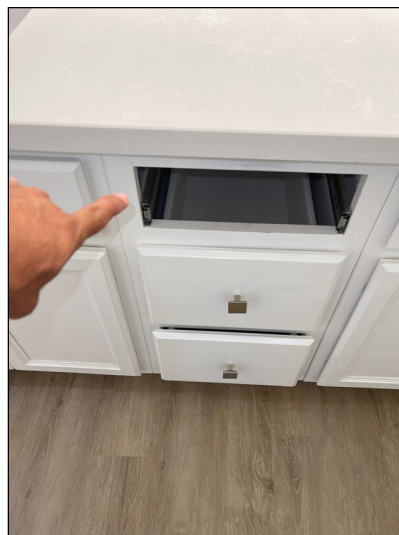
6.2. Cabinets/drawers missing in the bathroom.

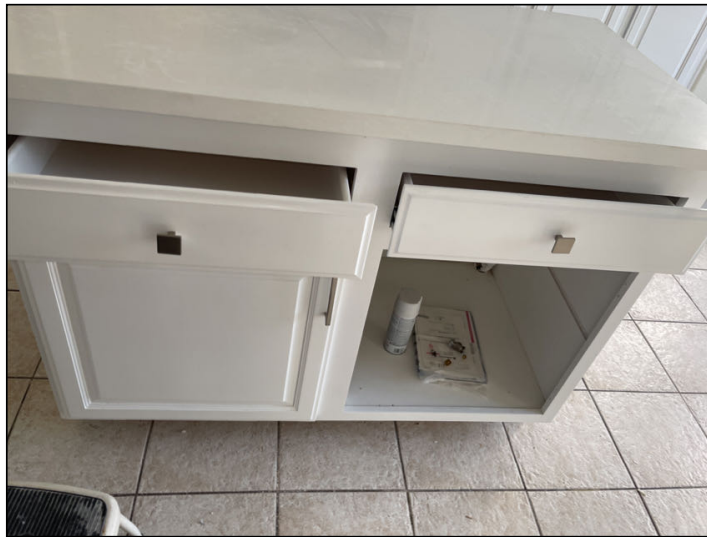
6.1. Cabinets/shelving are missing/incomplete.

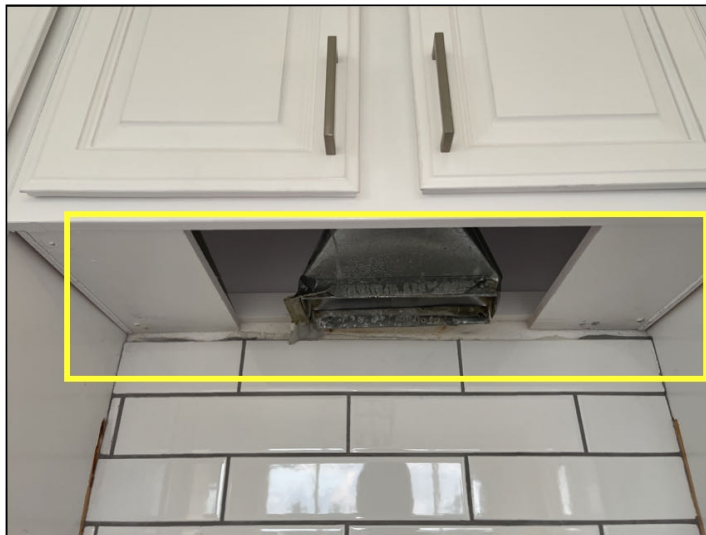
15.1. Fan hood not installed

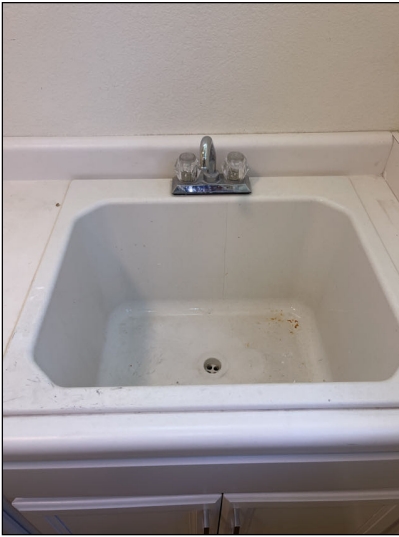
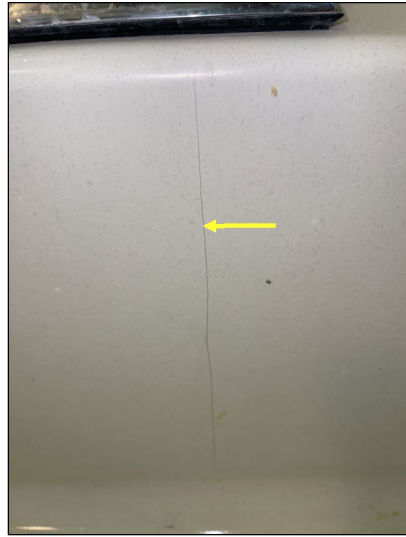
- 3.1. Sink appears to be cracked.
