WOOD DESTROYING PESTS AND ORGANISMS INSPECTION REPORT

Building No. / Street 2455 Amity Street	City San Diego	Zip 92109	Date of Inspection 05/18/2022	Number of Pages 1 of 7
--	-------------------	--------------	----------------------------------	---------------------------

General Description: Occupied Single Family Two Story Attached Garage Slab Foundation with Composition Roof	Inspection Tag Posted: Garage
	Other Tags Posted: None

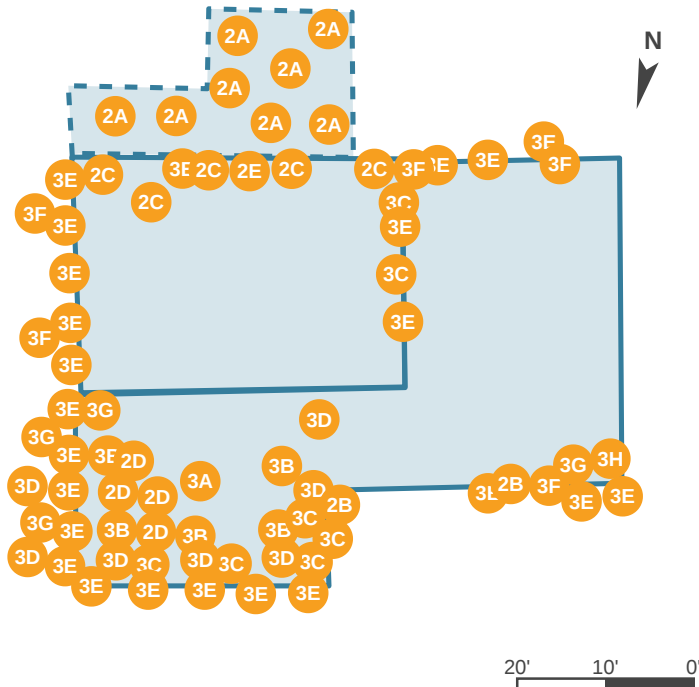
- 2) Drywood Termites
 3) Fungus/Dryrot

2A	Finding Termite damaged wood found at patio cover marked on diagram.	Recommendation Owner to contact a licensed contractor to remove patio cover.
2B	Finding Termite damage in starter board.	Recommendation Owner to contact a licensed contractor to make necessary repairs.
2C	Finding Termite damaged wood found at interior baseboards marked on diagram.	Recommendation Owner to contact a licensed contractor to make necessary repairs.
2D	Finding Evidence of drywood termites found in garage ship lap ceiling. See diagram.	Recommendation Cover entire structure(s) and fumigate with Sulfuryl Fluoride for the elimination of drywood termites. Chloropicrin will be used as a warning agent. Cover or remove accessible termite pellets. Lloyd Termite Control Company assumes no responsibility for damage to any plant life or roofing caused by fumigation operation.
		Price: \$2800.00
2E	Finding Interior Window casing is damaged by termites. See diagram.	Recommendation Owner to contact a licensed contractor to make necessary repairs.

3A	Finding Heavy storage found in area(s) marked on diagram.	Recommendation Make further inspection when area is made accessible. Any work found necessary will be additional.
3B	Finding Water stains found in areas marked on diagram. No visible signs of fungus at this time.	Recommendation Owner to contact a licensed contractor to make necessary repairs.
3C	Finding Fungus damage in trim.	Recommendation Owner to contact a licensed contractor to make necessary repairs.

3D	Finding Fungus damage in hand rail.	Recommendation Owner to contact a licensed contractor to make necessary repairs.
3E	Finding Fungus damage in rafter tail.	Recommendation Owner to contact a licensed contractor to make necessary repairs.
3F	Finding Fungus damaged wood found in fascia board(s) as marked on diagram.	Recommendation Owner to contact a licensed contractor to make necessary repairs.
3G	Finding Fungus damage in starter board.	Recommendation Owner should contact a licensed roofer to check and repair as deemed necessary.
3H	Finding Fungus damaged wood at interior window casing marked on diagram	Recommendation Owner to contact a licensed contractor to make necessary repairs.
