Sunset Property Inspection

Confidential - Property Inspection Report - Confidential

14068 Pebble Brook Ln

Date of Inspection: 6/28/2022

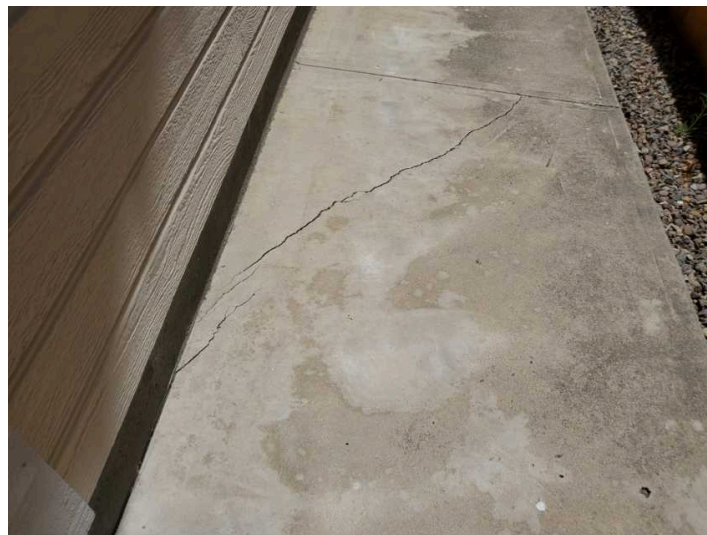
- Improve: Typical cracking was observed at the concrete surfaces. Further deterioration will occur as water expands and contracts from freeze and thaw cycles. Recommend sealing the cracks to prolong the life of the concrete.

Crack

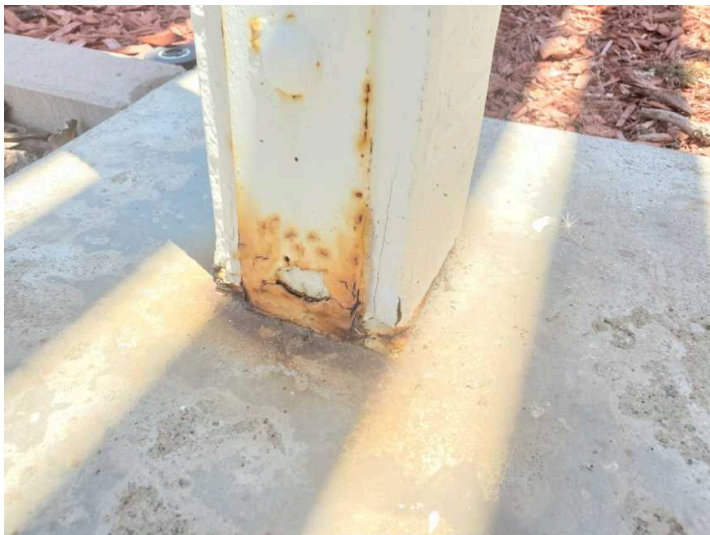
- It is beyond the scope of this inspection to determine the presence of wood destroying organisms, however, there is evidence of possible termite activity on the wood structure over the patio. It is recommended that a licensed structural pest control company be contacted for further inspection and repair recommendations.
- Rusted braces observed at base of posts. Posts in contact with the concrete patio at the rear of the house. Posts should be elevated off the ground on a footing/strap system to prevent moisture damage. We recommend corrections by a deck contractor as needed.

Rusted brace

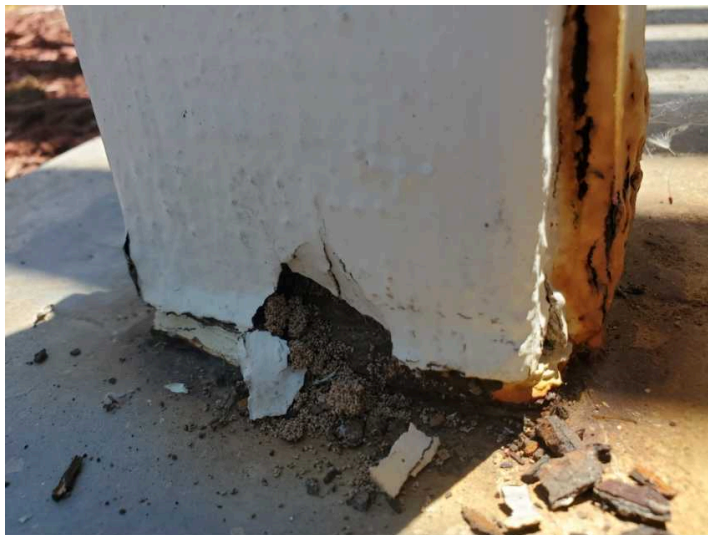
Potential wood destroying organisms

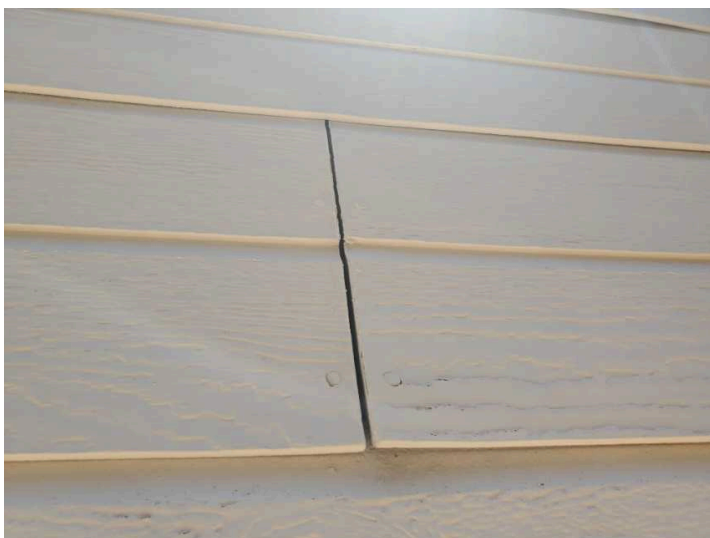
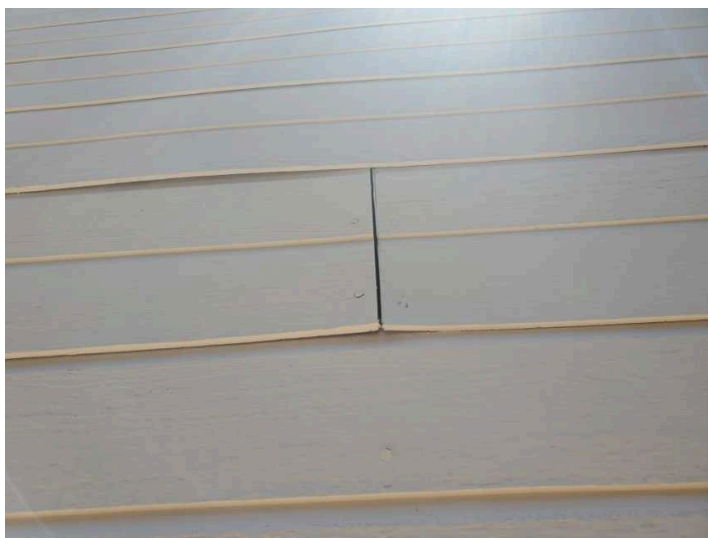
- Loose siding and gaps noted at various locations. We recommend sealing holes & gaps in the siding to keep water infiltration from causing further damage. A qualified contractor is needed.

Gaps

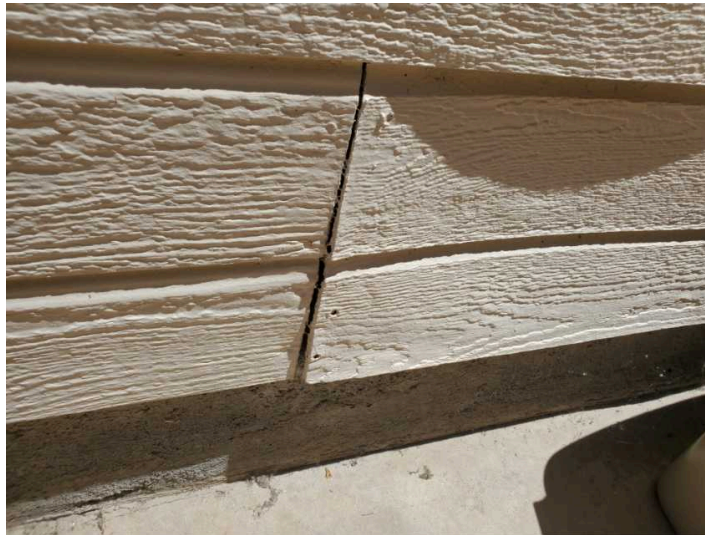
Loose

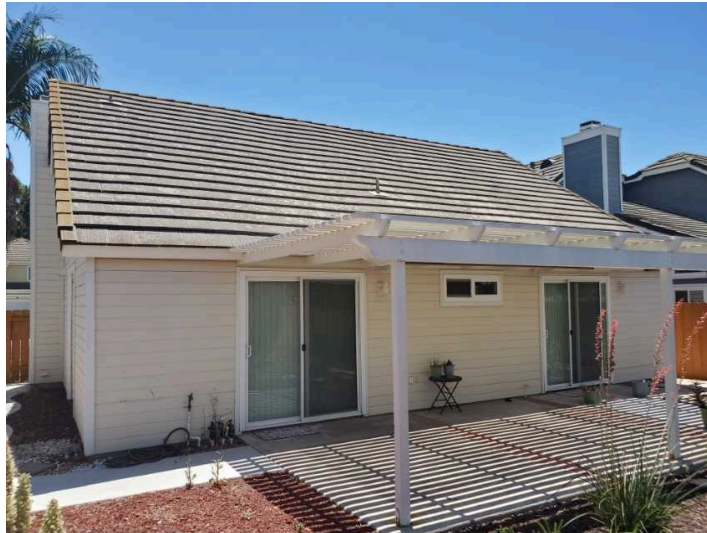
- There is no gutter/downspout installed at the roof drainage system. Location: Rear of home. Potential water intrusion can occur and damage components. Recommend installing a gutter/downspout and properly extending away from the foundation to allow for proper drainage.

No gutter

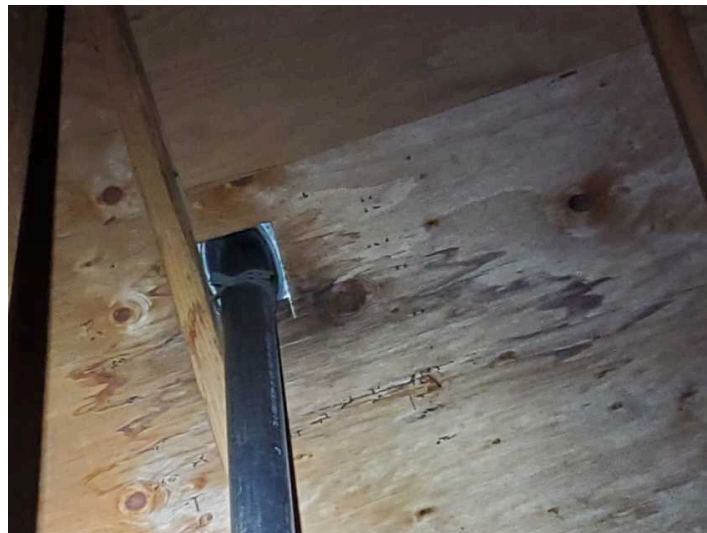
- Stain(s) observed in the roof sheathing and/or framing at various areas in attic. Water stains on the ceilings, or on the framing within attics will not necessarily confirm an active leak. This roof may have had past repairs preformed since the roof covering was installed. The staining found in the attic may have resulted from previous roof leaks which may have been repaired. Staining in the attic was dry at the time of the inspection. We recommend asking the seller if repairs were performed by a qualified licensed roof contractor.

Moisture stains

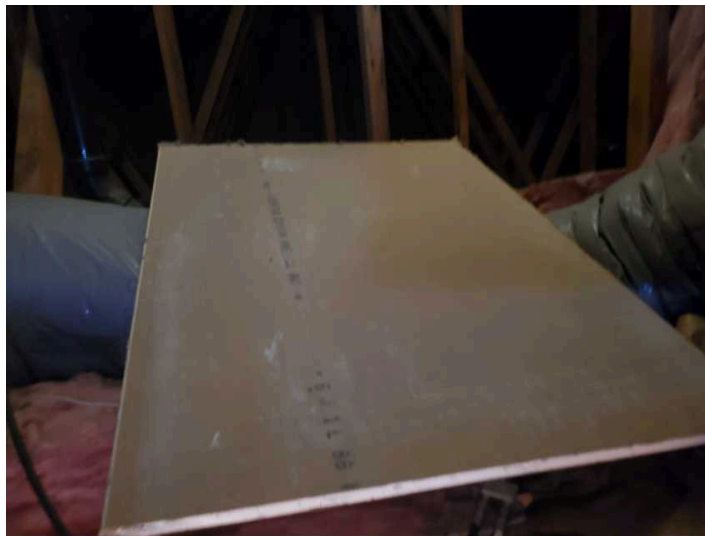
Observations: Missing insulation noted at the attic access panel at the time of the inspection. This condition will lead to heat loss and wasted energy. Recommend adding insulation to improve thermal efficiency of this home by a qualified professional.

Missing insulation

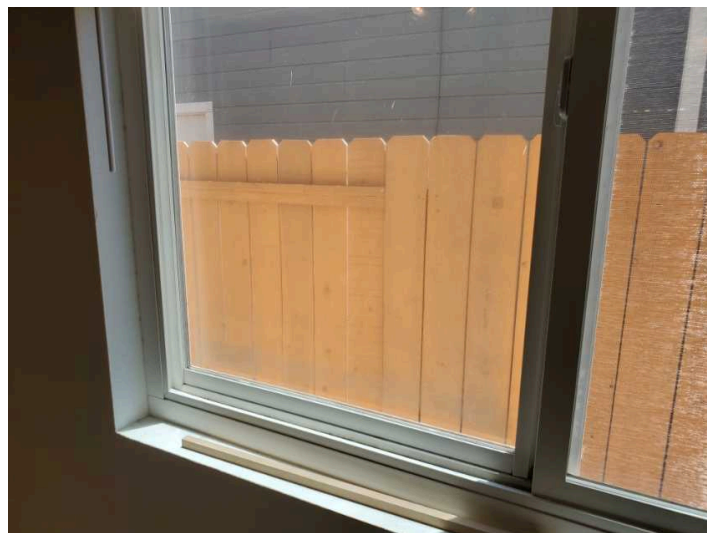
- The window in the guest bedroom appears to be equipped with a window tint or film. Aging, peeling, scratched or damaged window tint/film noted. This may be an indication of failing tint or a possible issue with the window seal. You may wish to view this for yourself and have further evaluated and repaired by a licensed window contractor as necessary.

Cloudy window

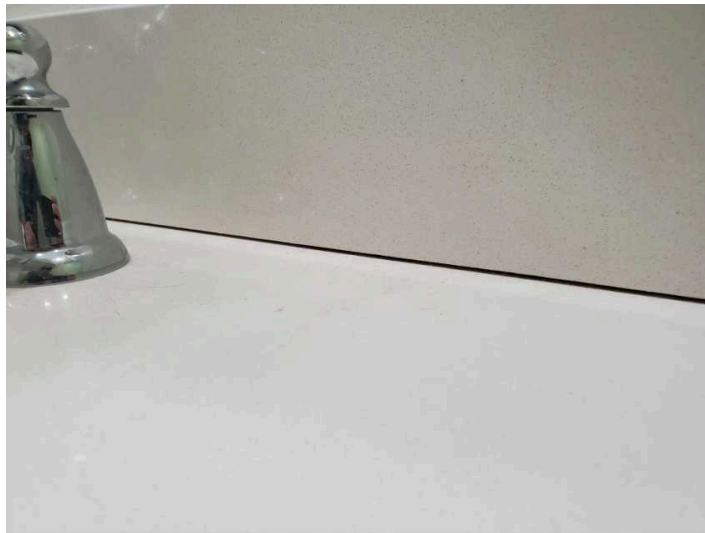
- Caulking Needed. There are some areas that need some Caulk / grout at the counter backsplash. Gaps or missing grout, around this area can lead to water intrusion and moisture issues. It is recommended that the sink be properly caulked at these locations.

Caulking needed

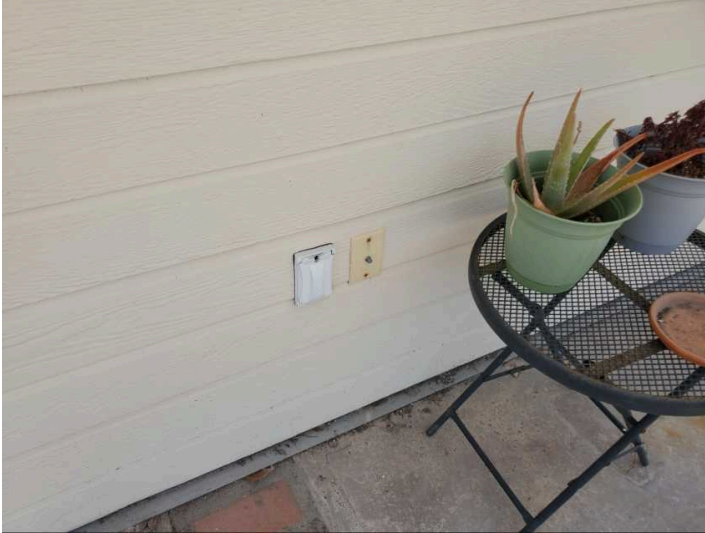
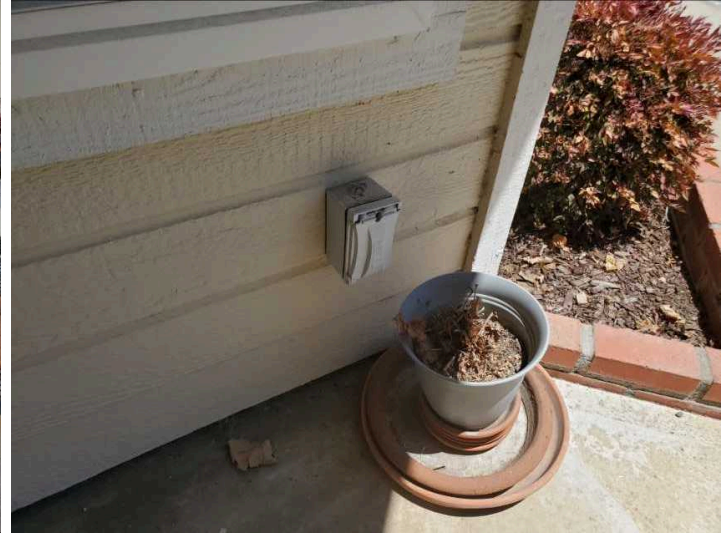
- The majority of grounded receptacles were tested and appear to be wired correctly as determined with a standard receptacle outlet tester.
- Receptacles located at the exterior of the home are without the benefit of In-use covers. In-use covers help protect the outlets from moisture while a plug or cord is in use. Installation of proper In-use covers are recommended to be installed at all exterior receptacles by a qualified electrician.

In-use cover not installed

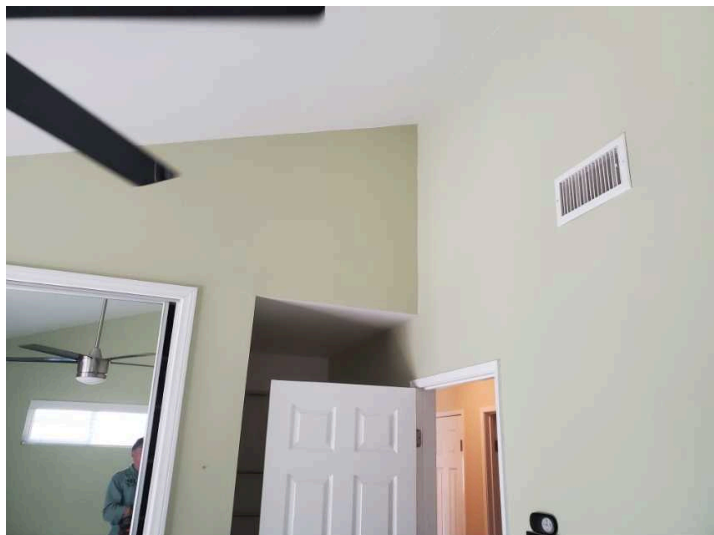
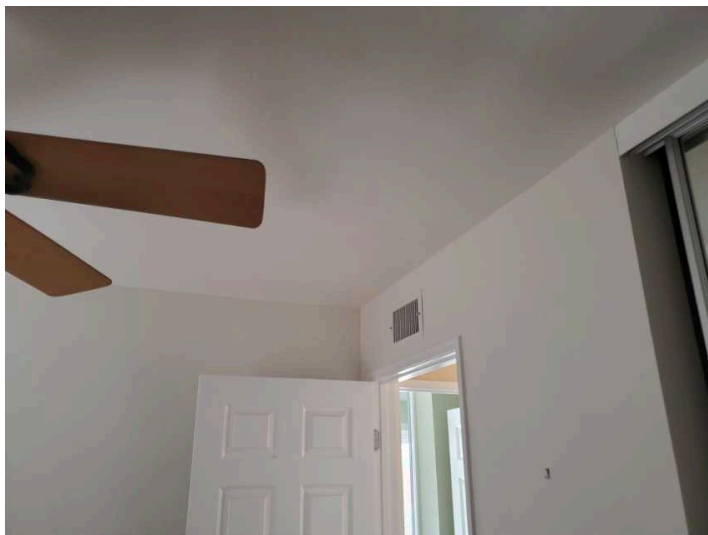
- Testing of smoke detectors is not included in this inspection. Pushing the "Test" button only verifies that there is power at the detector--either a battery or hard wired to the house power--and not the operational workings of the detector. The operational check is done by filling the sensor with smoke and is beyond the scope of this inspection. Battery operated smoke alarms should be checked routinely and the batteries changed frequently.
- IMPROVE: Recommend installing one in each bedroom to bring up to modern safety standards

No detector

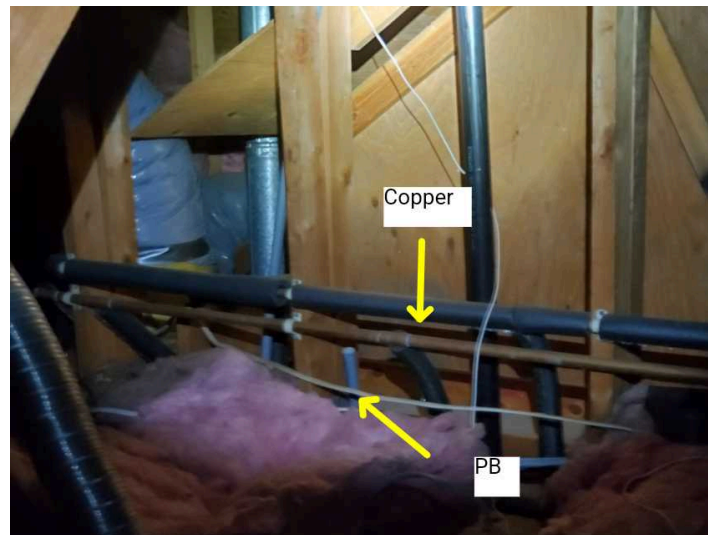
- The original Polybutylene plumbing distribution system appears to have been replaced with copper where visible. However, The Polybutylene piping was still present in the attic. Unable to confirm that the plumbing system was entirely replaced. Advise inquiry with seller and licensed plumber as necessary. This system of plumbing has experienced a higher than normal failure rate associated with leaks where the pipes are joined together. There is also a current theory that chemicals in municipal water systems react with the piping and resins in the fittings, weakening the pipes and joints. The manufacturers have been involved with and settled class action lawsuits alleging manufacturing defects with this plumbing system containing plastic or metal insert fittings (including copper and brass). For further details about PB contact the Consumer Plumbing Recovery center at 800-392-7591 or the web: <http://www.pbpipe.com> or <http://www.polybutylene.com>. Recommend you research further this type of plumbing system and rely on the evaluation and advice of a licensed plumbing contractor prior to the close of escrow.

Old and new piping

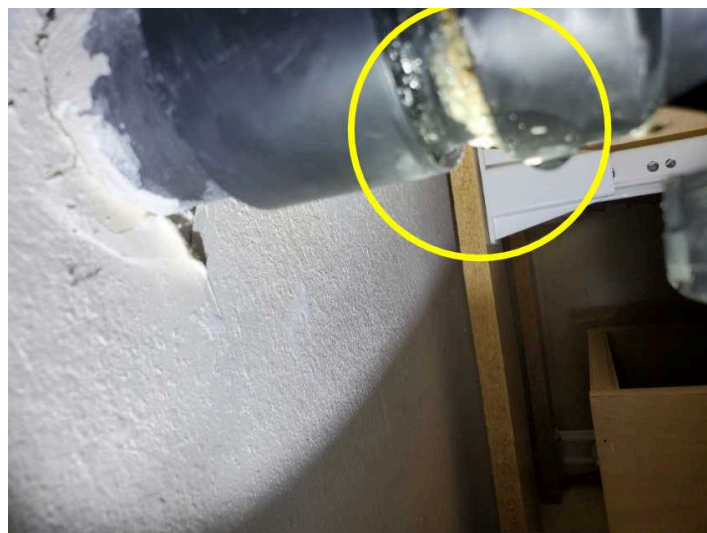
- Evidence of leak in guest bathroom sink drain trap. Repair as needed.

Leak

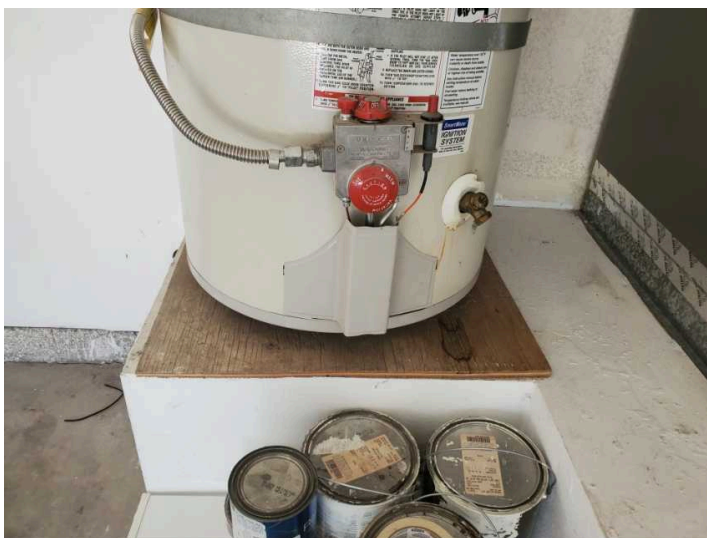
No drip pan installed

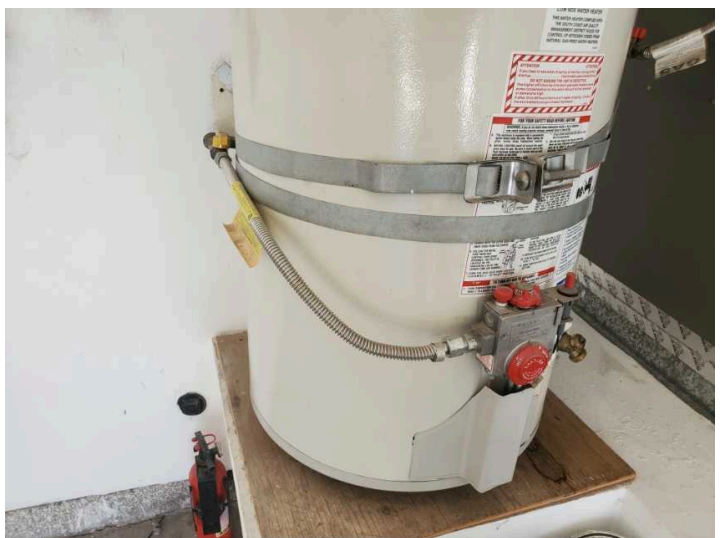
No sediment trap

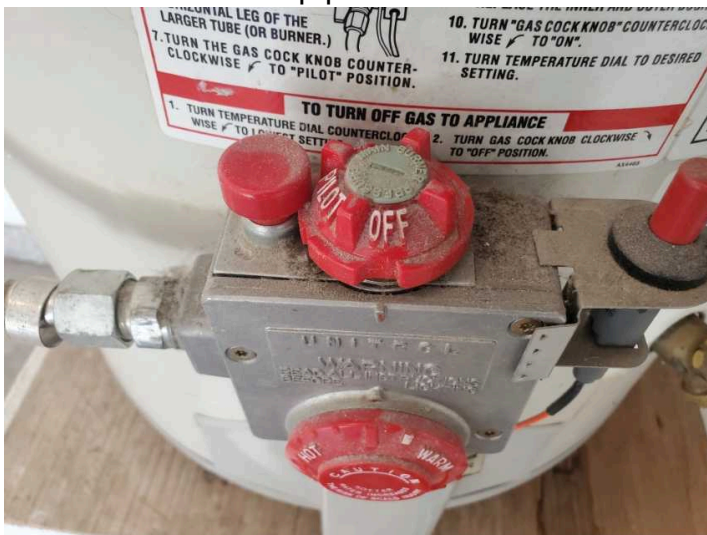
- **IMPROVE:** The water heater was shut down at the time of inspection. No testing of functional hot water service to bathrooms or kitchen was performed. Water heater appeared to be at the end of its typical service life. Recommend further evaluation by a qualified plumber.

OFF at time of inspection

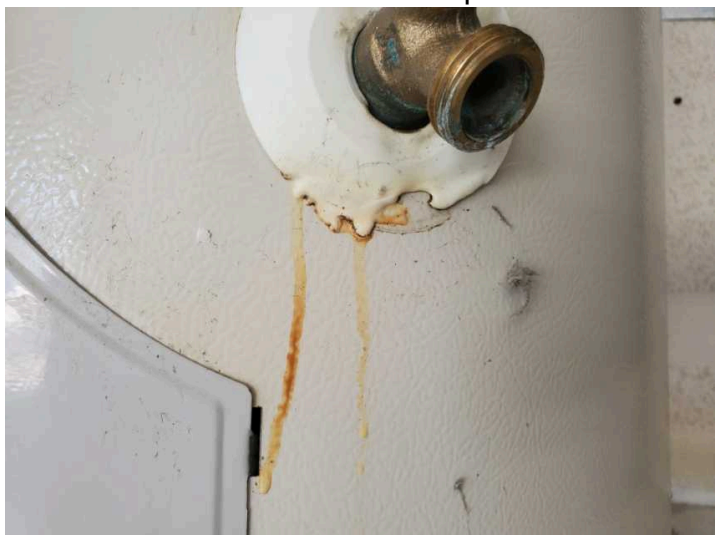
- The plastic ring around the lower drain valve is melted. Unable to determine how this damage has occurred. Recommend further evaluation by a qualified plumber.

Melted plastic

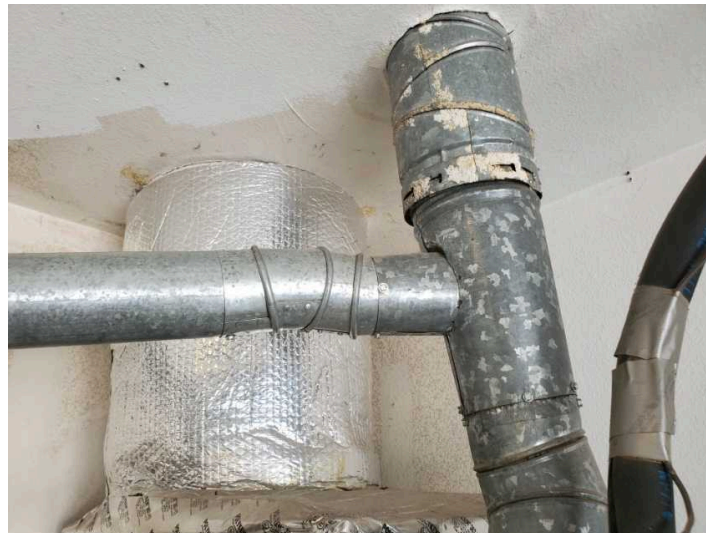
- The water heater exhaust vent pipe is improper in that it has a T shaped pipe fitting instead of the required Y shaped pipe fitting. A properly installed vent pipe is necessary for safe and efficient venting of heat and exhaust fumes from the water heater.

"T" connection

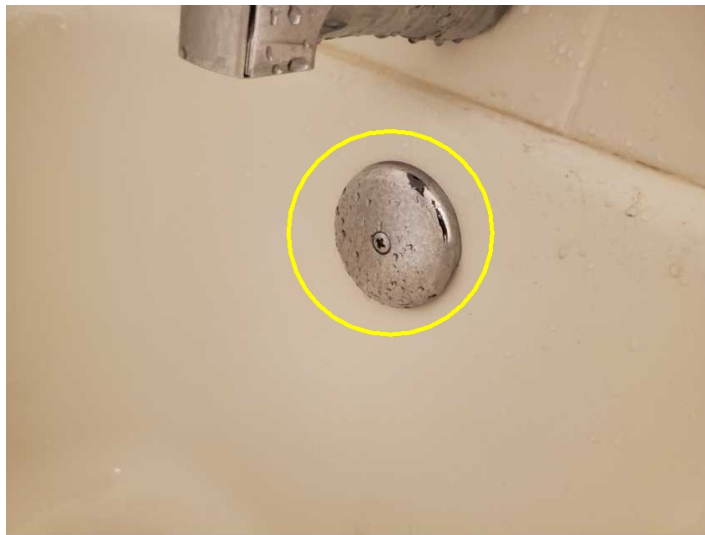
- The drain overflow at the guest bathtub is loose. The drain line behind may also be loosely connected to the backside of the bathtub. However, confirming this is outside the scope of this inspection. Leaving this loose can lead to hidden leaks resulting in damage to the home. I recommend further evaluation by a licensed plumber before the end of your contingency period to determine repairs necessary at this time.

Loose

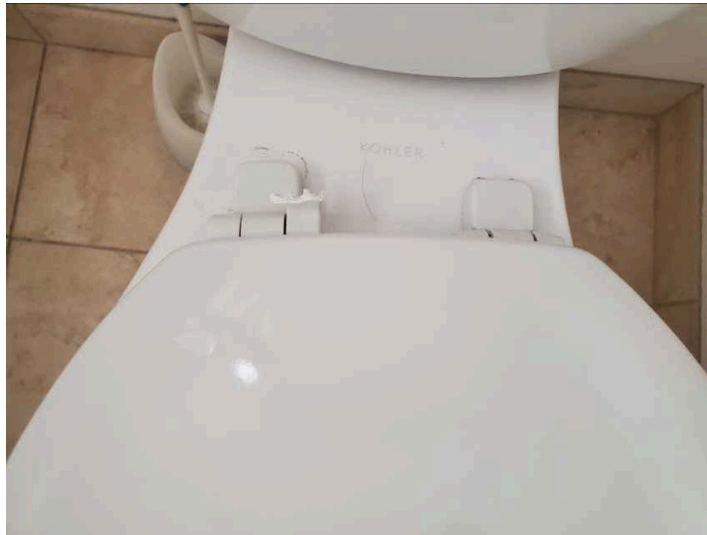
- Operated when tested. No deficiencies noted.
- As of January 1, 2017, building standards/state law require that flow rates for fixtures in the home not exceed 1.6 gpf for toilets, 2.2 gpm for faucets and 2.5 gpm for shower heads. It is beyond the scope of the inspection to determine the flow rates of the plumbing fixtures in the home. Refer to seller.
- Tank lid is cracked/broken.

Damaged seat lid

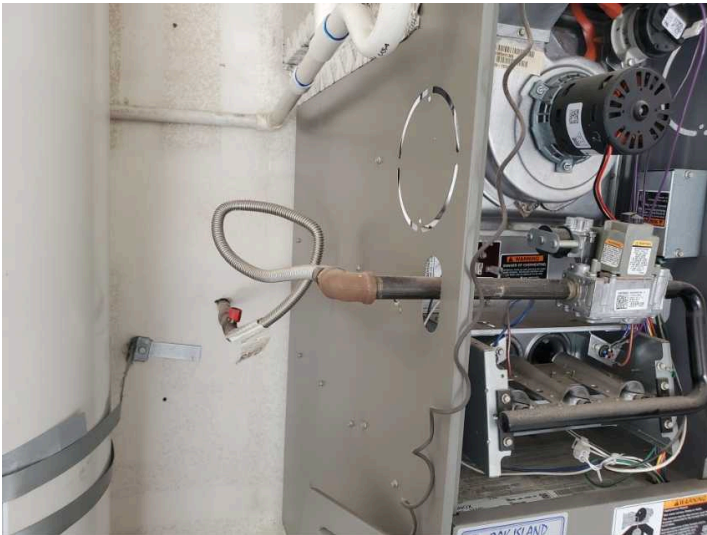
- NOTE: Gas Furnace- Limited Inspection. The Scope of this inspection does not include a thorough analysis of the inner components of the furnace. This includes but is not limited to cracks in the heat exchanger and areas of the heater that are not accessible. The average live expectancy for gas fired furnaces is typically considered to be about 15-20 years depending on use. It is recommended that all heaters be thoroughly evaluated by a licensed HVAC specialist every year to ensure proper working conditions.
- IMPROVE: The unit is dirty and there are no records of prior service. Recommend an HVAC contractor perform a system Clean-and-Check. HVAC systems require yearly maintenance.
- Furnace gas supply line missing sediment trap. This trap serves as a collection area for sediment to reduce the chance of clogged gas valves or burners. recommend installation by a qualified HVAC contractor.

Missing sediment trap

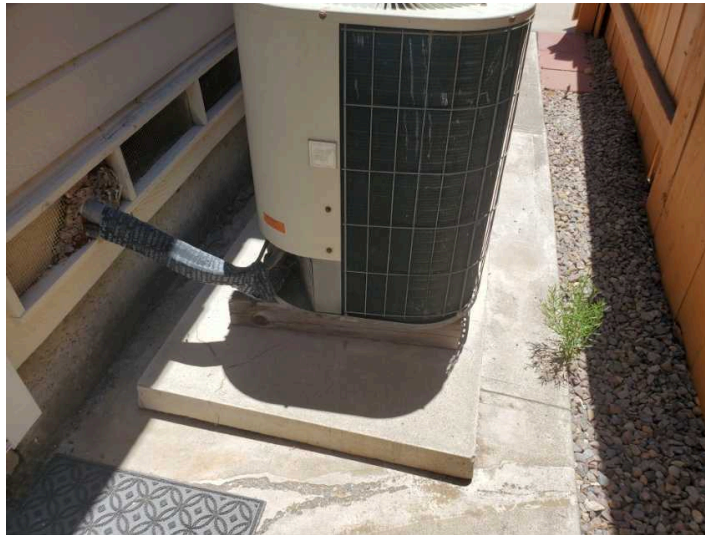
- The air conditioning system in this building is at or approaching the end of its service life. Effective January 2020, the Department of Energy mandates that all manufactured air conditioner condensing units use R 410-A freon. The older R 22 freon will no longer be allowed. Acquiring Home Warranty insurance protection to help mitigate the costs of the new freon regulation is recommended.
- AC unit(s) are not strapped to pad(s). Most manufacturers installation instructions require strapping condensers to the pads. Movement of the units due to internal vibration (or earthquake) can damage the refrigerant lines and their connections. We advise repair with qualified person.

Not strapped to pad

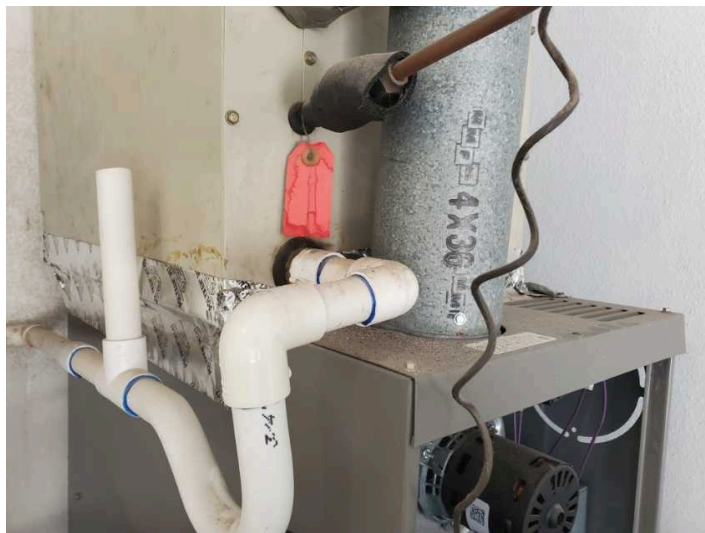
- IMPROVE: There is no emergency drain line connected. Should the main line become clogged there are no other approved means for the condensation to exit the system. The potential for moisture damage to the furnace and the surrounding structure exists. Recommend installing an emergency drain line or a cut out switch. Further review for repairs is needed by a qualified HVAC contractor.

Emergency drain line not installed
