# WOOD DESTROYING PESTS AND ORGANISMS INSPECTION REPORT

| Building No.<br>4402 | Street<br>Moraga Avenue | City<br>San Diego | ZIP<br>92117 | Date of Inspection<br>12/16/2022 | Number of Pages<br>4 |
| <div style="margin-left: 20px;"> <b>Spartan Termite Inc</b><br/> 682 Bauer Place<br/> Vista CA 92081<br/> (760) 295-9949<br/> moniquefrost@spartantermite.com </div> | | | | Report # : 13399<br>Registration # : PR8435<br>Escrow # :<br><input type="checkbox"/> CORRECTED REPORT | |

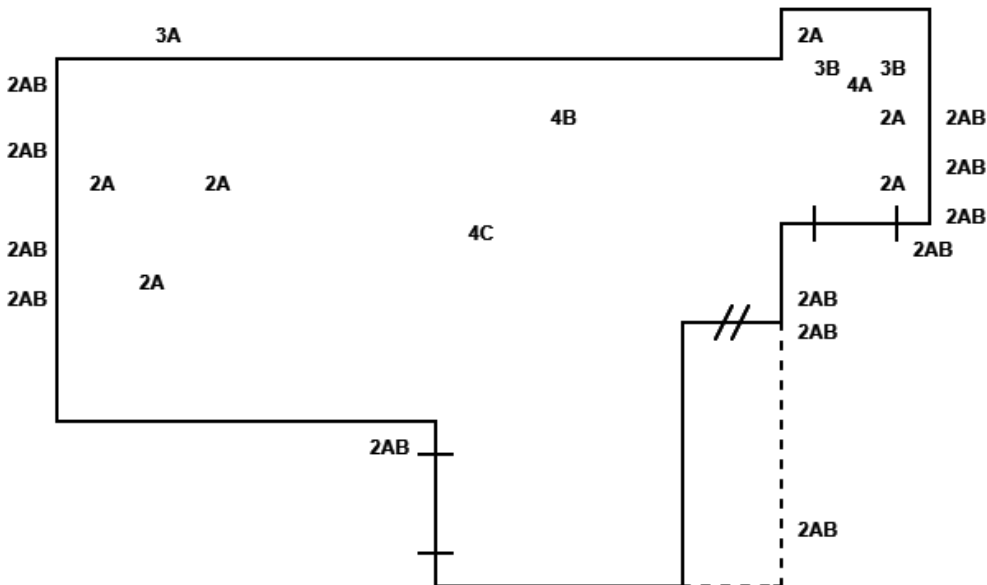
**Diagram Not To Scale**

**FINDING** - Evidence of drywood termite infestations at attic, garage framing, fascia, rafter tail, out looker, roof sheathing, and beam, as indicated on the diagram.

**FINDING** - Evidence of termite damaged wood members noted at time of inspection at fascia, rafter tail, out looker, roof sheathing, and beam as indicated on the diagram.

**FINDING** - Dry-rot and fungus damaged wood members found at time of inspection at fascia, as indicated on the diagram.

**FINDING** - Surface fungus condition visible at time of inspection at garage roof sheathing, as indicated on the diagram.

**RECOMMENDATION** - Fumigate the structure for the control of drywood termites. Remove or cover drywood termite fecal pellets in accessible areas. Owner/agent to prepare for fumigation as per list of instructions to be furnished by this company. The structure must be vacated until released for re-entry by the licensed fumigator. See fumigation notice for terms and liabilities.

**RECOMMENDATION** - Remove and replace and/or repair the damaged wood member(s) as necessary in currently available widths and grades. Minor damage may be filled, or where impractical, reinforcement will be done. If the paint is provided for us then painting is included in the price of the bid.

**RECOMMENDATION** - Scrape and chemically treat fungus condition. Patch any minor surface damage found during treatment.
