Subject: 4402 Moraga Ave.
San Diego, California
Geologic Inspection

GEOLOGIC INSPECTION 4402 MORAGA AVENUE SAN DIEGO, CALIFORNIA

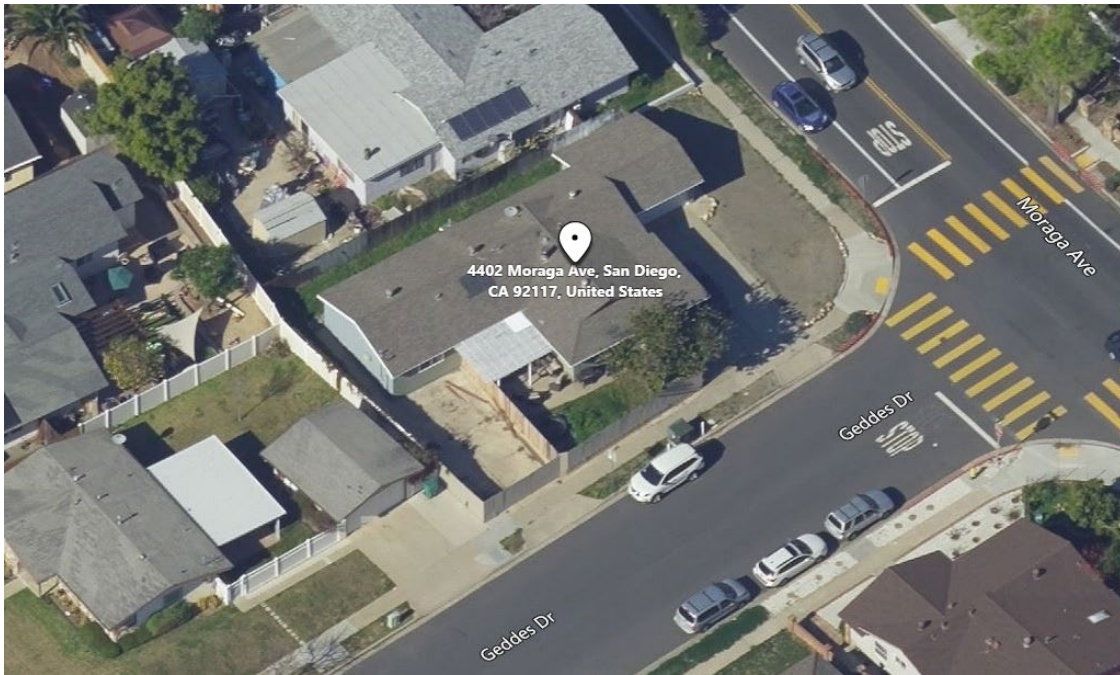
Figure 1. Oblique view to north of 4402 Moraga Avenue.
