AmeriSpec
 22471 Aspan St., Ste. #104
 Lake Forest, CA 92630
 Ph#: (949) 454-0508

Doc #:	202101-85905	Inspector:	Tom McCorkell
Date:	1/15/2021		
Client:	Cheryl Jackson		
Address:	25741 Coldbrook, Lake Forest, CA

GENERAL CONDITIONS

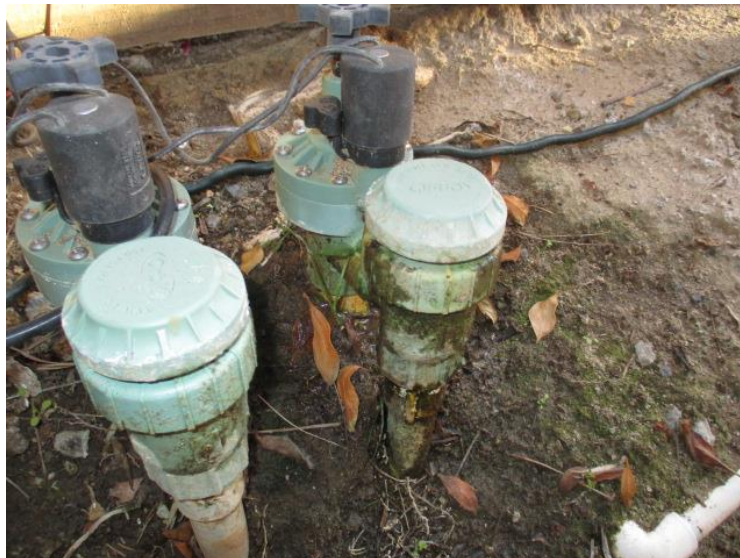
Step #	Component	Comment
101..	Driveway	Serviceable. Concrete.
102..	Walkways/Stairs	Serviceable. Brick and concrete.
103..	Walls/Fence/ Gates	Serviceable. Block walls with wood gates.
104..	Siding	Serviceable. Stucco and wood.
105..	Trim	Serviceable. Wood.
106..	Window Frames	Serviceable. Vinyl.
107..	Electrical	S
108..	Gutters/ Downspouts	S
109..	Sprinklers	System was tested in manual override only. Accuracy of the timing clock was not tested. Timer is located at the right side rear. Leak noted at one valve.

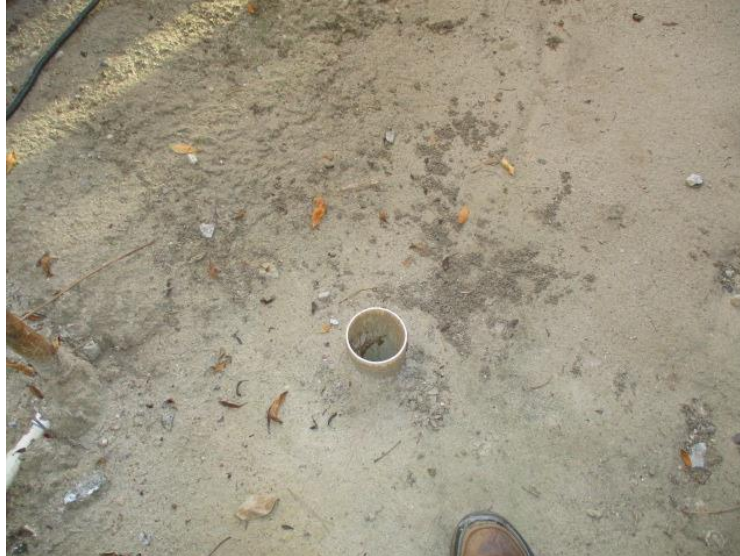
- 112.. Lot
 Grade/Drainage Home is built on a flat lot with a slope in the rear.
 Geological evaluations are beyond the scope of this report.
 We recommend consulting with a geotechnical engineer if
 concerned by conditions listed in this report or which you
 have observed. Grade at the foundation appears to be
 adequate. Ground drains noted, not tested as they are
 beyond the scope of this inspection. Some drains are above
 the grade. Missing drain caps noted.

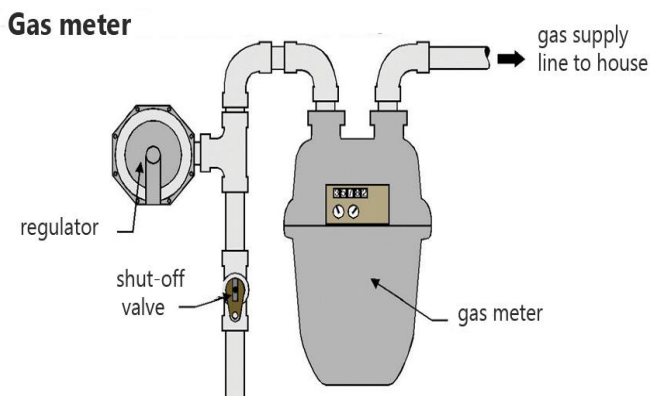
- 113.. Gas Meter Gas meter is located on the left side.

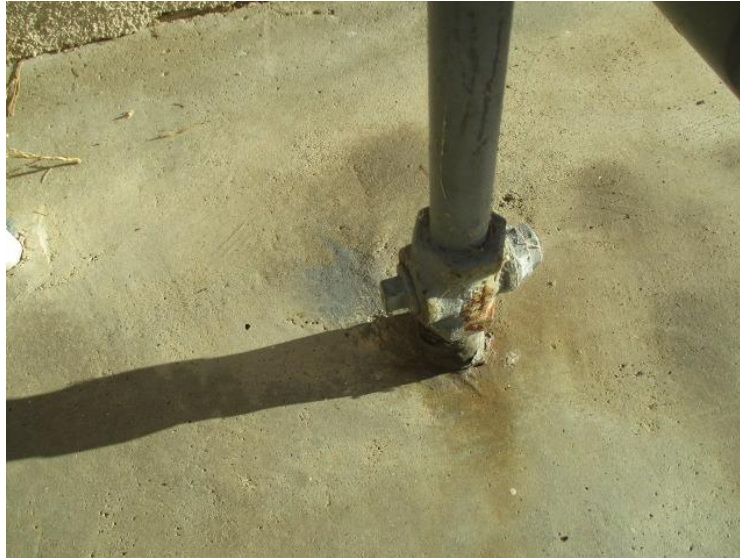
Shut-off valve noted.

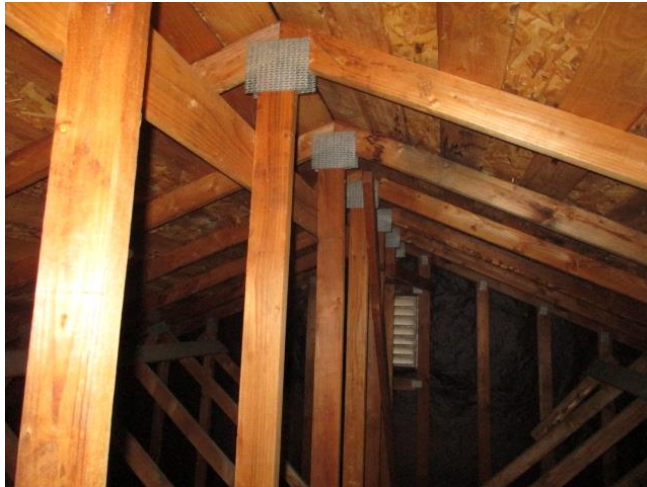
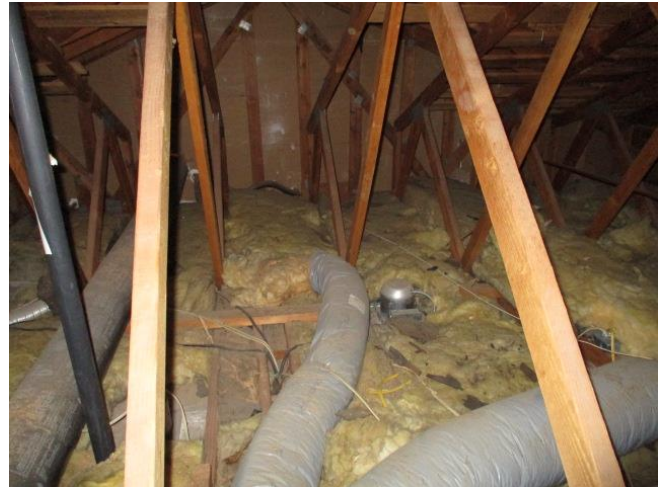
Step #	Component	Comment
141..	Access	Located in the master bedroom closet.

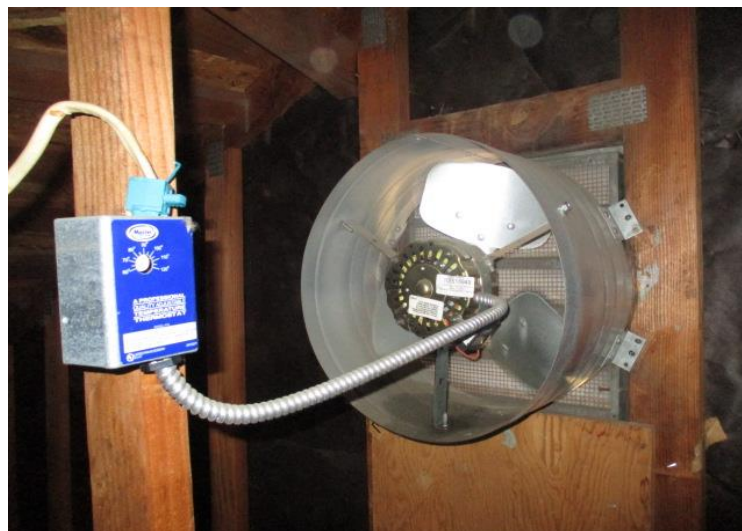
142..	Framing	Serviceable. Trusses.
143..	Sheathing	Serviceable. 1x6 slats and O.S. board.
144..	Evidence of Leak	No.
145..	Insulation	Yes, fiberglass batts.
146..	Ventilation	Attic fan is operable. Set at 90 degrees.

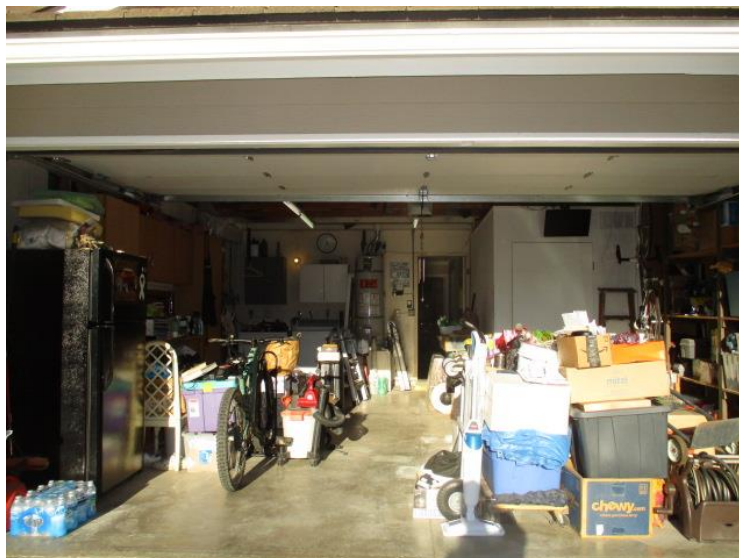
313..	Electrical	Added outlet noted, unable to determine if GFCI protected for safety.
314..	Other Comments	Storage appears to be an addition, unable to determine if properly installed or permitted. Rafters are not designed for storage purposes. Unable to fully inspect the garage, blocked by personal belongings.

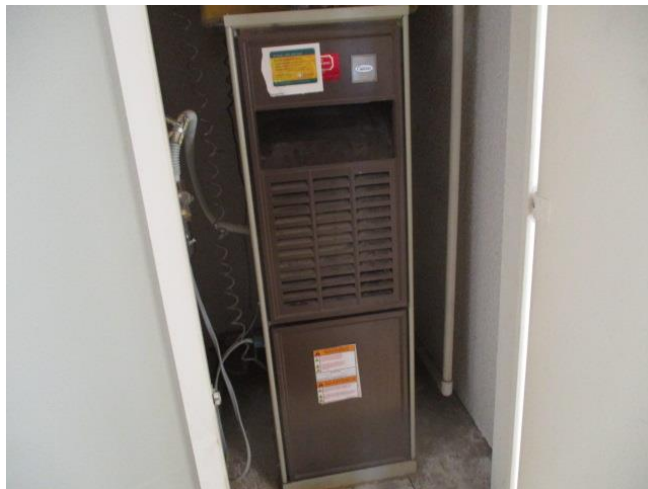
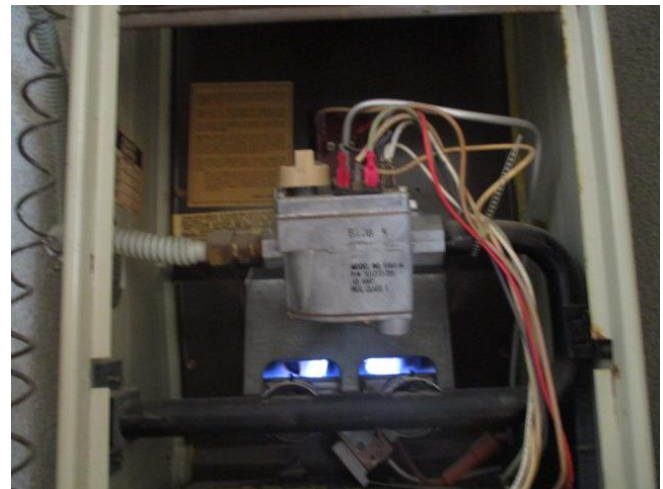
Step #	Component	Comment
400..	Heater location	Hall closet.
401..	Heating	Gas forced air unit. Manufactured date is 1981. Suggest contacting the gas company for a courtesy review due to the age of the unit. Filter is located under the heater.

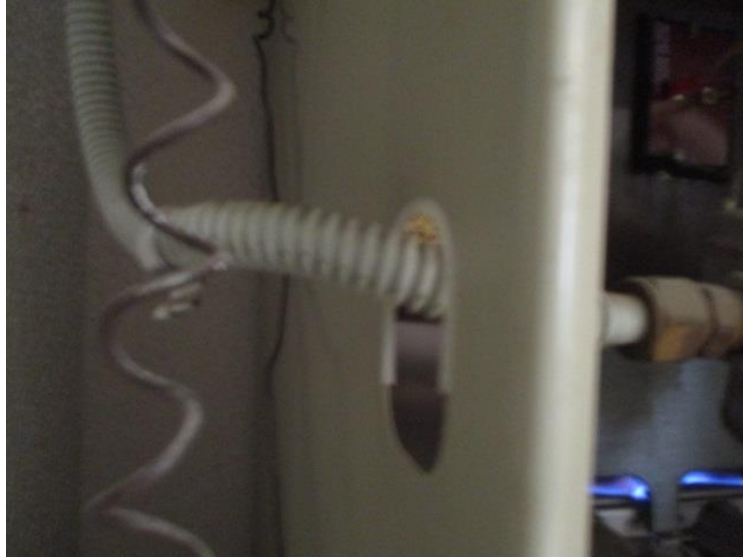
Flexible gas line noted through the burner compartment, not the recommended material, suggest further review with a licensed HVAC contractor.

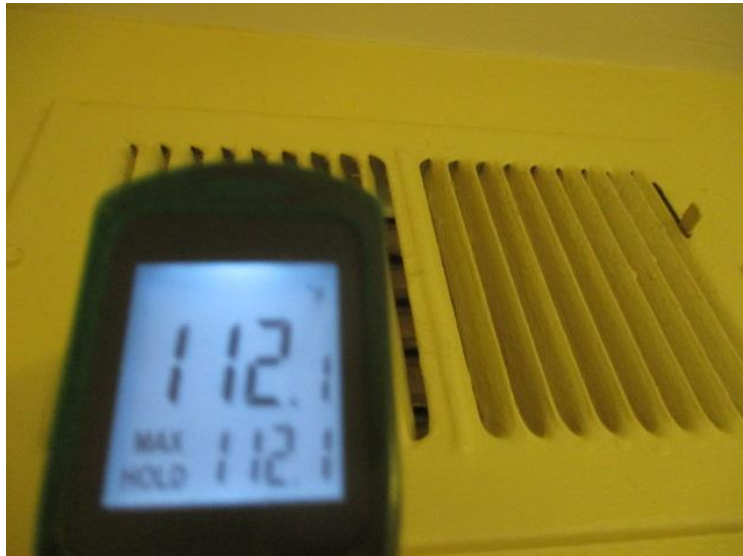
78° noted at the intake; 112° noted at the register, unit is heating within guidelines.

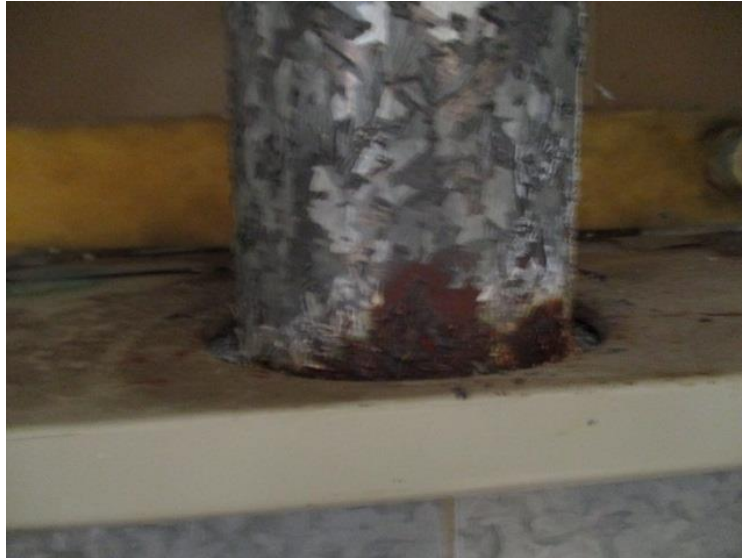
401a.. Venting Rust noted at the vent pipe.

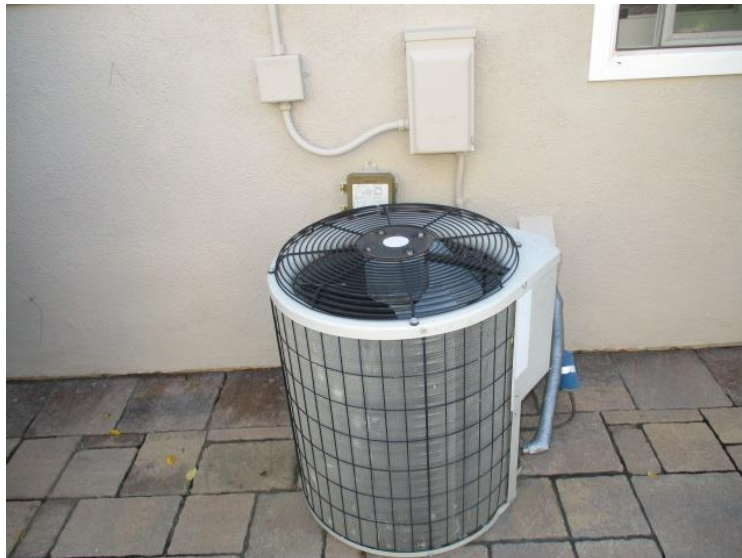
402.. Air Conditioning Compressor is located on the patio. Manufactured date is 1982.

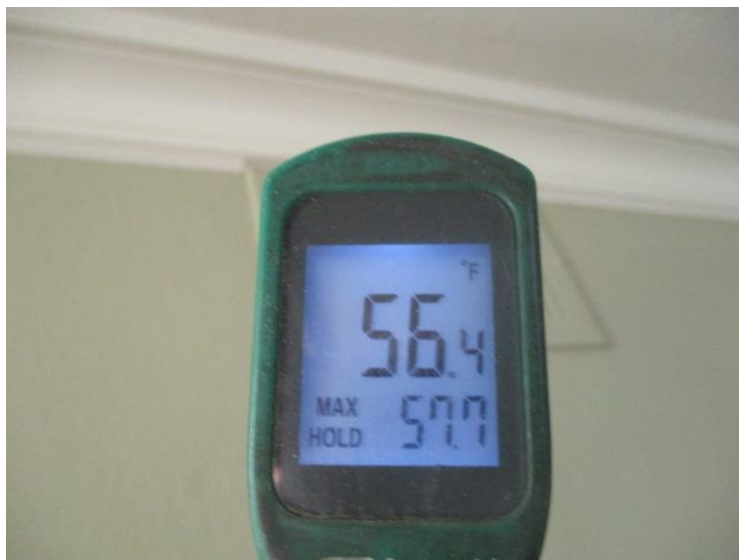
78° noted at the intake; 56° noted at the register, unit is cooling within guidelines.

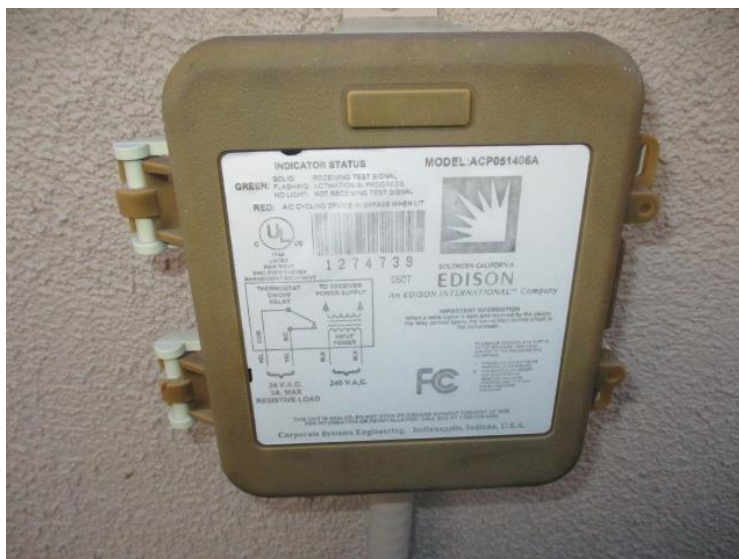
An energy conservation control box, which may interrupt usage, has been attached to this unit. Suggest contacting the utility company if more information is desired.

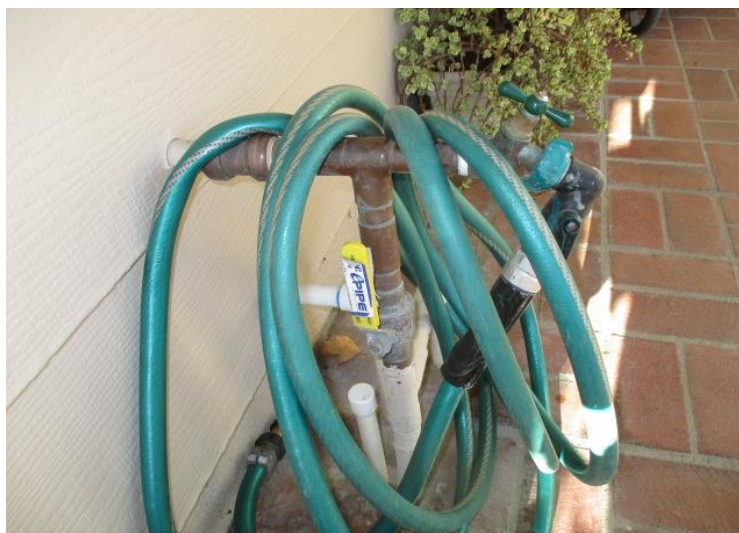
Step #	Component	Comment
420..	Piping	Piping, where visible, is copper. Plumbing pipes have been epoxy lined per the homeowner/agent, not inspected as it is beyond the scope of this inspection.
421..	Main Shut-off	Main shut-off is located in the front. The main water shut-off was not tested. These can fail at any time due to non-use and corrosion.

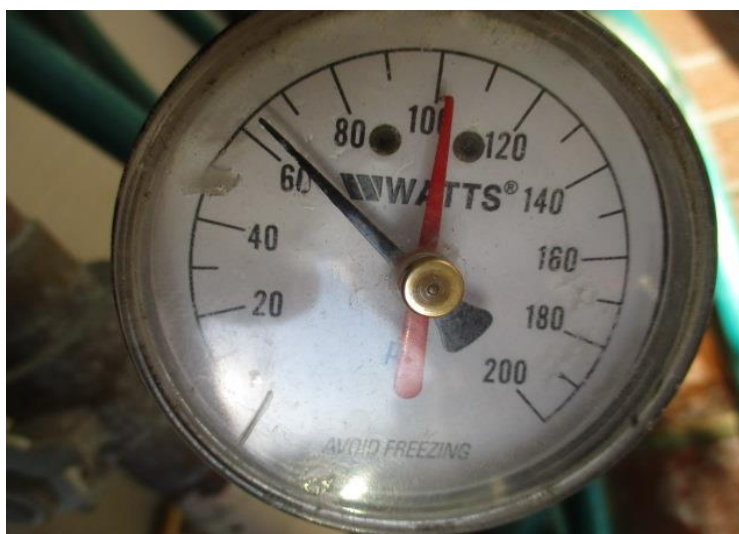
422..	Drain/Waste Vents	S
423..	Other Comments	Pressure regulator and 65 psi noted.

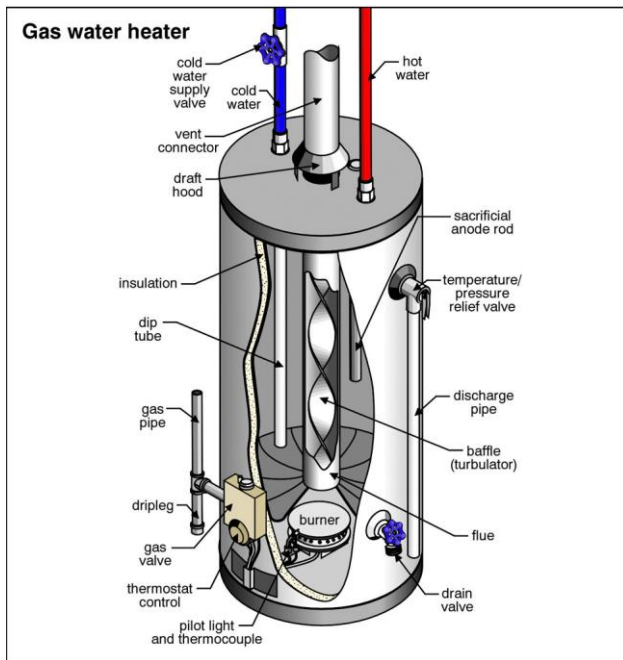
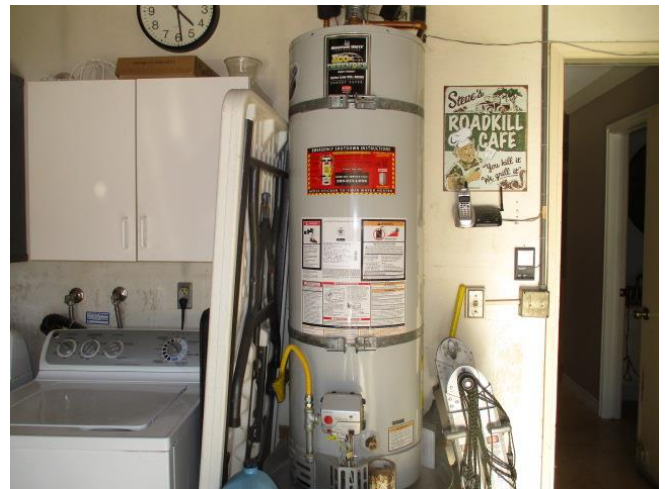
Step #	Component	Comment
430..	Capacity/Fuel/Location	40-gallon gas unit is located in the garage.

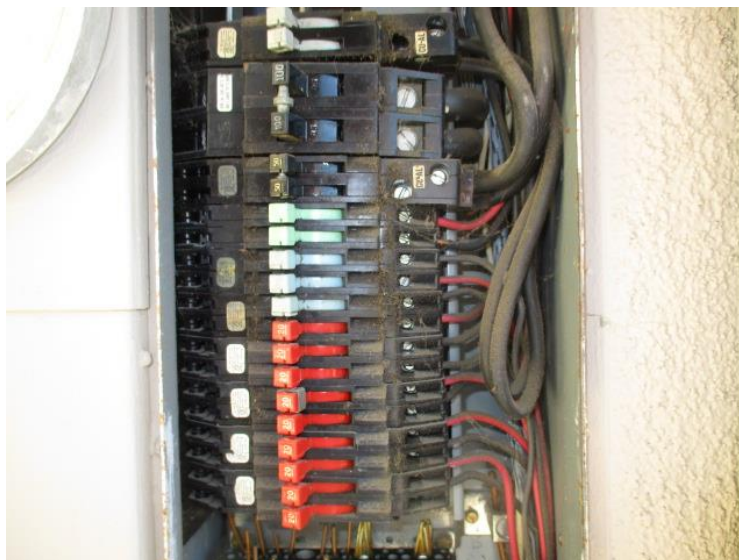
Step #	Component	Comment
440..	Amperage	The main electrical service is 100 amps.
441..	Service Entrance	Service entrance is underground.
442..	Main Panel	Main panel is located on the left side.

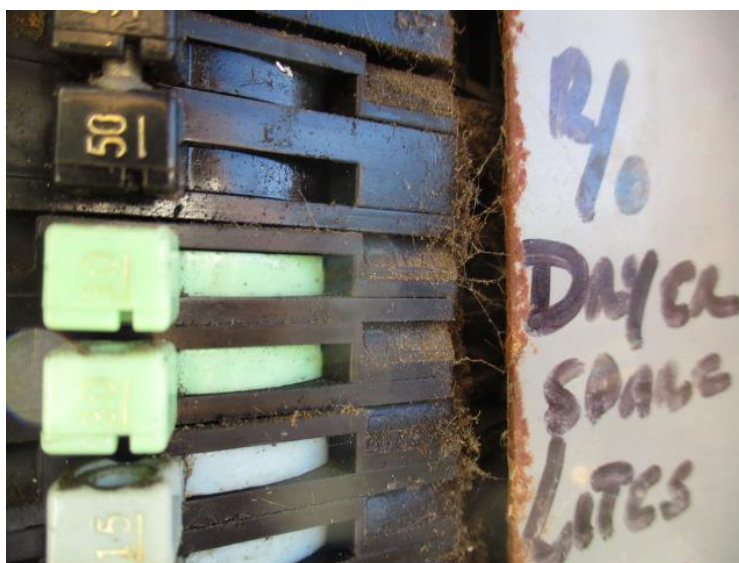
443..	Sub Panel	N
444..	Overload Protection	Overload protection is provided by breakers. Bridge is not present at the dryer breaker, noted as a possible safety hazard, suggest further review with a licensed electrician.

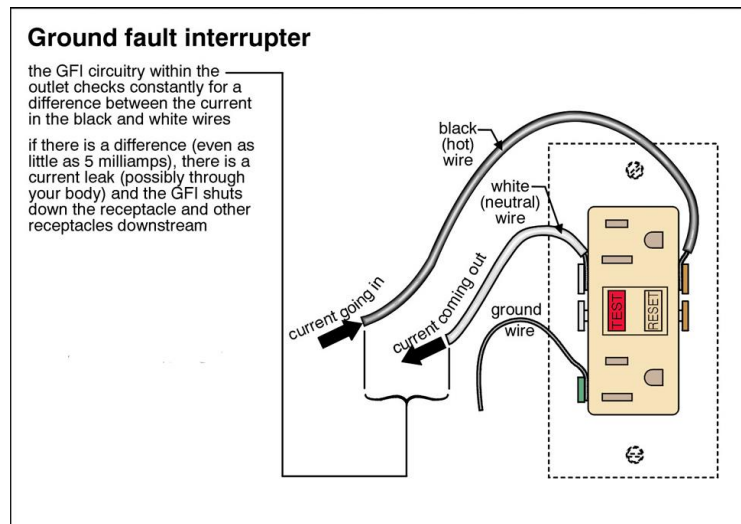
Step #	Component	Comment
640..	Floors	Serviceable. Tile.
641..	Walls	Hole noted under the sink.
642..	Ceiling	S
643..	Doors	S
644..	Windows	N
645..	Screens	N
646..	Electrical	Serviceable. Ground fault circuit interrupter is provided for safety. We suggest periodic testing to ensure proper working order.

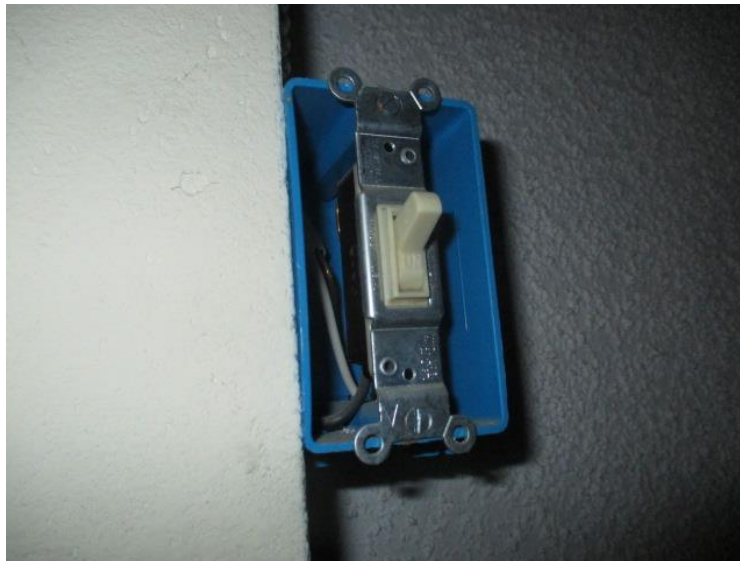
Step #	Component	Comment
801..	Floors	Serviceable. Tile.
802..	Walls	S
803..	Ceiling	S
804..	Doors	S
805..	Windows	N
806..	Screens	N
807..	Electrical	No safety cover plate noted at one outlet in the heater closet.
