Confidential Inspection Report

Property Address:

4090 Falcon St

Unit 2B

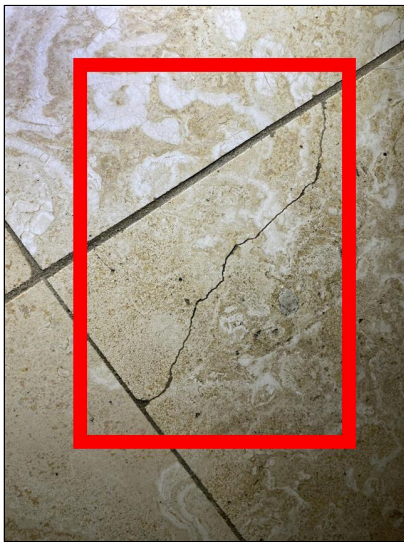
3.9.B Floors

Comments: Marginal

Crack in the bathroom tile.

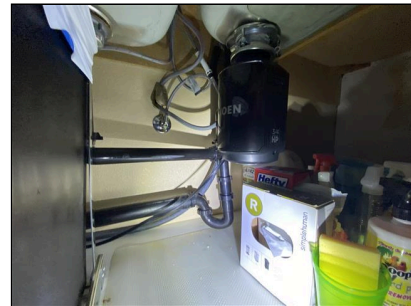
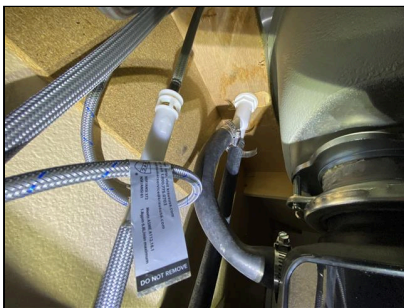
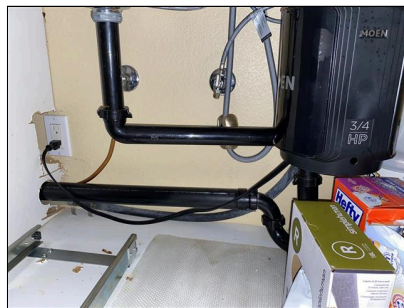
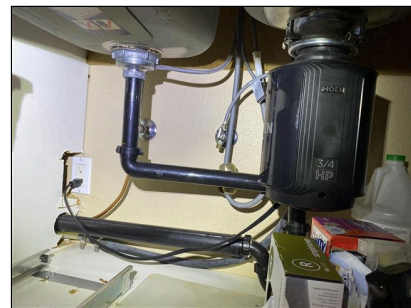
4.6 Plumbing Drain, Waste Disposal

Comments: Defective

Garbage disposal splash guard is missing. This is a life safety concern. The splash guard prevents items from being ejected out of the disposer when turned on. Recommend plumber to repair.

Area viewed through Infra Red Camera. No indications of a current leak at time of inspection.

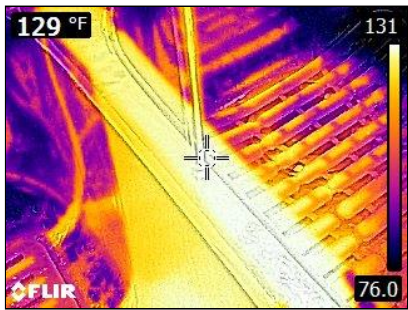
Water temperature is 129

The Department of Energy recommends having your tank-based hot water heater set to 120 degrees Fahrenheit. Temperatures higher than 120 degrees can cause scalding burns in under 5 minutes. The water temperature at the faucet should reach max temp within 1 minute.

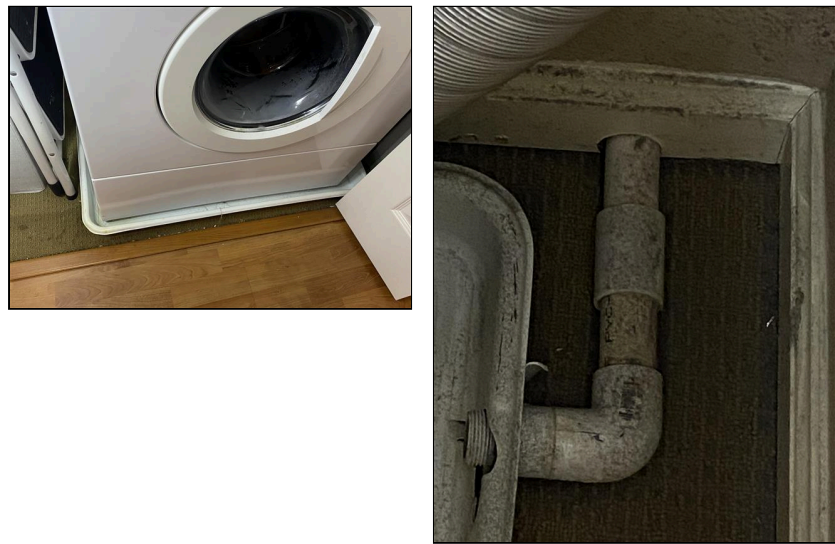
5.4 Washer floor pan installed?

Comments: Acceptable
Floor pan present and plumbed to drain outside..

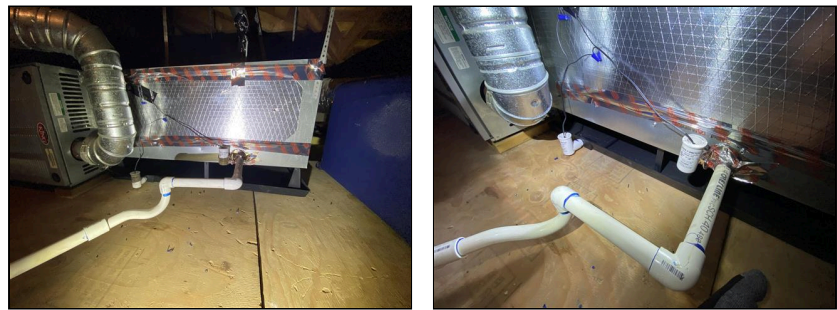
Comments: Acceptable

Primary and secondary condensation lines present. Primary line is a drain, secondary is a moisture kill switch. Kill switch in the pan as well.

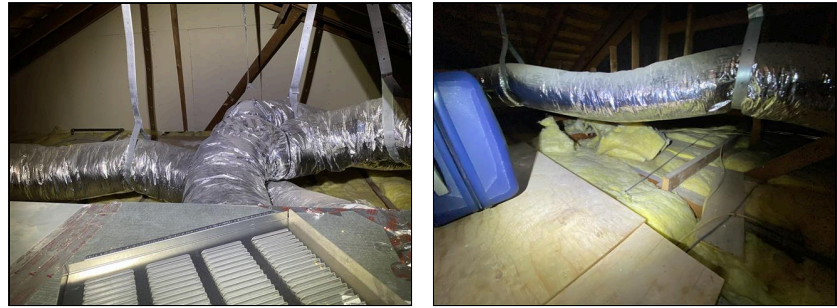
7.7 Air Distribution (including ducts and piping, air filters, registers, radiators)

Comments: Acceptable

Insulated ductwork, no signs of defect.

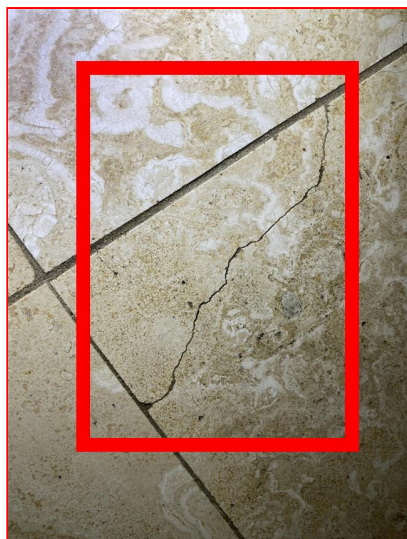
Marginal

Crack in the bathroom tile.

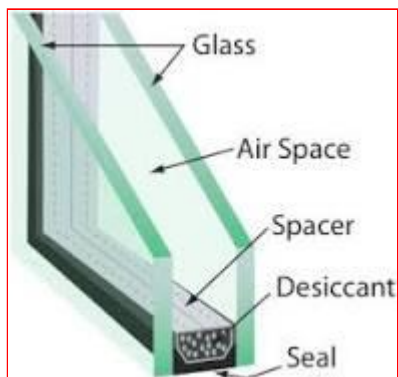
Defective

The seal/dessicant between glass panes are failing at some windows. This has compromised the space between the panes of glass and may allowed moisture in, causing discoloration and haze. Window contractor to advise.
