WOOD DESTROYING PESTS AND ORGANISMS INSPECTION REPORT

BUILDING NO. 5875	STREET, CITY, STATE, ZIP Highplace Drive, San Diego CA 92120	Date of Inspection 4/7/2023	No. of Pages 7

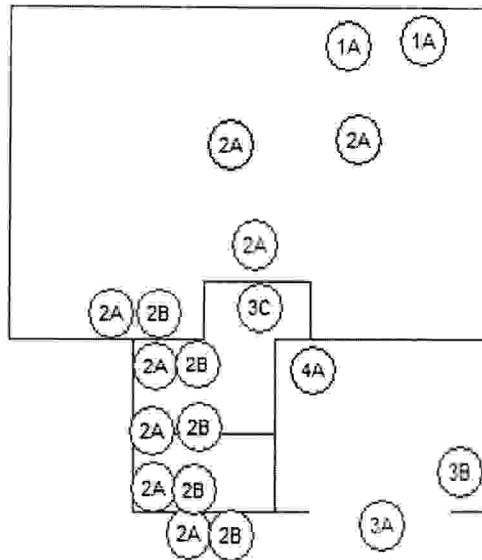
Diagram not to scale, findings in approximate locations.

FINDING: Evidence of subterranean termites noted in attic of residence, see 1A on diagram.

FINDING: Evidence of drywood termites noted in exposed wood members of residence, see 2A on diagram.

FINDING: Evidence of drywood termite damage noted in entryway eaves, beams, and posts of residence, see 2B on diagram.

FINDING: Fungus damage noted in eaves of residence, see 3A on diagram.

FINDING: Fungus damage noted in garage door jambs of residence, see 3B on diagram.

FINDING: Fungus damage noted in roof beam tail of residence, see 3C on diagram.

FINDING: Moisture damage noted in small garage door of residence, see 4A on diagram.

RECOMMENDATION: Drill through concrete slab of infested areas, inject chemical (TERMIDOR) as needed for control of subterranean termites. Plug holes and break down all visible and accessible subterranean tubes as needed. Chemically treat exterior foundation as needed for control of subterranean termites. Chemical to be used (TERMIDOR). **NOTE When D & S Termite Control must drill through concrete that is covered by carpet, furnishings or any other floor coverings, D & S Termite Control cannot be responsible for moving furniture or replacement of the carpet, padding or other floor coverings. If D&S Termite Control must drill through tile flooring we cannot be responsible for chipped or cracked tile or matching of grout. **PLEASE notify D&S Termite Control technician of any PVC (Plastic) plumbing, ducting, radiant heating or any other concealed conduits in the areas to be treated. D&S Termite Control cannot be responsible for any plumbing leaks that may occur. Treatment guaranteed for one year.

RECOMMENDATION: Fumigate entire structure with lethal fumigant Sulfuryl Fluoride (VIKANE) Introduce Chloropicrin (tear gas) as needed as a warning agent. Fumigation will assure complete elimination of drywood termites, cover or clean up all visible and accessible pellets as needed. Fumigation notice and pesticide disclosure MUST be read and signed prior to injection of fumigant. Fumigation guaranteed for two years. **ALL FUMIGATIONS CANCELED LESS THAN 72 HOURS PRIOR TO SCHEDULED DATE WILL BE SUBJECT TO A CANCELLATION FEE OF 25% OF THE FUMIGATION COST.**

RECOMMENDATION: Remove and replace or repair drywood termite damage as needed. Work completed by D&S Termite guaranteed for one year. If certification is required D&S Termite must re inspect work completed by others. D&S Termite does not guarantee work completed by others. D&S Termite & Pest Control will apply primer coat, but cannot be responsible for match of color. If during the course of repair work, fungus and/or termite damage extends into inaccessible areas, there may be an additional charge for repairs. D&S Termite & Pest Control will contact you about additional charges if any.

RECOMMENDATION: Remove and replace or repair fungus damaged wood as needed. Work completed by D&S Termite guaranteed for one year. If certification is required D&S Termite must re inspect work completed by others. D&S Termite does not guarantee work completed by others. D&S Termite & Pest Control will apply primer coat, but cannot be responsible for match of color. If during the course of repair work, fungus and/or termite damage extends into inaccessible areas, there may be an additional charge for repairs. D&S Termite & Pest Control will contact you about additional charges if any.

RECOMMENDATION: Install kickplate as needed. Work completed by D&S Termite guaranteed for one year. If certification is required D&S Termite must re inspect work completed by others. D&S Termite does not guarantee work completed by others. D&S Termite & Pest Control will apply primer coat, but cannot be responsible for match of color. If during the course of repair work, fungus and/or termite damage extends into inaccessible areas, there may be an additional charge for repairs. D&S Termite & Pest Control will contact you about additional charges if any.
