Inspection Report
1745 South Harvard Boulevard, Los Angeles 90006

Report ID
NXT-229-001696

Inspection Date
June 17, 2021 at 10:00 AM

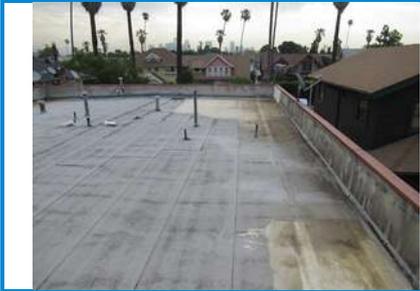
Location: ROOF

Evidence of ponding were noted on the roof. This creates Chance of water damage to structure, further evaluation and repair by a licensed roofing contractor.

1.1 Ponding /temporary patch work

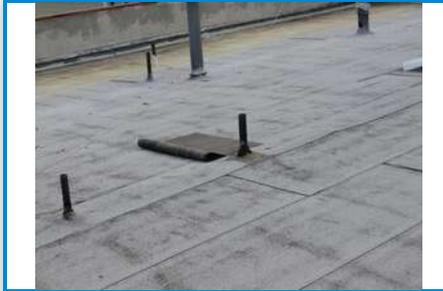
Location: ROOF

1.2 Ponding /temporary patch work

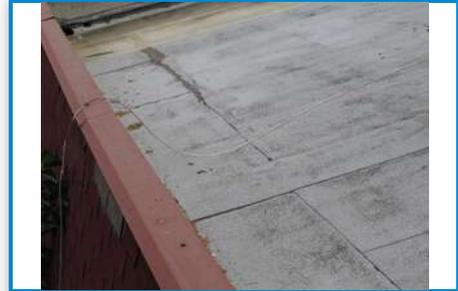
Location: ROOF

1.3 Ponding /temporary patch work

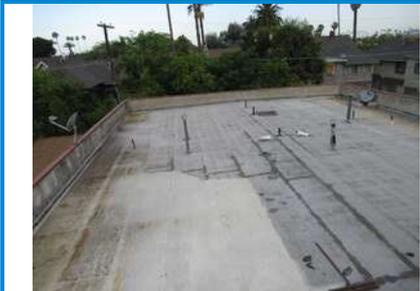
Location: ROOF

1.4 Ponding /temporary patch work

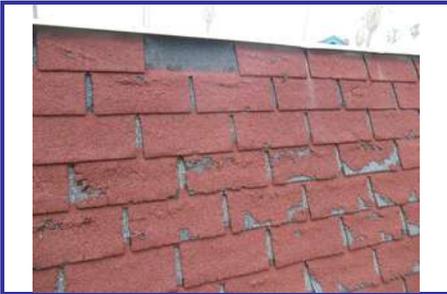
Location: ROOF

The roof had shingles that were damaged or had exposed roofing nails, unsealed nails or other defects in various locations at the time of the inspection. The Inspector recommends sealing of any exposed nails and replacement of any damaged shingles by a qualified roofing contractor to industry standard in order to avoid damage from moisture related issues. After these repairs are made the roof should be certified for five years.

1.1 Damaged shingles

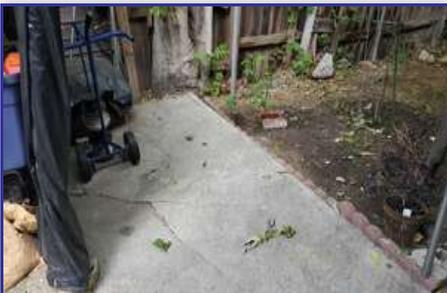
Location: EXT GROUNDS /REAR PATIO

Tree roots have caused movement and damage to area(s) of the walkway/driveway. Removal of the tree or root should be considered and repairs made to the driveway/walkway. The Inspector recommends that the affected area(s) be evaluated, replaced or repaired, as needed, by a professional concrete contractor.

1.1 Heaving (roots)

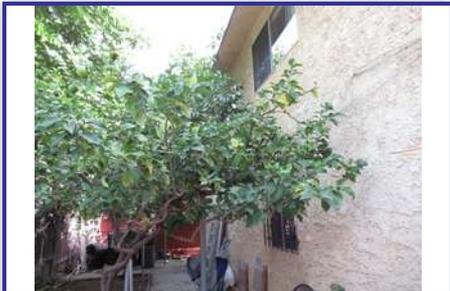
Location: ROOF

There are tree limbs that are in contact with roof, or hanging near roof and should be trimmed back. The inspector recommends that the trees be trimmed, by a professional tree trimming contractor.

1.1 Vegetation near or in contact with structure

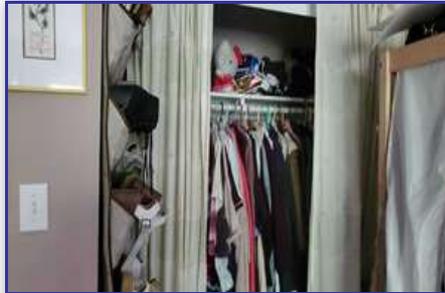
Location: 2ND FLOOR UNIT 1749 /BEDROOM 1

Closet doors were missing/not installed in one or more locations. Recommend installing as necessary.

1.2 Missing closet door

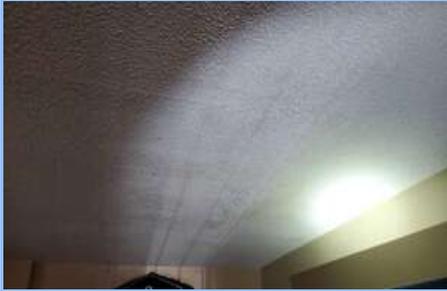
Location: UNIT 1745/LIVINGROOM

Stains and/or elevated levels of moisture were found in one or more ceiling areas. The stains/moisture appear to be due to an active plumbing leak. Recommend that a qualified contractor evaluate and repair as necessary.

1.1 Ceiling stains (dry at time of inspection)

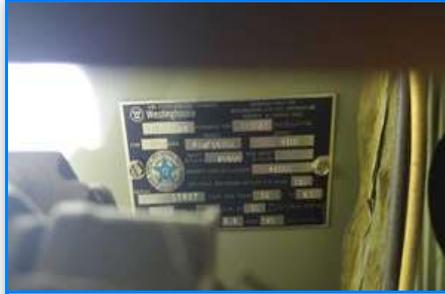
Location: 1745/ FURNACE

The furnace was at or past its recommended lifespan. It was visibly old and dirty and should be serviced at the least. The Inspector recommends that the furnace is evaluated, serviced or replaced, as needed, by a professional HVAC contractor, to ensure the best possible working condition.

4.1 Service and certify unit (past life expectancy)

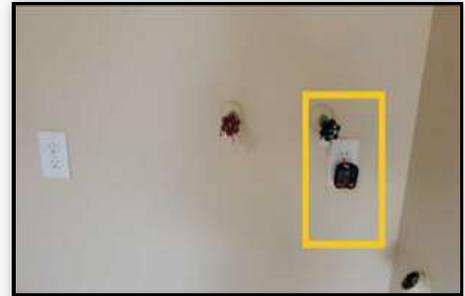
Location: KITCHEN

Kitchen electrical outlets were operable at the time of the inspection but no Ground Fault Circuit Interrupter (GFCI) protection were installed. GFCI protection should be installed for outlets within 6 feet of plumbing fixtures or on kitchen counters, as they were required in kitchens starting in 1987 by the NEC. Recommended this be done by a professional electrical contractor.

1.2 Missing gfci (update)

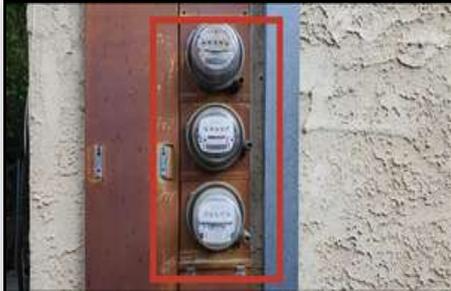
Location: EXT BUILDING

The seal for the metal ring securing the electric meter to its base is missing or broken. The utility company installs these seals. Recommend consulting with the property owner(s) about this and/or contacting the utility company to have one reinstalled.

1.1 Missing seal lock

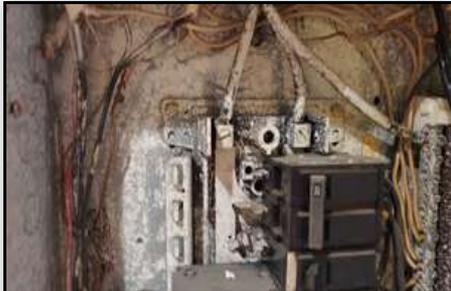
Location: 1745/ HALLWAY/ DISTRIBUTION PANEL

There was paint and other materials in the panel. We recommend that the panel be cleaned and and repaired as needed.

1.1 Overspray in panel

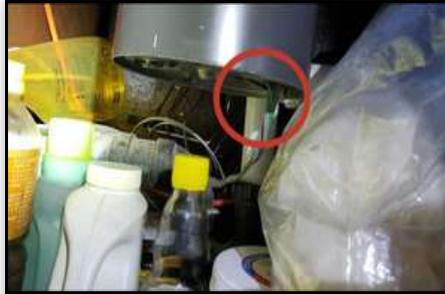
Location: 2ND FLOOR UNIT 1749 KITCHEN

The opening for the electric power cord to exit the bottom or side of a garbage disposal housing has sharp edges. The concern is that these sharp edges, due to use, vibration, reaching for items under the sink, or over time, may cut into the electric cord and cause a short or spark.

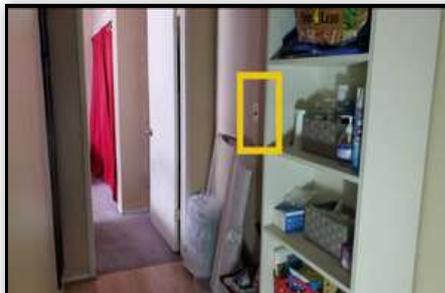
Location: 1745/ FURNACE

The light fixture in one or more long hallways or room that can be entered from two locations was controlled by a single switch at one end. This is a safety hazard due to inadequate lighting. The light should be controlled by 3-way switches at each end of the hallway / room so it can be easily operated at both ends. Recommend that a qualified electrician repair per standard building practices.

1.2 Improper connection 3 way

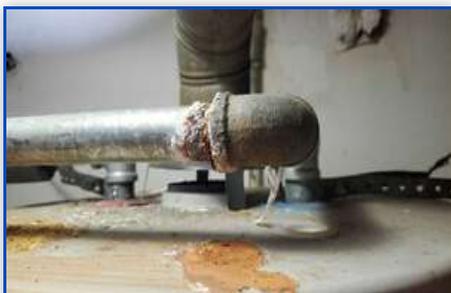
Location: 1745 WATER HEATER/GARAGE

Corrosion was found at water supply pipes, water shut offs, and/or fittings. This can indicate past leaks, or that leaks are likely to occur in the future. Recommend that a qualified plumber evaluate and replace components as necessary.

3.1 Corroded galvanized water lines

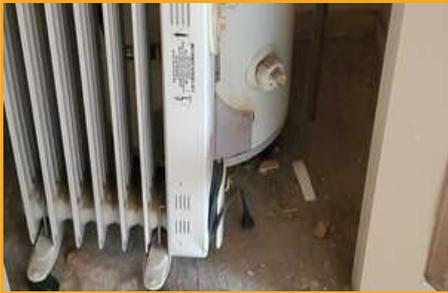
Location: 2ND FLOOR UNIT 1747 /WATER HEATER

There were scorch marks above the burner chamber indicating flame roll out. This unit needs to be serviced as soon as possible.

3.1 Scorched marks

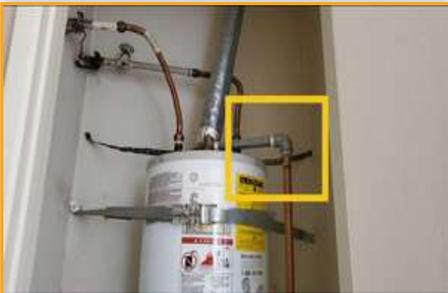
Location: 2ND FLOOR UNIT 1747 /WATER HEATER

The TPR discharge pipe was threaded on the end leaving it easy to connect other lines to it such as a hose or other fittings. This is not to industry standard and can be unsafe. The inspector recommend that the discharge pipe be repaired to industry standard with the proper material by a professional plumbing contractor.

4.1 Threaded parts
