Sunset Property Inspection

Confidential - Property Inspection Report - Confidential

14068 Pebble Brook Ln

Date of Inspection: 6/28/2022

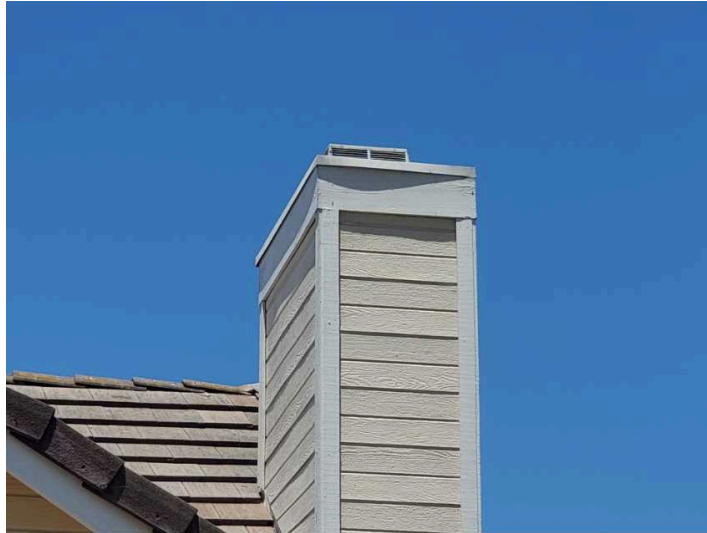
- Appeared functional (using binoculars) with no deficiencies noted, at time of inspection.

View of chimney

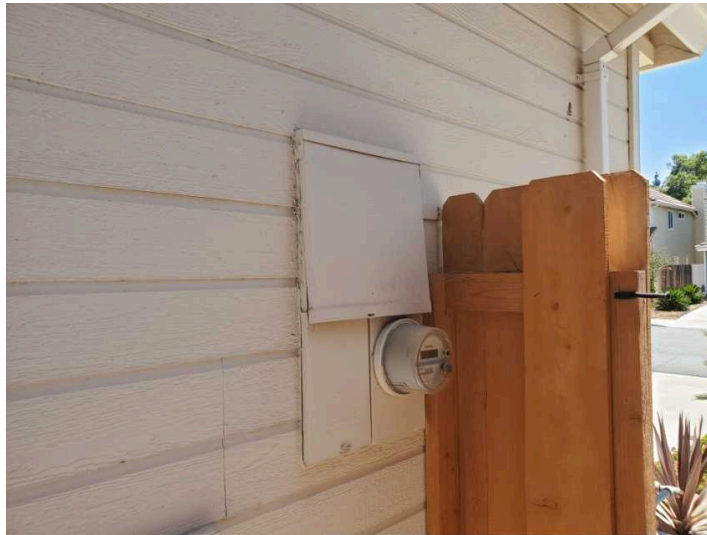
Main panel location

- Maintenance - Branch circuits were not labeled. All circuits should be labeled so that any one circuit can be quickly turned off in an emergency.

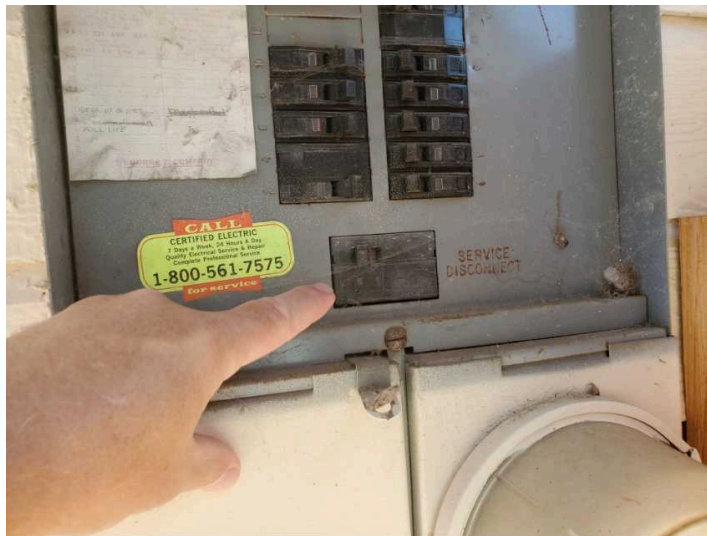
Main disconnect

- Main electrical disconnect at the 100 amp circuit breaker on panel. See photo below.

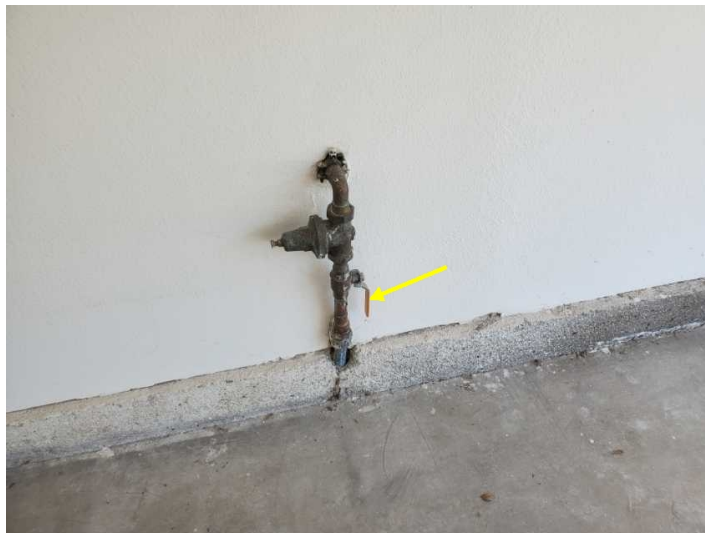
Main water shut off

- The main water supply shut off appears to be located in the garage. In the event the water needs to be shut off this valve will likely cut off the flow of water to the home. (Recommend confirming this with the property owner). Typically, the water can also be shut off at the water meter which is usually located at the sidewalk.

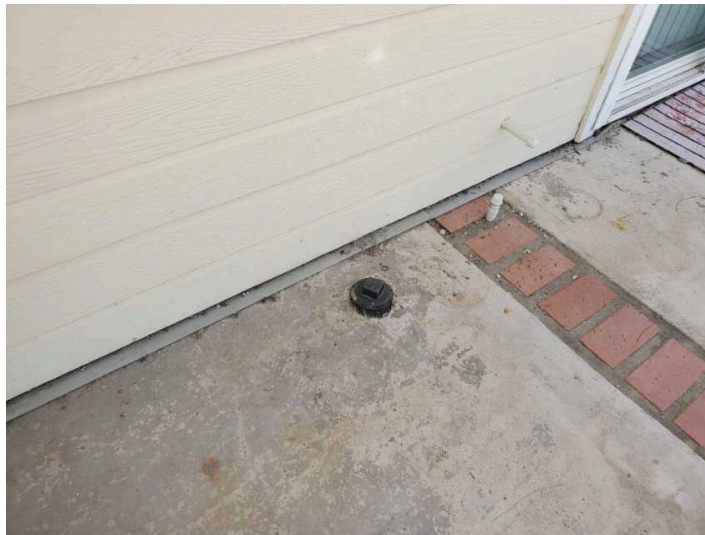
Cleanout location

- The portions of the drain, waste, and vent lines which are visible throughout the home are of the ABS plastic type and appear to be in satisfactory condition at this time. Determining the condition of the interior of the drain lines requires specialized equipment and is beyond the scope of this inspection.

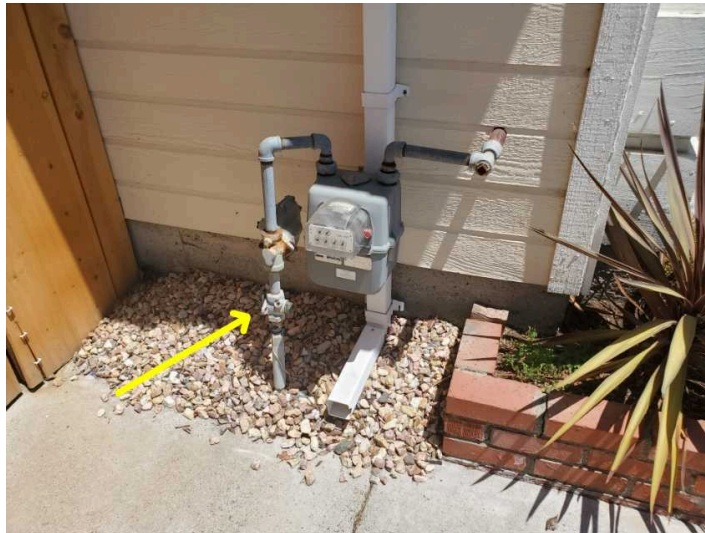
Main fuel shut off

- Public utility gas meter. Interior gas lines were not fully visible. Gas lines are rigid iron pipe. The life expectancy of the gas piping is for the life of the structure.

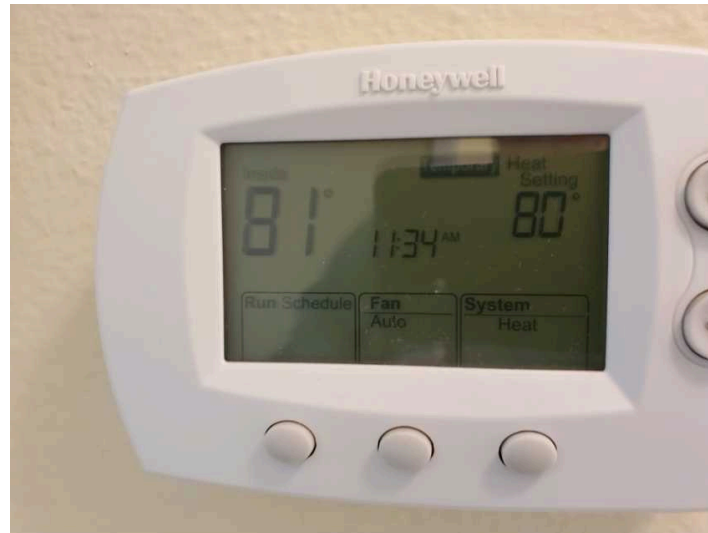
- No deficiencies noted. The temperature inside the home was too hot to test the furnace.

Temperature inside the home

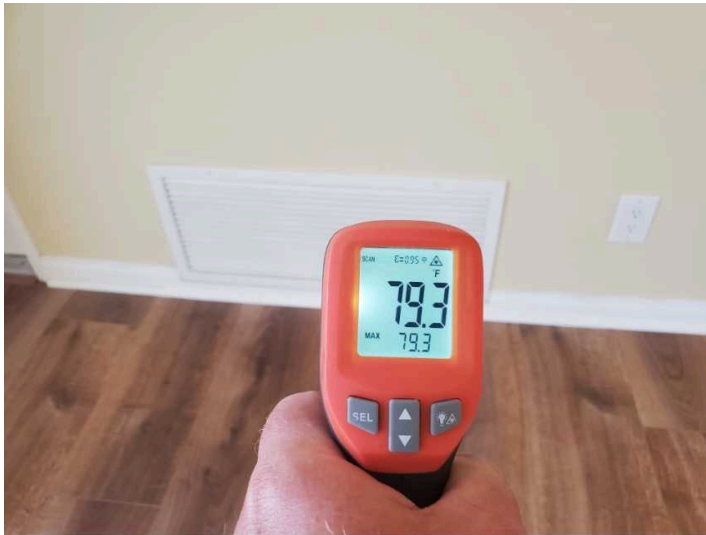
- *****COOLING*****
- An air temperature test was performed by using a thermal camera on the AC system to determine if the difference in temperatures of the supply and return air are between 14 degrees and 22 degrees which indicates that the unit is cooling as intended. Actual measured cooled supply air temp: 59 degrees - Ambient return air temp: 79 degrees. 20 degrees difference (Good Range). This is not an exhaustive test and cannot predict the performance of the AC on extremely hot or humid days.

Room temperature at return

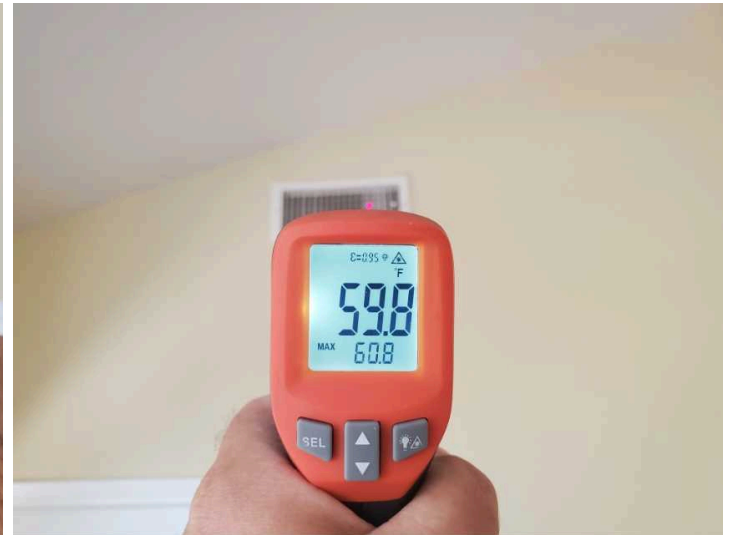
Cooled temperature at register
