Property Inspection Report

, 1333 E J Street, Chula Vista, CA 91910
Inspection prepared for: & Joy & Rob Auman
Date of Inspection: 9/28/2021 Time: 5:30 pm
Age of Home: 1999 Size: 2314 sq ft (redfin)
Weather: Clear

Inspector: Eric Martinez
NACHI12100924
2122 W Mission Rd, Escondido, CA 92029
Phone: 619-501-8282
Email: emartinez@theinspectorscompany.com

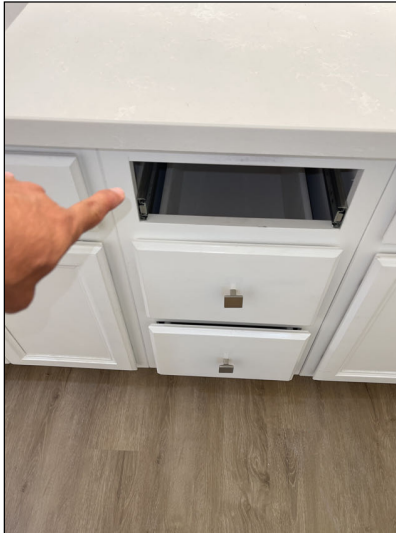
Page 39 Item: 6 Cabinets

[6.2. Cabinets/drawers missing in the bathroom.](#)

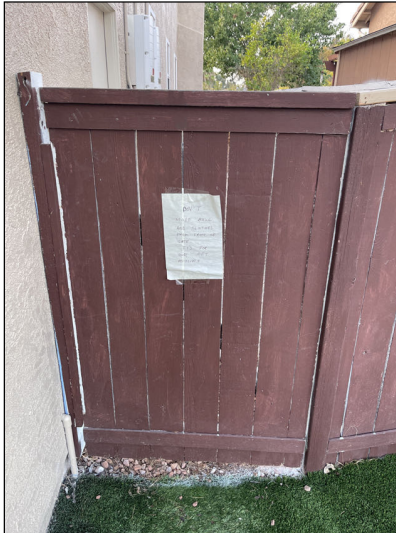
6. Gate Condition

6.1. The side yard gates were functional during time of inspection.

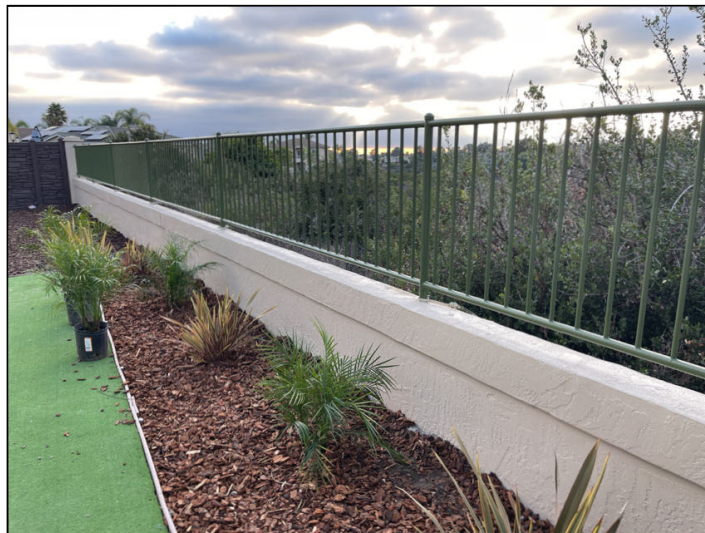
7. Fence Condition

7.1. The fences appeared serviceable at time of inspection.

7.2. The concrete block walls are in acceptable condition.

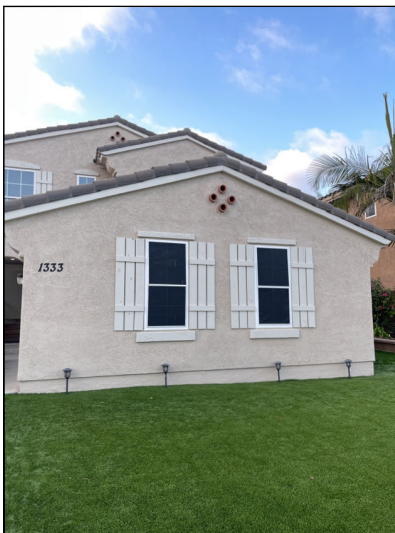
1.1. No major system or safety concerns noted.

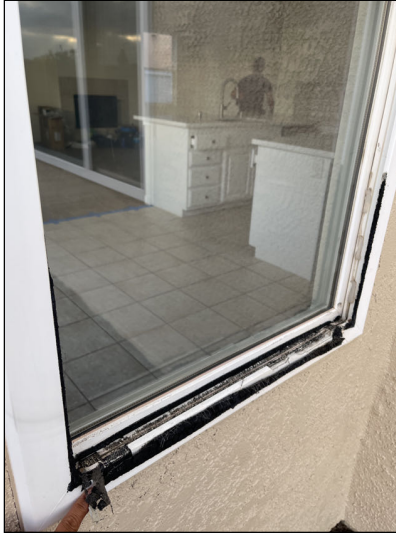
2. Window Condition

2.1. Foam insulation strips glued to windows. Recommend removal.

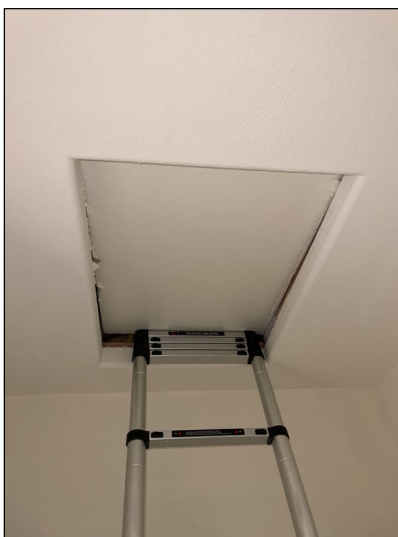
1.1. The attic access is located in the master bedroom closet.

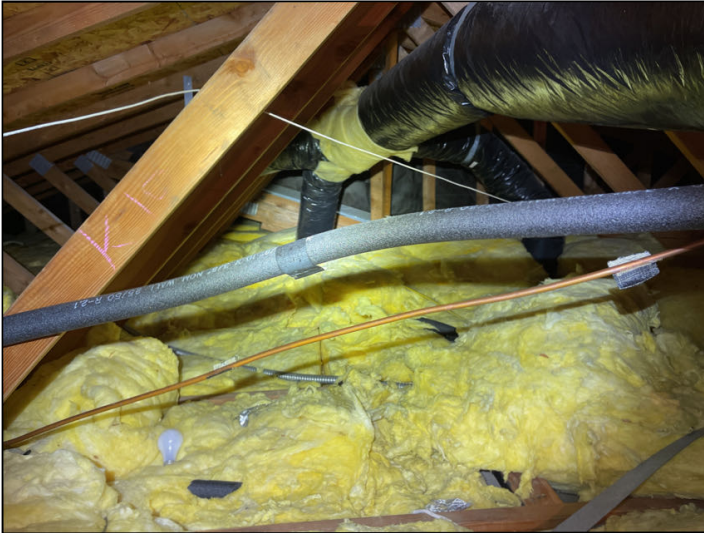
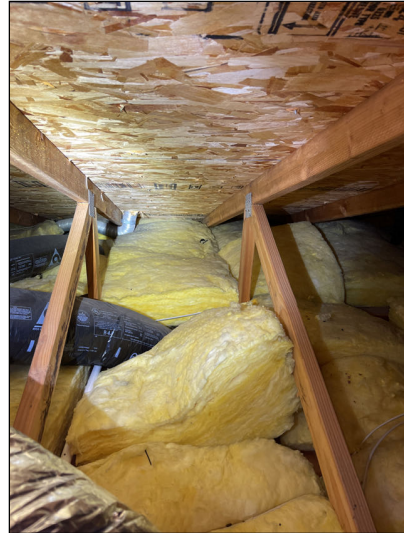
2. Insulation Condition

Unfinished fiberglass batts noted.

2.1. Insulation appears standard and adequate.

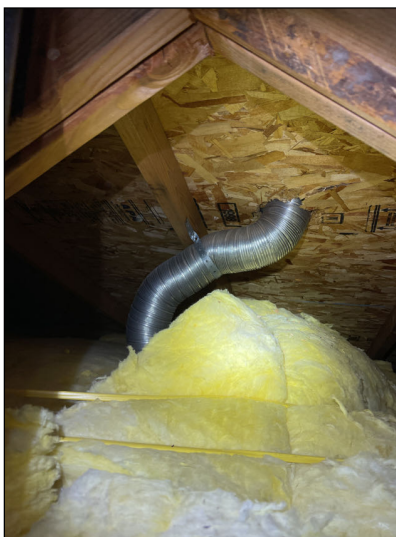
5.1. Appears to be functional.

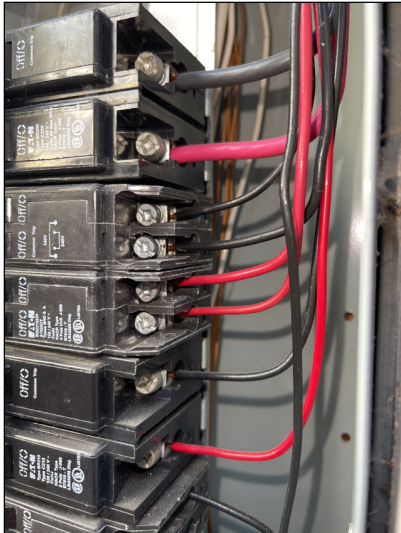
6.1. The visible portions of the wiring has no visible deficiencies.

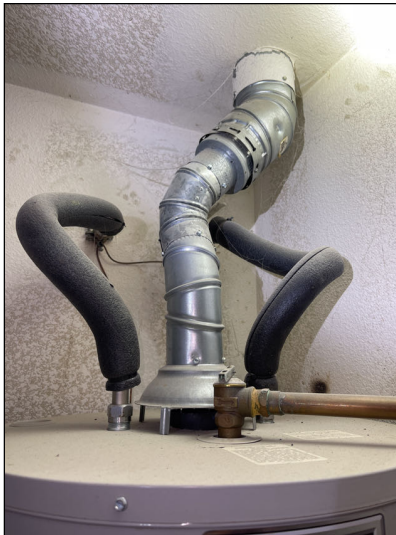
5.1. Appears functional during the time of inspection.

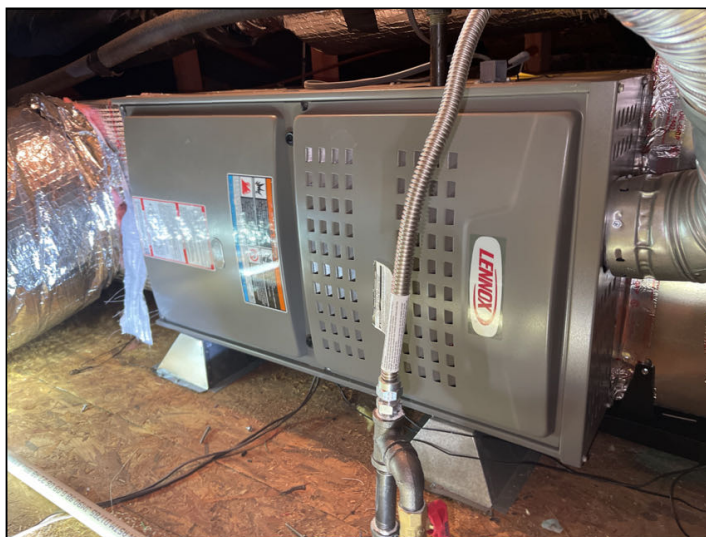
1. Heater/FAU Condition

1.1. The heating unit is functional at the time of the inspection.

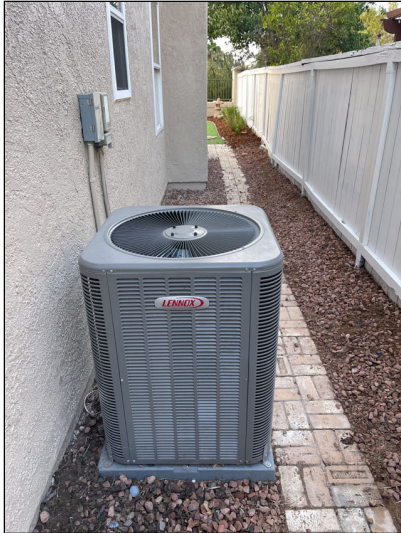
9. AC Condenser Condition

9.1. Appeared functional at the time of inspection.

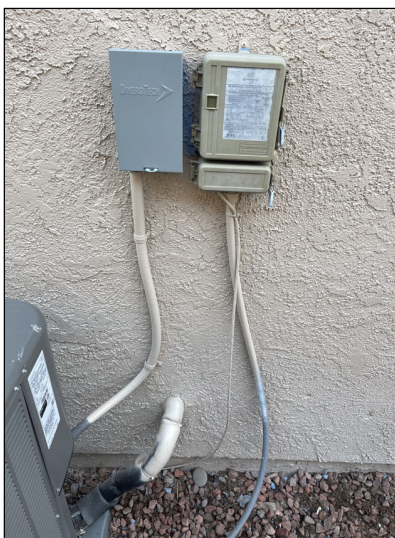
10. AC Disconnect

10.1. Disconnect present

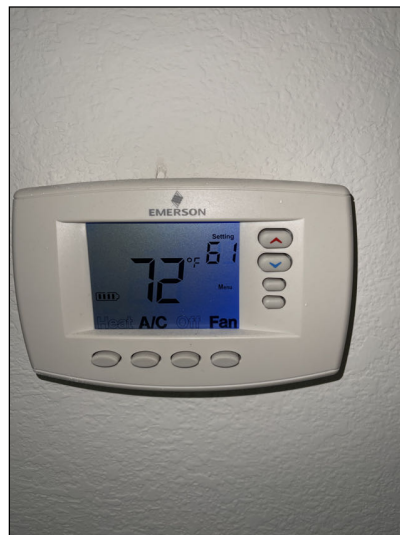
13. Thermostats

13.1. Functional at the time of inspection.

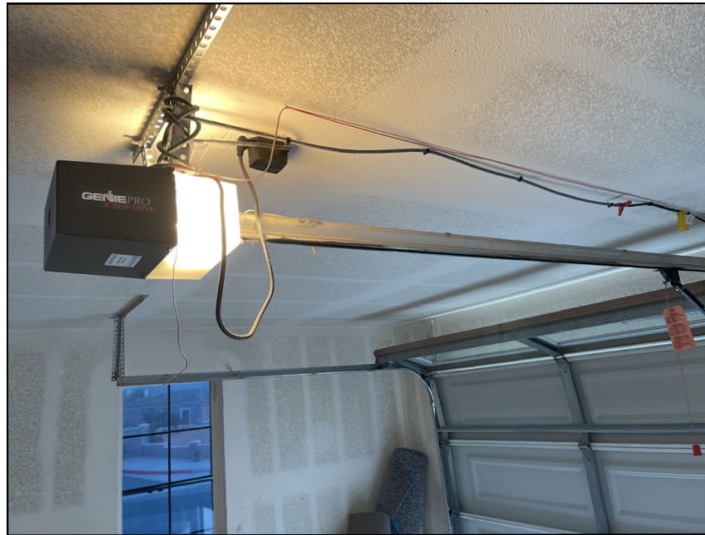
3.1. The garage door opener and its components were functional at the time of inspection.

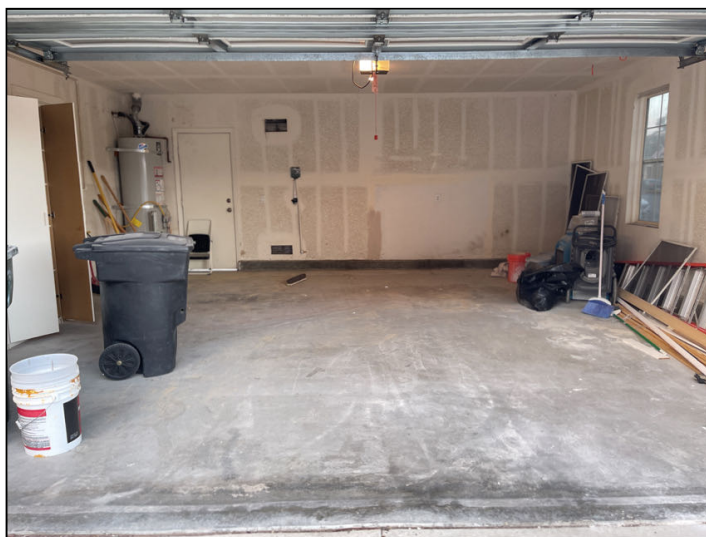
8.1. Appeared satisfactory, at time of inspection.

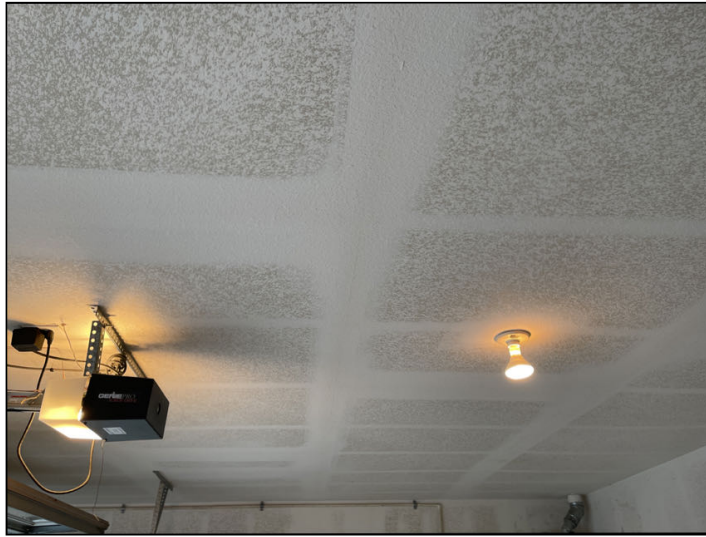
9. Rafters & Ceiling

9.1. The garage ceilings are in acceptable condition.

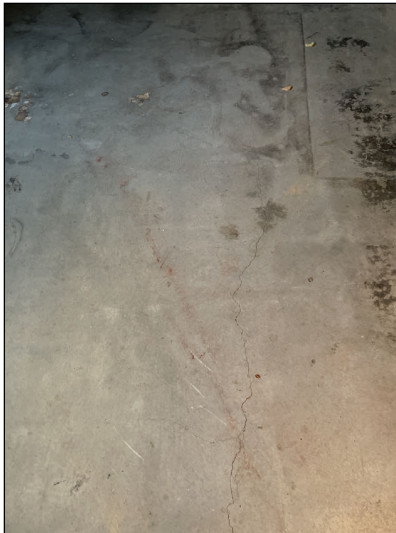
10. Floor Condition

10.1. The slab floor is in acceptable condition. Small cracks are common and result as a consequence of the curing process, seismic activity, common settling, or the presence expansive soils, but are not structurally threatening. Also, you may notice some salt crystal formations that are activated by moisture penetrating the slab.

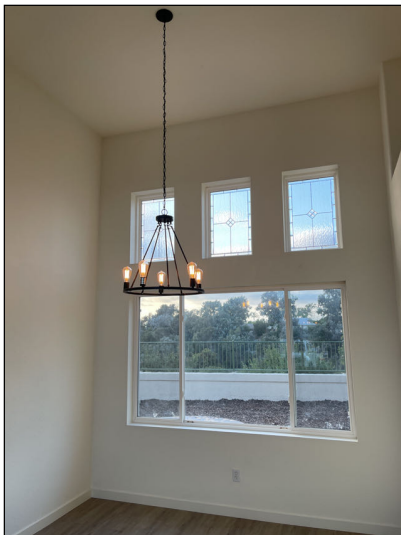
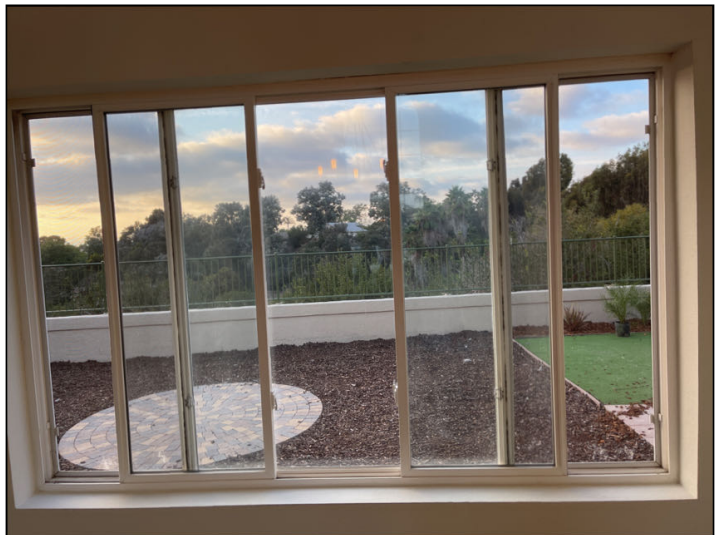
1.1. The general condition of the interior floor, walls, ceiling, windows, outlets are functional and in satisfactory condition.

1.2. Limited review of the interior during the time of inspection due to a number of personal items blocking access. Advise verifying condition with a qualified professional as needed.

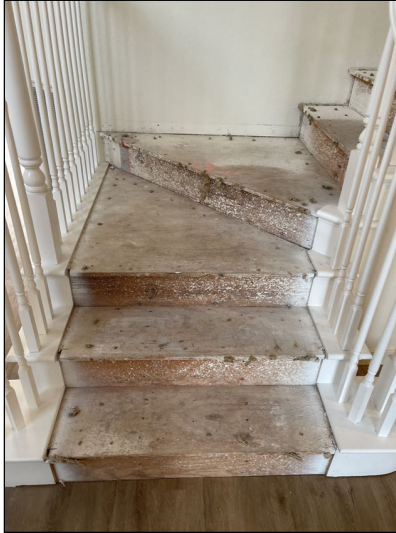
2. Floors Condition

2.1. Flooring/carpet not installed in some areas.

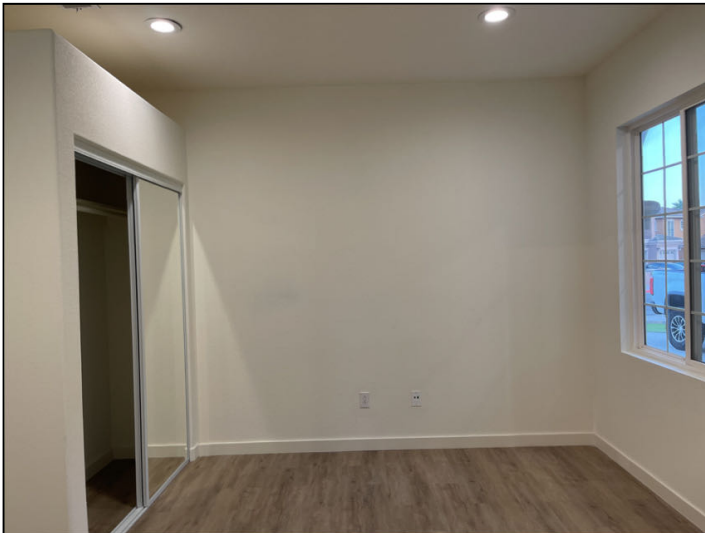
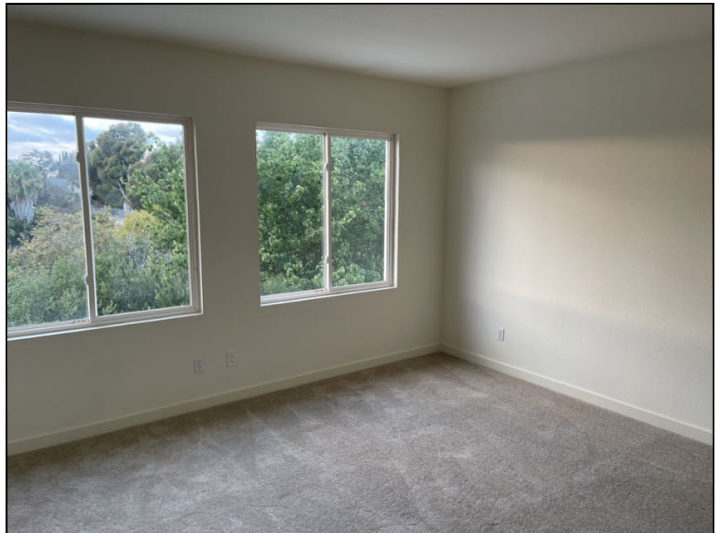
1. General Comments/Observations

1.1. The general condition of the bedroom floor, walls, ceiling, windows, outlets are functional and in satisfactory condition.

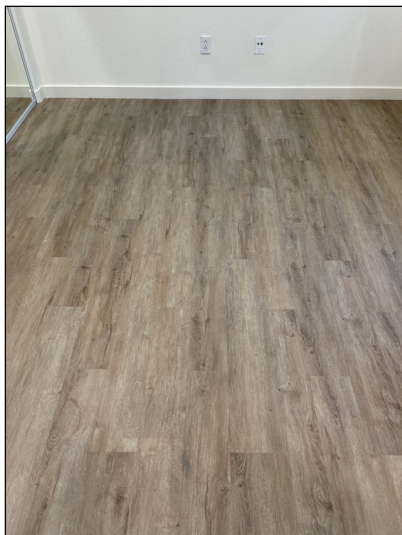
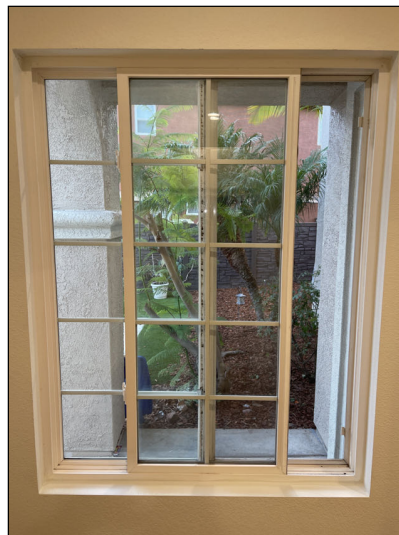
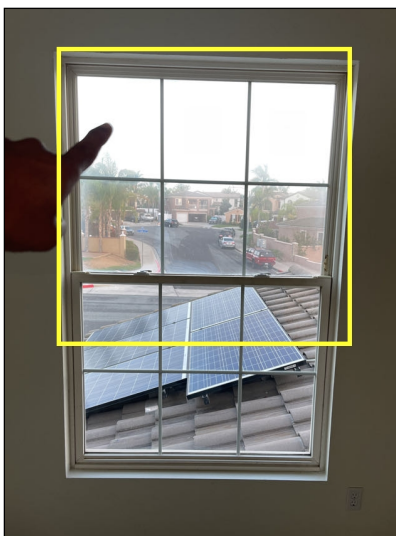
2. Window Condition

2.1. Bedroom windows show signs of loss of seal/condensation.

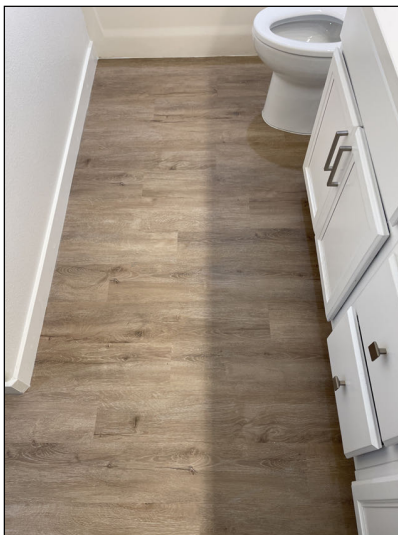
4. Floor Condition

4.1. The bathroom floors have no significant defects.

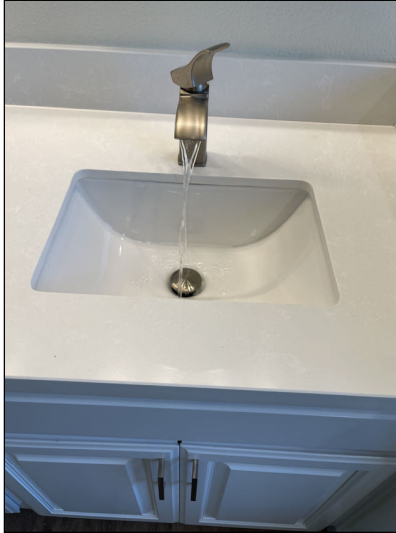
7.1. The bathroom(s) counter tops are in acceptable condition.

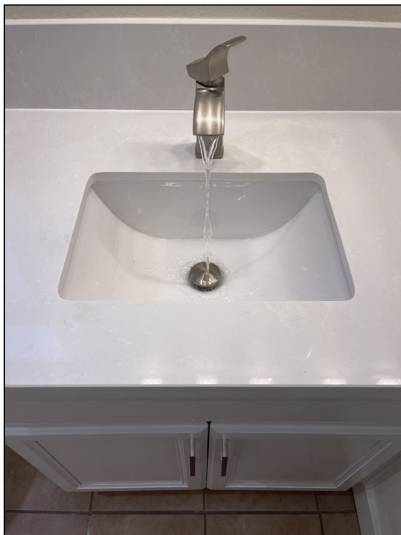
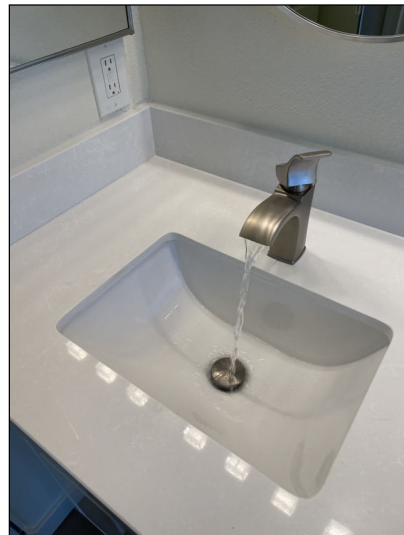
8. Sinks

8.1. The bathroom sink and its components were functional.

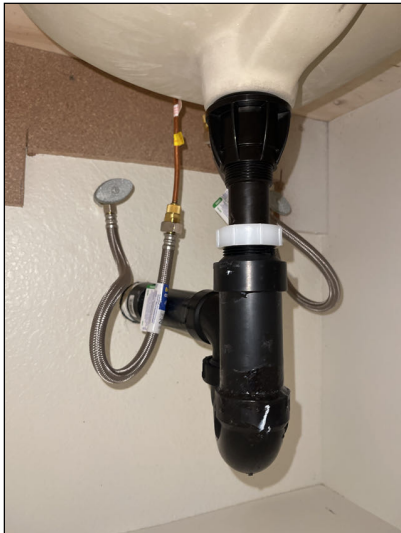
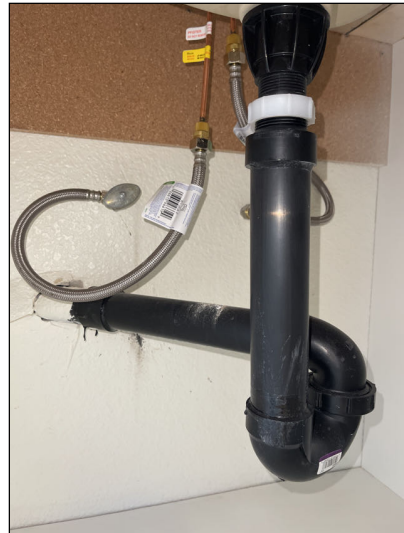
9. Plumbing

9.1. The sink drain P- trap and drain are functional.

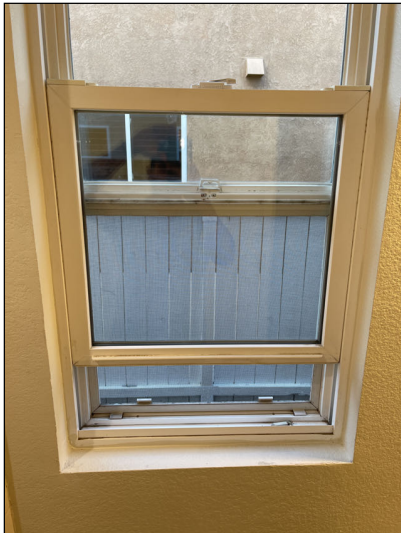
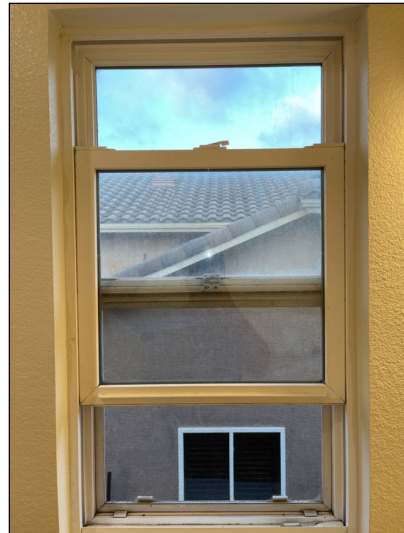
10. Window Condition

10.1. The bathroom(s) windows were functional at the time of the inspection.

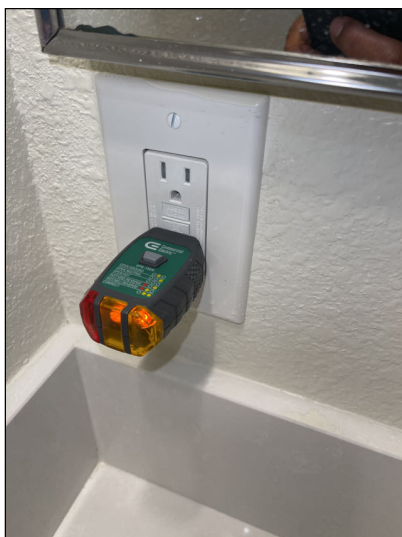
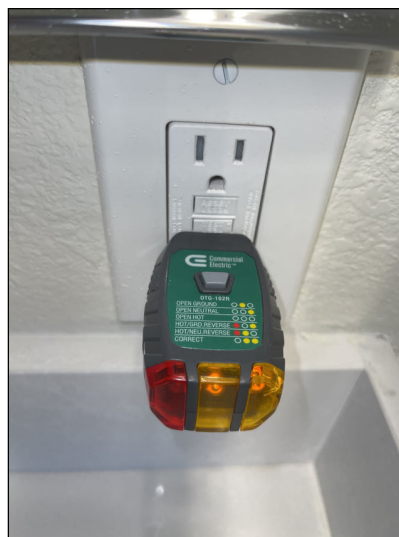
11. GFCI

11.1. GFCI in place and operational.

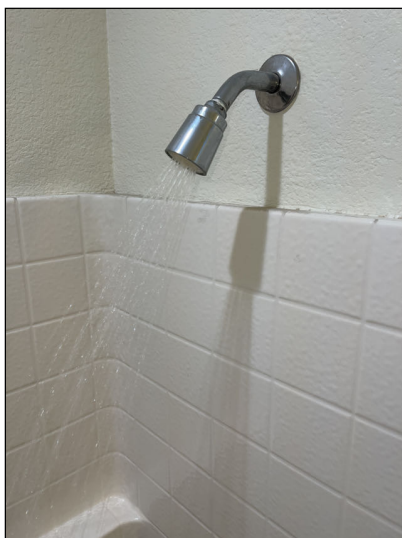
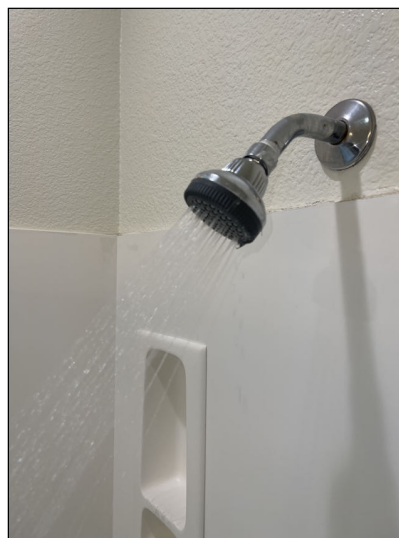
12. Showers

12.1. The bathroom showers was functional.

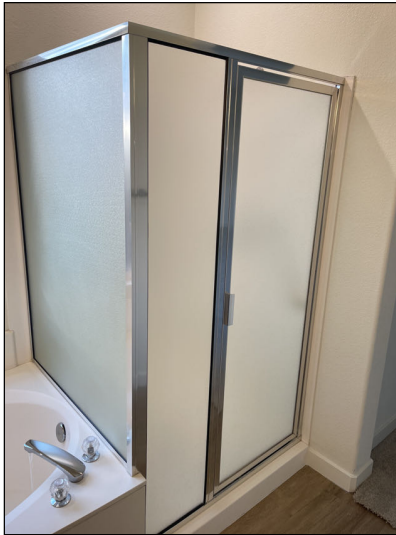
14.1. The shower enclosure was functional at the time of the inspection.

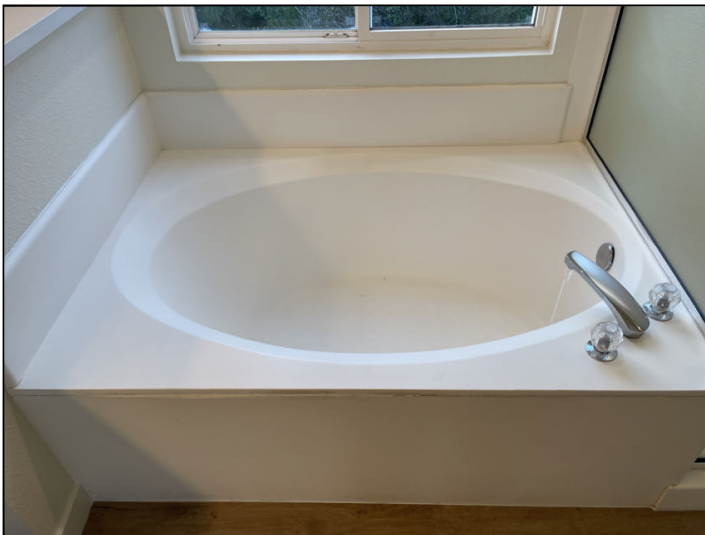
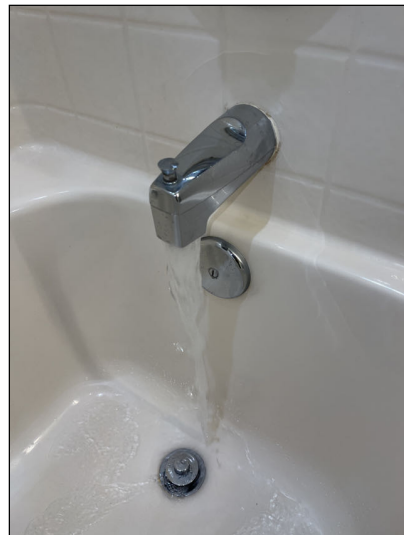
15.1. The bathroom tub is functional.

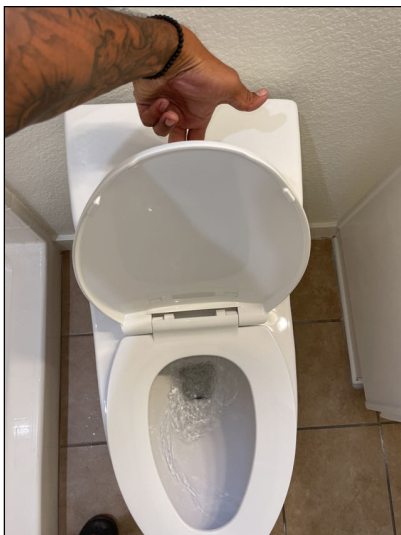
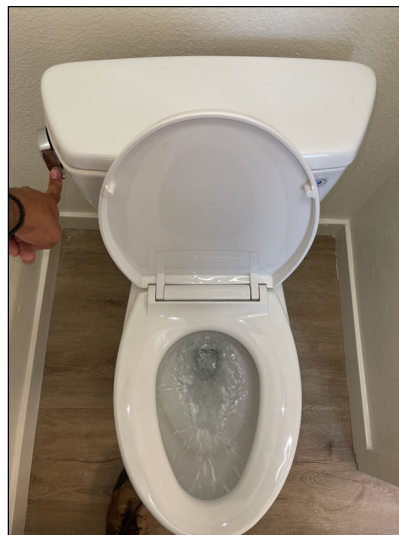
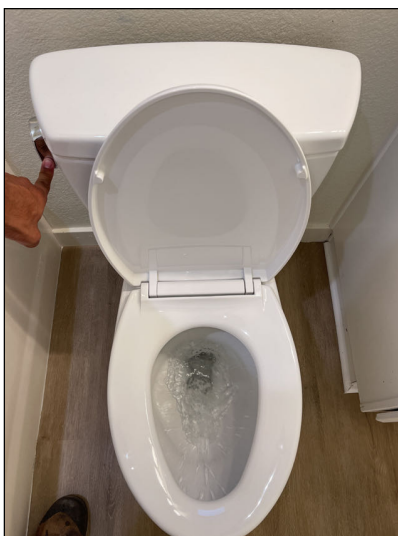
16.1. Toilets are functional and in good visual condition.

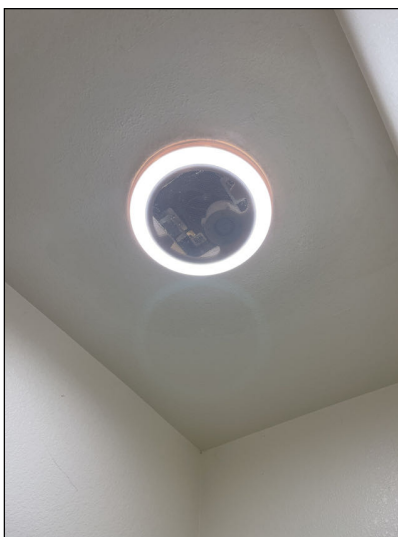
17.1. The bathroom exhaust fan operated when tested at the time of inspection.

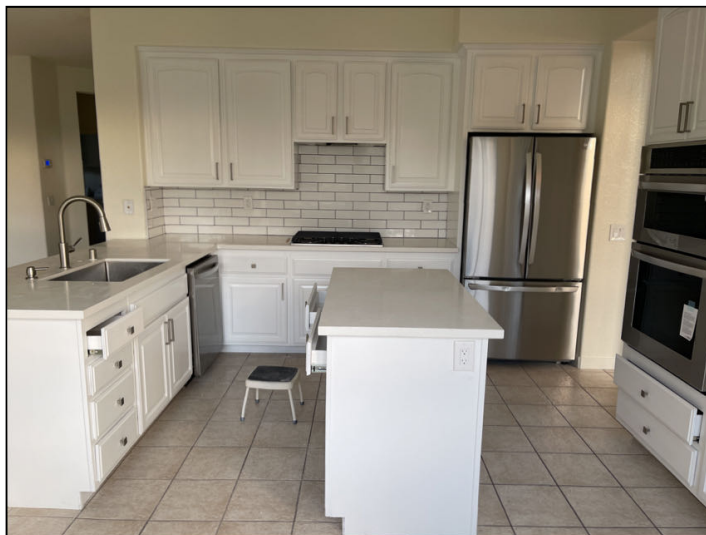
1.1. The general condition of the kitchen floors, walls, ceiling, windows, functional and in satisfactory condition.

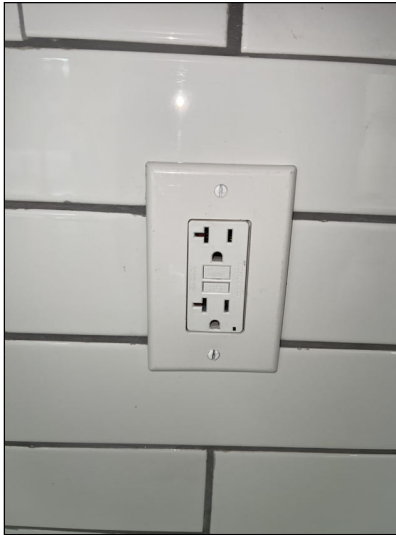
9.1. GFCI in place and operational at some outlets.

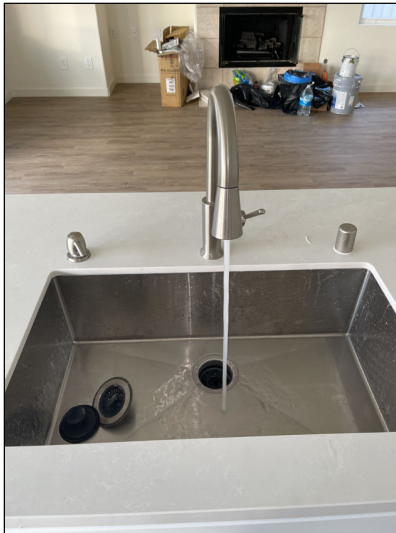
10.1. The kitchen sink valves and connector were functional at the time of inspection.

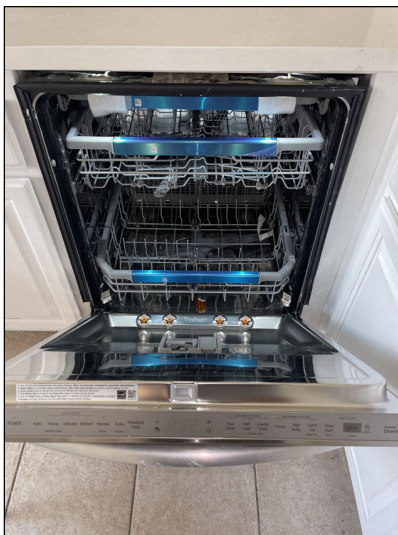
11.1. The dishwasher turned on and was functional.

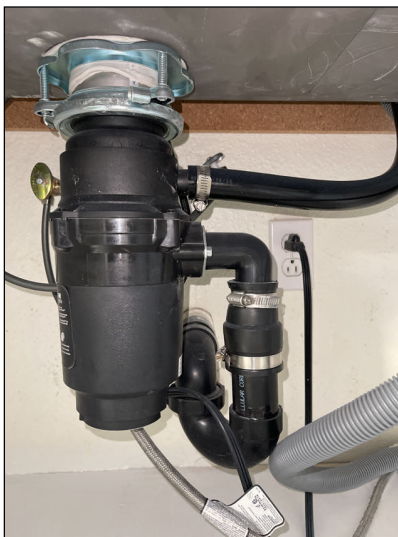
13.1. The sink drain P- trap and drain are functional.

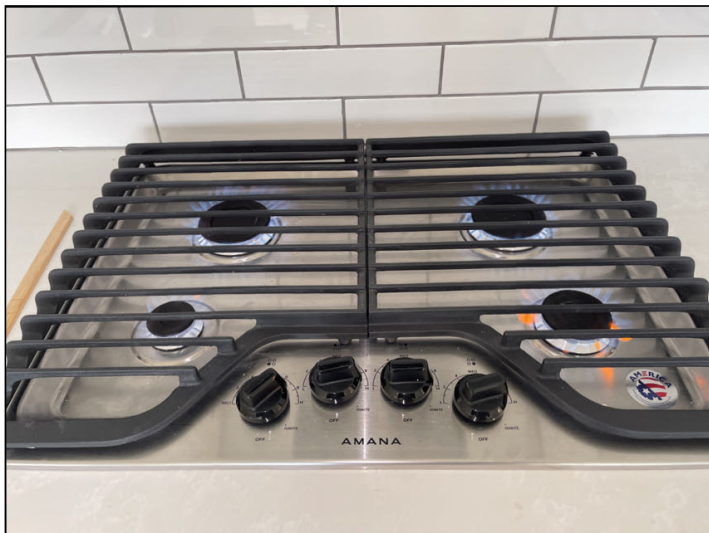
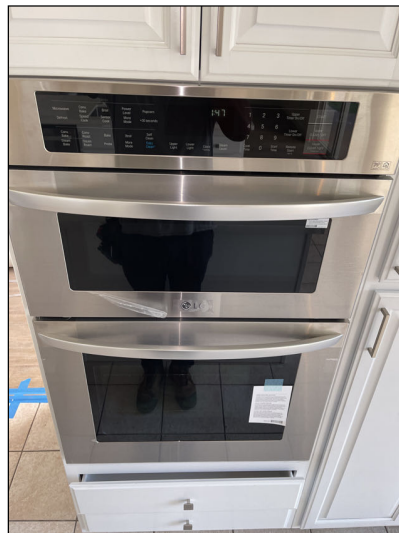
16.1. The cook top operated and was functional.

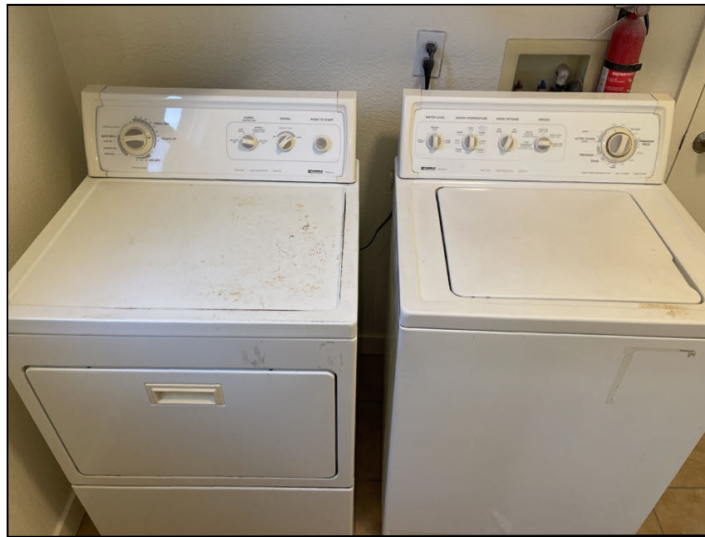
1.1. Our inspection did not include the laundry room and/or appliance. We do not remove / pull appliance away from the wall surface this can cause moisture damages. Also we do not test or evaluate the 240-volt electrical outlet and gas connections. Refer to the sellers disclosure to advise.

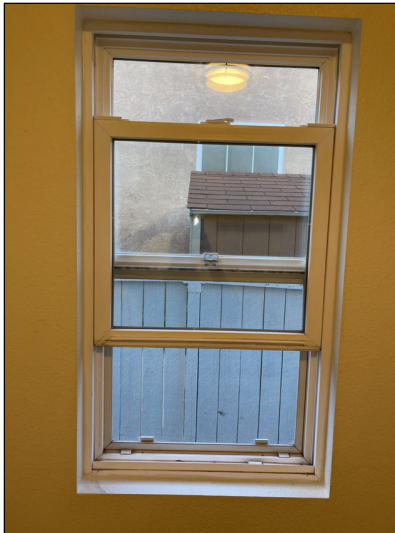
- The windows that were tested, are functional.

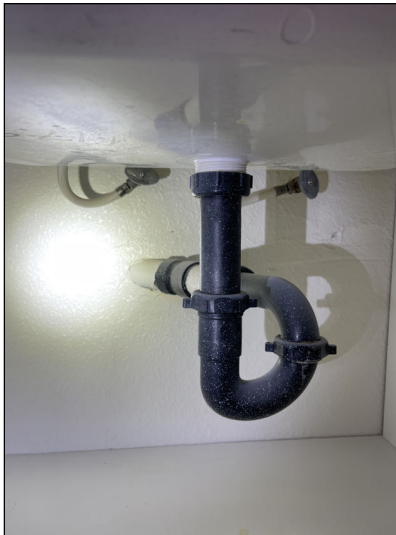
- 3.1. Sink appears to be cracked.
